A Bank Erosion Hazard Index (BEHI) Study of Dry Run Creek, Cedar Falls, Iowa

A BANK EROSION HAZARD INDEX (BEHI) STUDY
OF DRY RUN CREEK, CEDAR FALLS, IOWA

May 2013

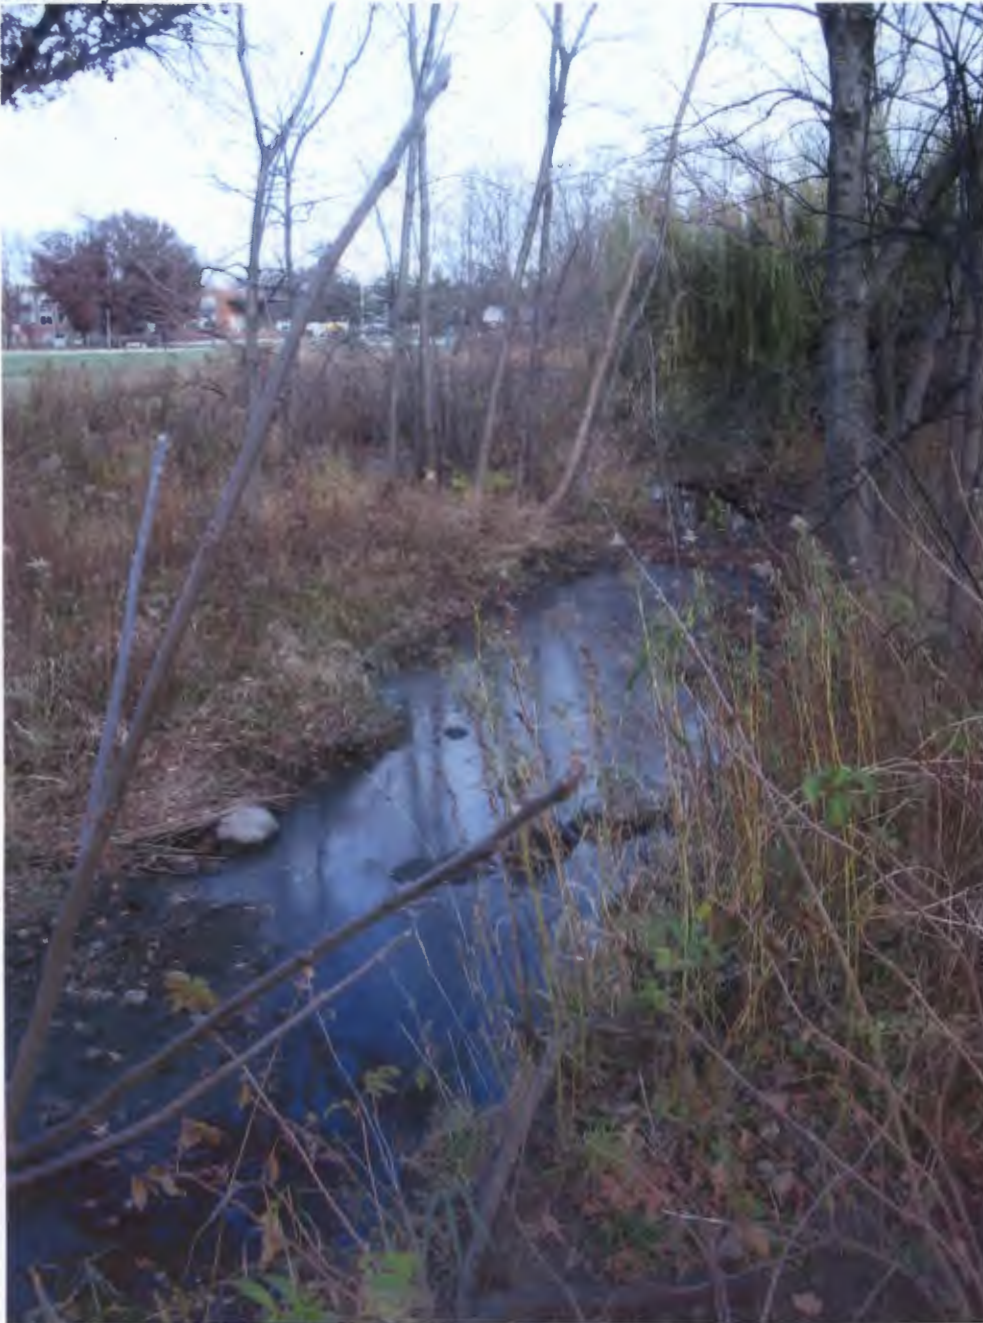
**Figure 6. Stretch U2**

Stretches U1 and U2 were similar in that they were in an urban area, had root density and surface protection of 30-79%, were composed of clay/silt, had a bank angle of 21-60°, and had root depth of 15-29%. Figure 6 represents conditions at U1 and U2. These stretches had a Moderate BEHI score.

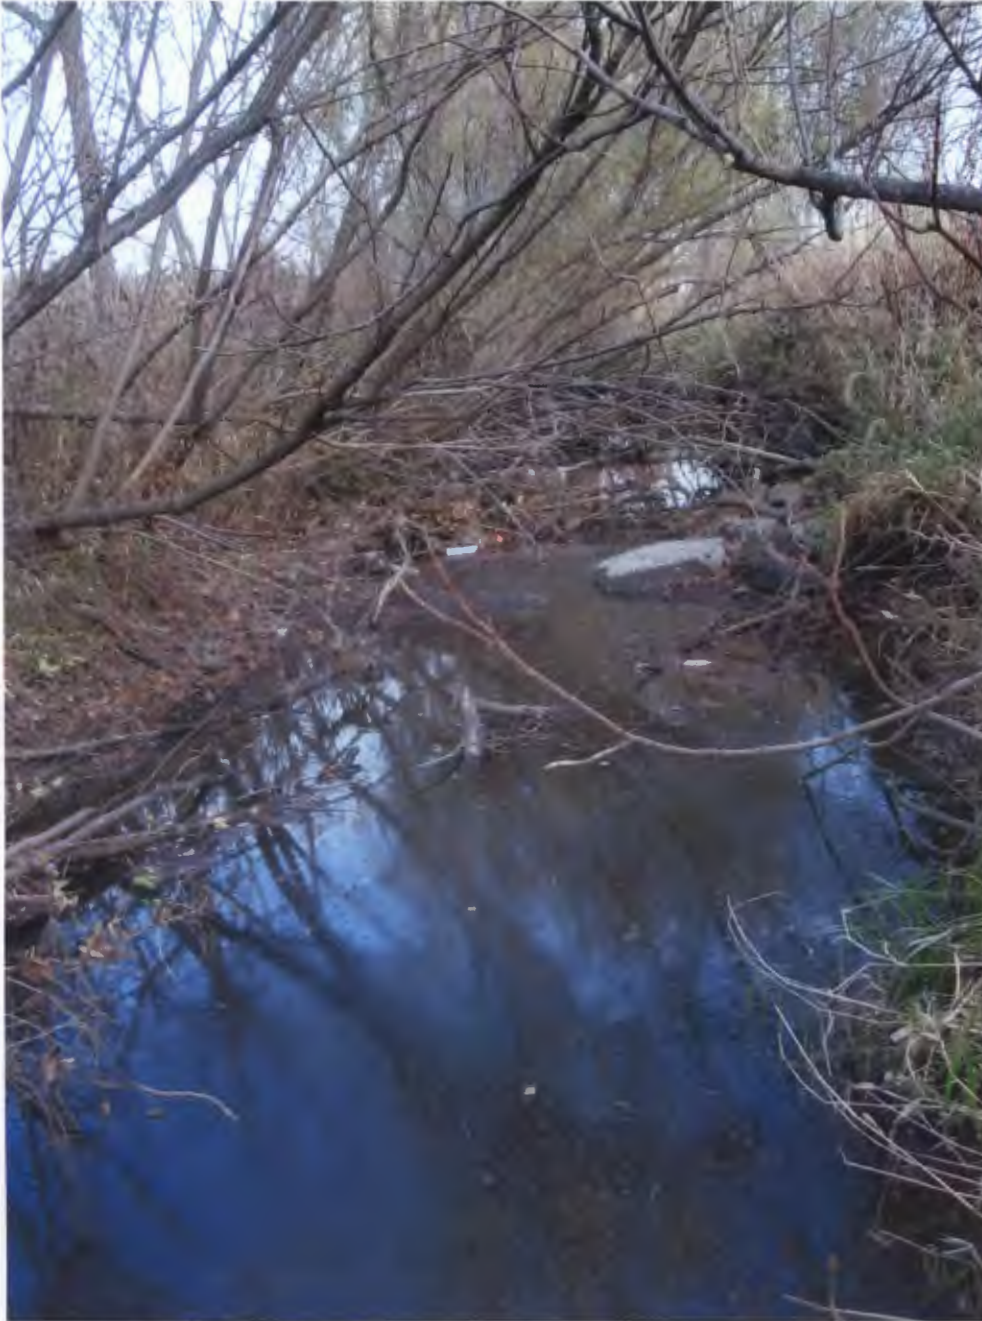
Figure 7. Stretch U4

Figure 7 represents the conditions at U3 and U4. These stretches had a Low BEHI score, and were in an urban area. A drainage pipe was located in the middle of stretch U3. These stretches had a bank angle of 21-60°, surface protection and root density of 55-79%, and root depth of 90-100%. The banks were composed of clay/silt.

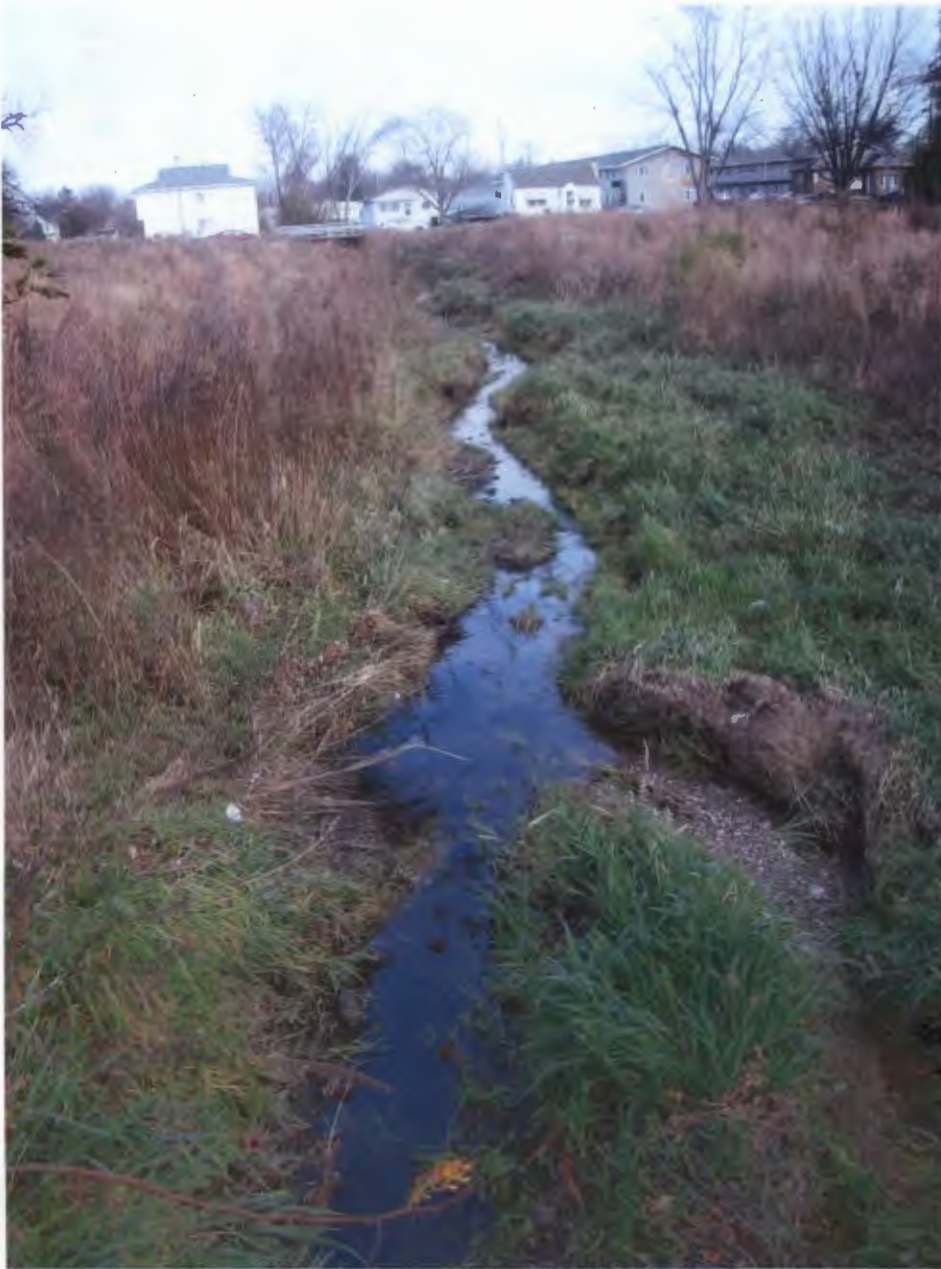
Figure 8. Stretch U5

Stretch U5 had a Moderate BEHI score due to composition of the bank, which was greater than 50% sand. This adds 10 points to the BEHI score. The other properties of the bank make it resistant to erosion, and can be seen in Figure 8. These include a bank angle of 0-20°, root density and surface protection of 80-100%, and root depth of 90-100%. This stretch was located in an urban area.

gentler grade. U5 and E1 may also benefit from Iowa vanes as they are composed of significant amounts of sand. New sediment deposits could add more clay/silt to those banks.

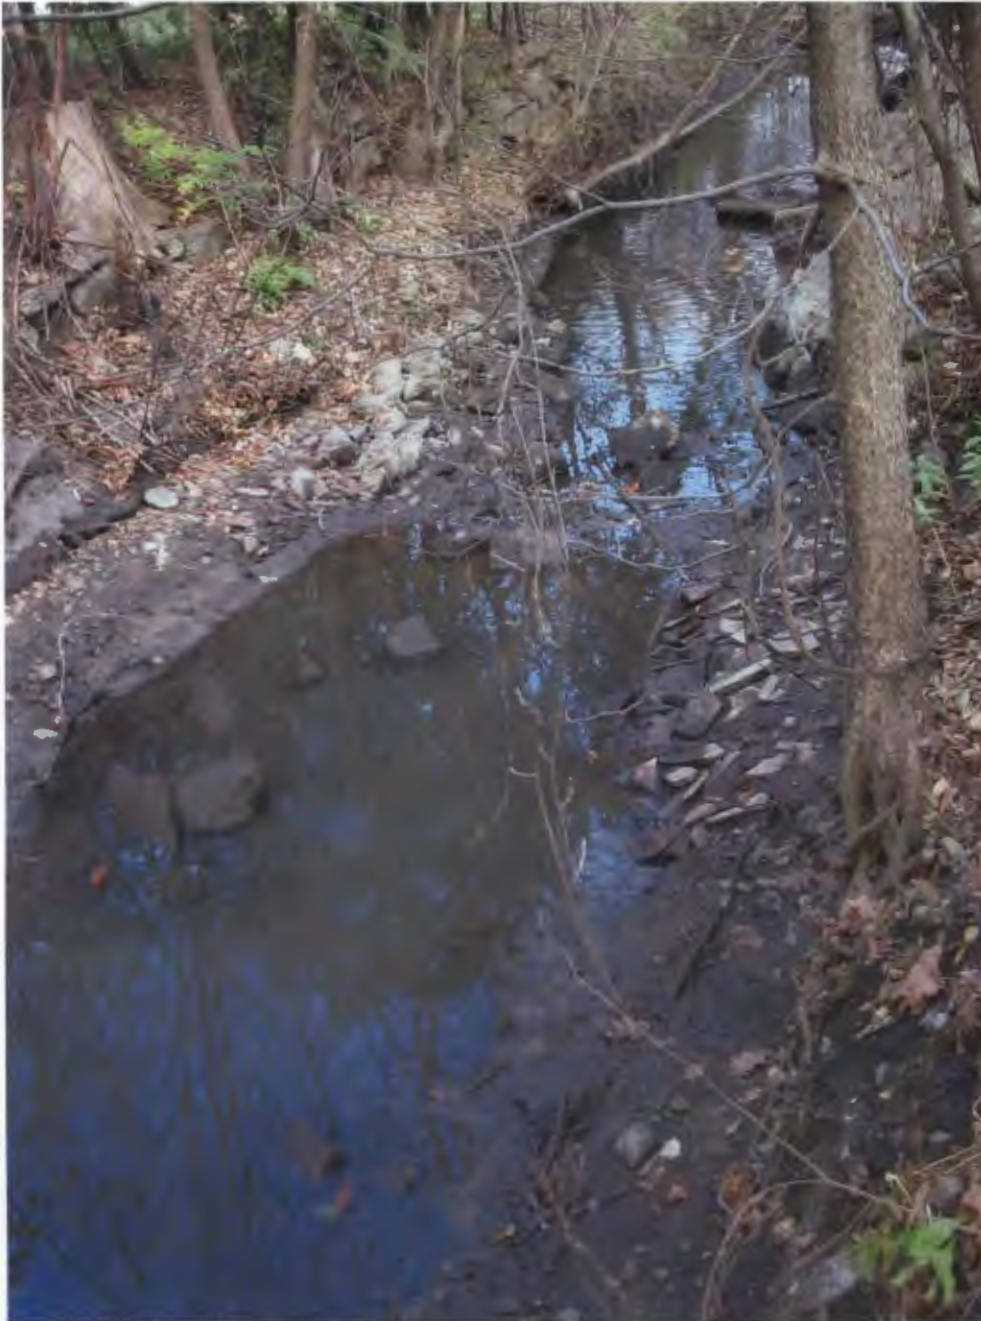
Figure 9. Stretch U6

Stretch U6 had a surface protection and root density of 30-54%, putting it into the Moderate BEHI category. The minimal vegetation cover can be seen in Figure 9. The bank angle was 21-60° and root depth 90-100%. The bank was composed of clay/silt and located in an urban area.

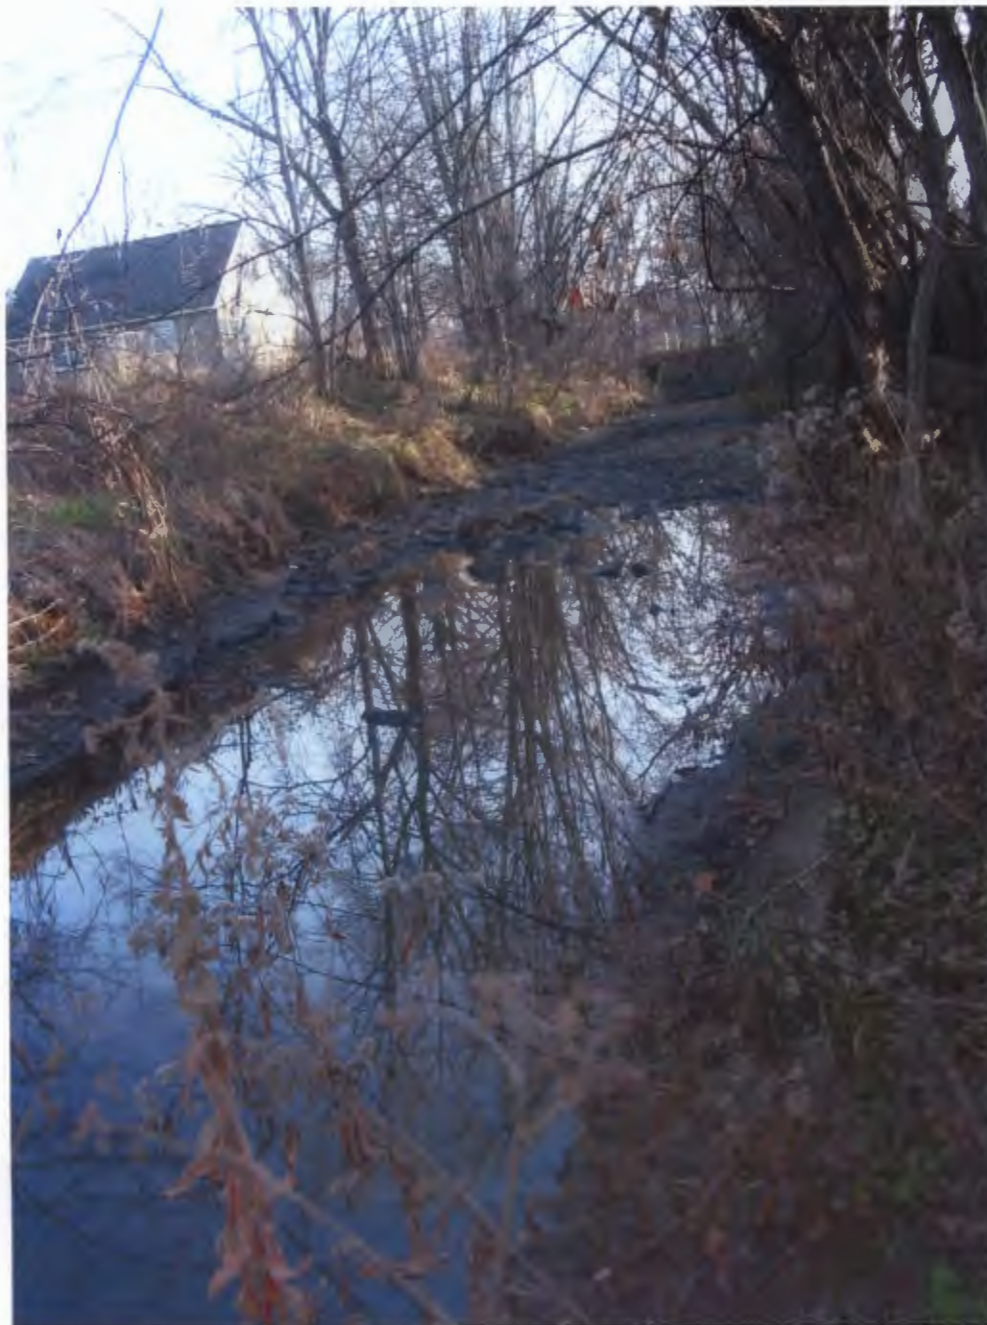
Figure 10. Stretch U9

Figure 10 represents the Low BEHI score conditions at U7, U8, U9, U10, U11, and U12. U9 and U10 were composed primarily of clay/silt and less than 25% sand, which did not affect their score. The rest of these stretches were composed of clay/silt. All had a bank angle of 21-60°, root density and surface protection of 55-79%, and root depth of 90-100%.

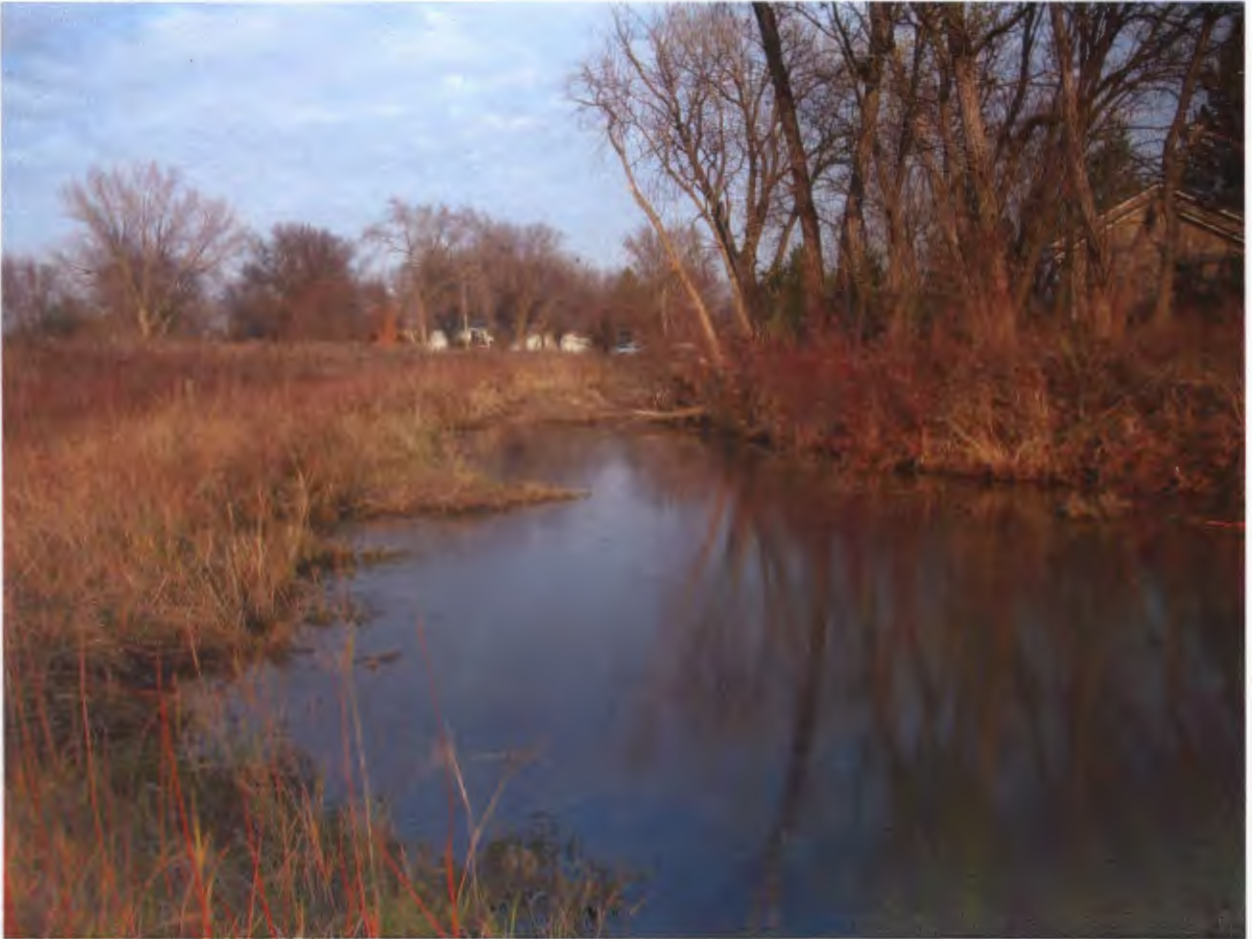
Figure 11. Stretch W1

Figure 11 represents the Low BEHI conditions at W1, W2, and W3. These stretches had a bank angle of 0-20°, root depth of 90-100%, and surface protection and root density of 80-100%. W3 contained an insignificant amount of sand in its banks, and W1 and W2 were composed of clay/silt. There was a drainage pipe located at the end of W3. They were located in a semi-urban area.

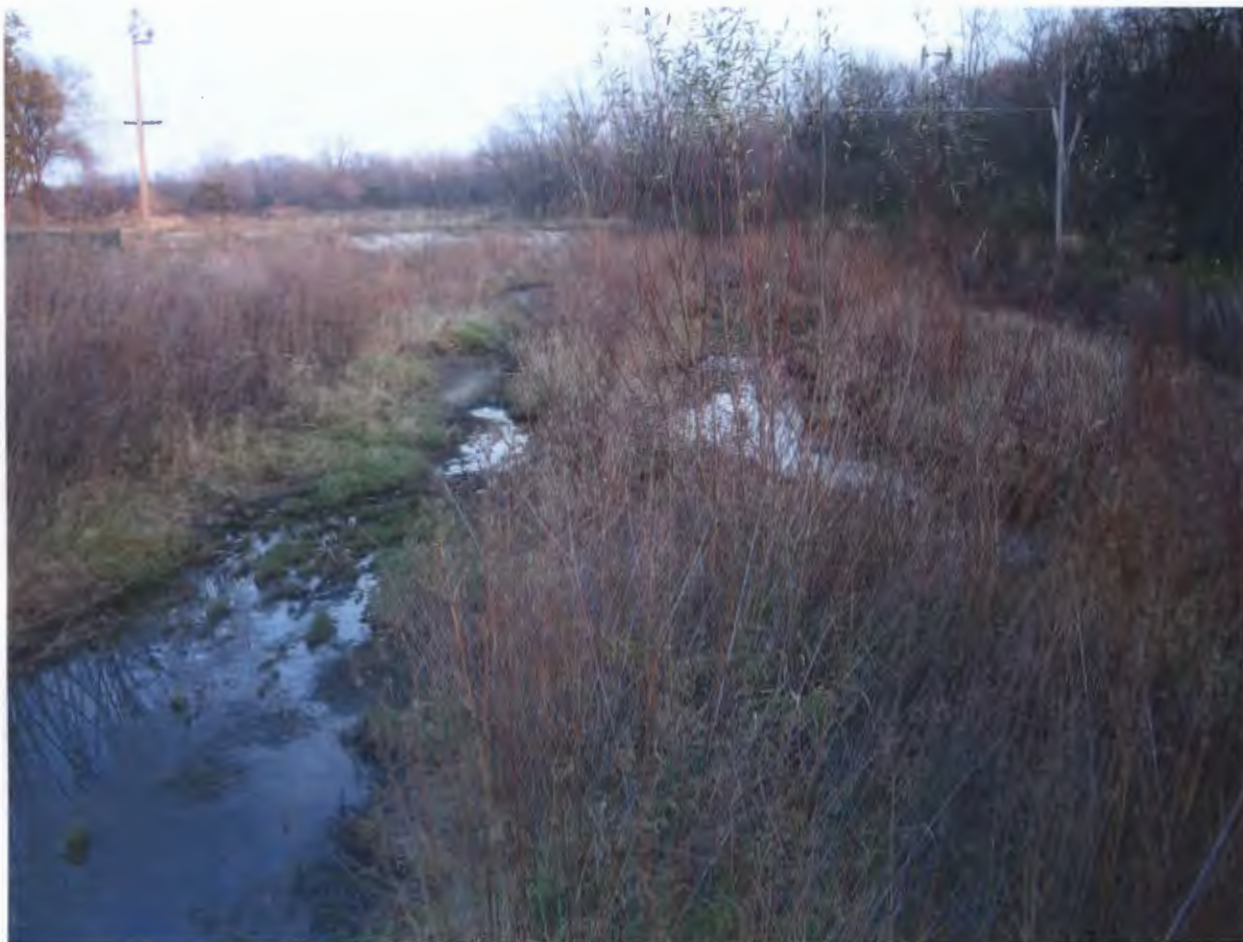
Figure 12. Stretch W4

W4 had a bank angle of 21-60°, root depth of 90-100%, and surface protection and root density of 80-100%. These properties can be seen in Figure 12. This stretch had a Low BEHI score, and was composed of clay/silt. The location was semi-urban.

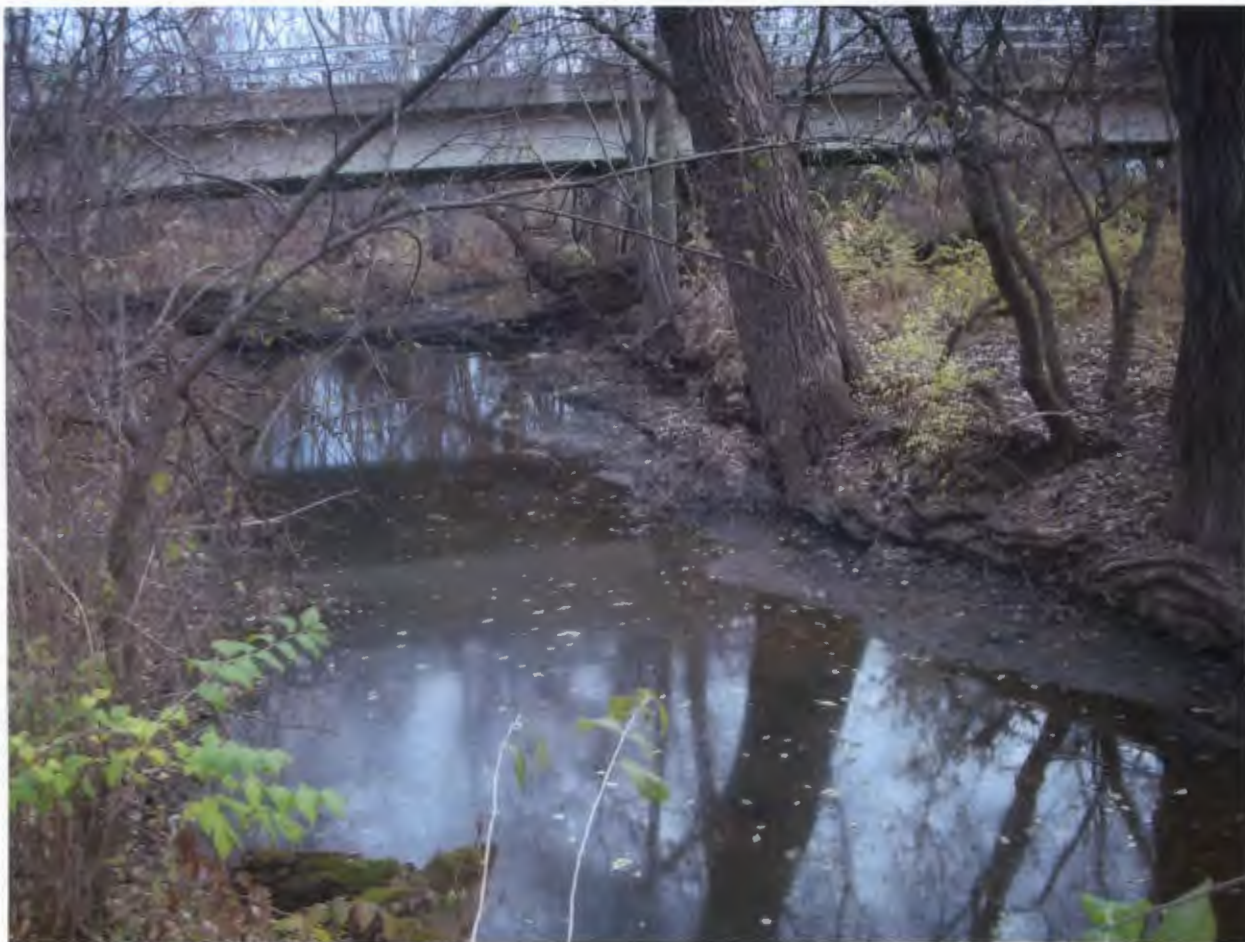
Figure 13. Stretch W6

Figure 13 represents stretches W5, W6, and W7. These stretches were in a rural area, and had a Low BEHI score. All had root depth of 90-100%, root density and surface protection of 55-79%, and bank angle of 21-60°. They also all contained small amounts of sand, but were primarily composed of clay/silt.

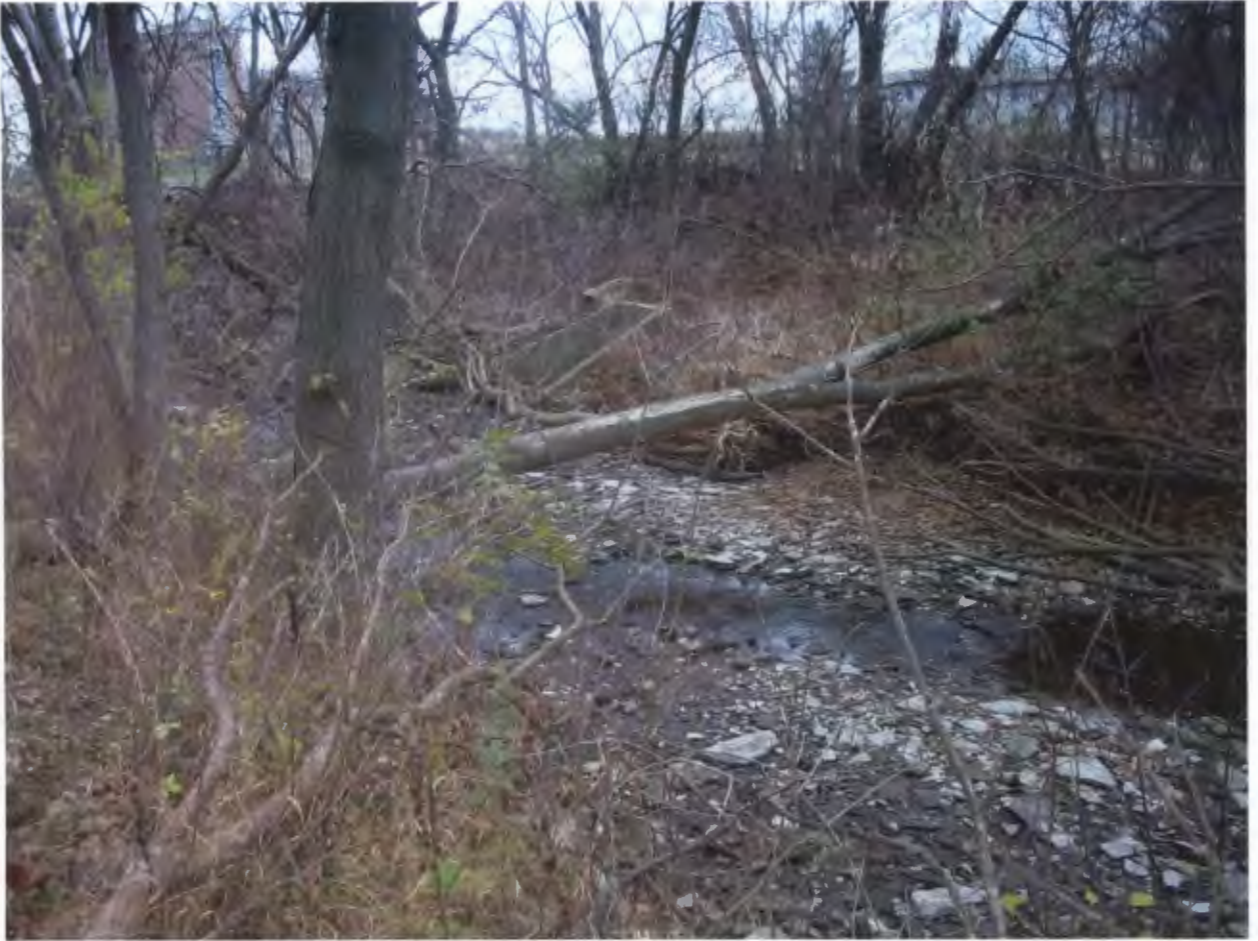
Figure 14. Stretch W8

Stretch W8 was in a rural wooded area, and the BEHI score was Low. The bank was composed of clay/silt. As can be seen in Figure 14, a significant amount of rock coverage provided high surface protection of 80-100%. The root density was 55-79%, root depth 90-100%, and bank angle 21-60°.

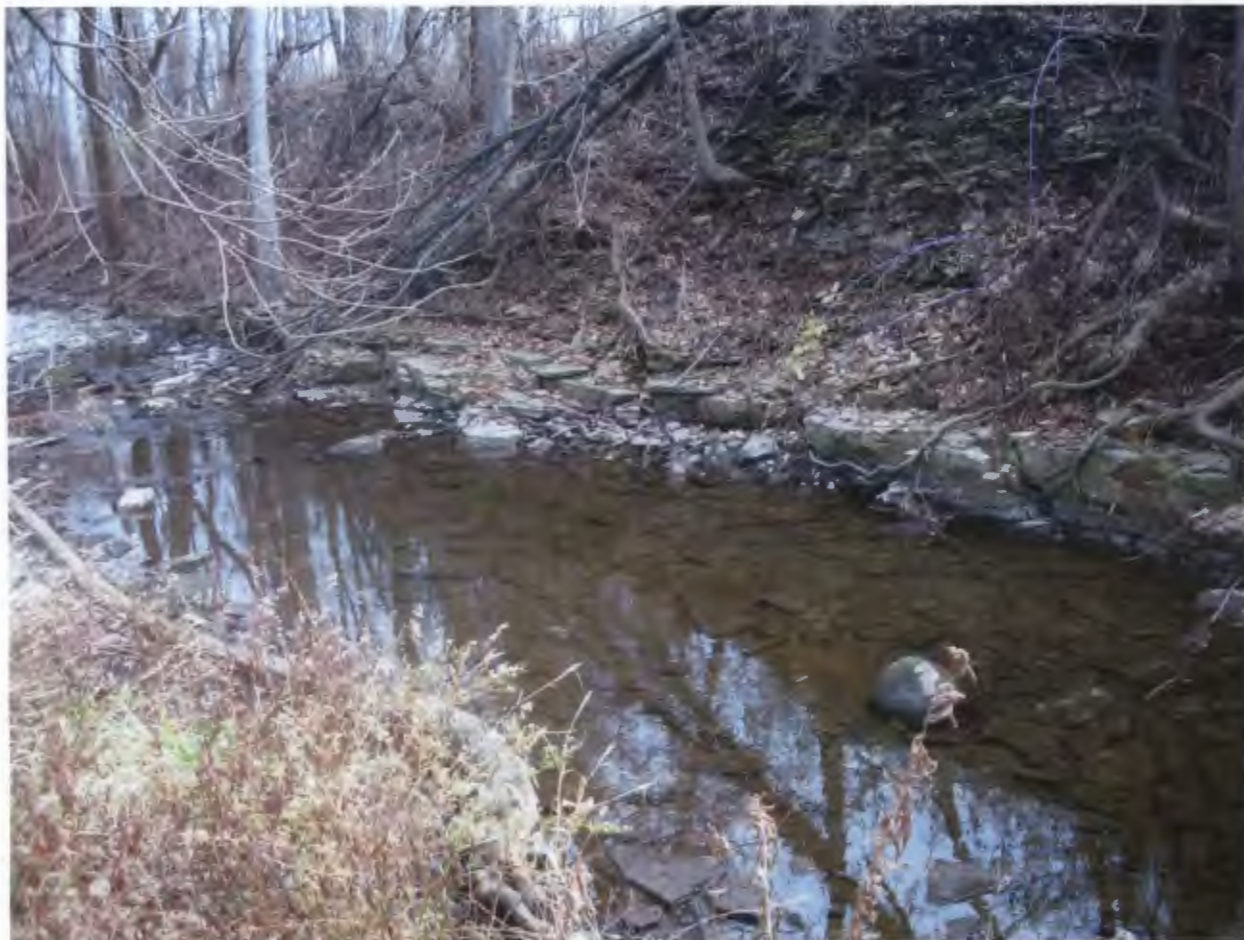
Figure 15. Stretch W9

Stretch W9 was unique in that the bank was composed primarily of limestone bedrock. This created an automatic BEHI rating of Very Low. As can be seen in Figure 15, the surface protection in this stretch was 80-100%. The root density was 55-79%, root depth 90-100%, and bank angle 21-60°.

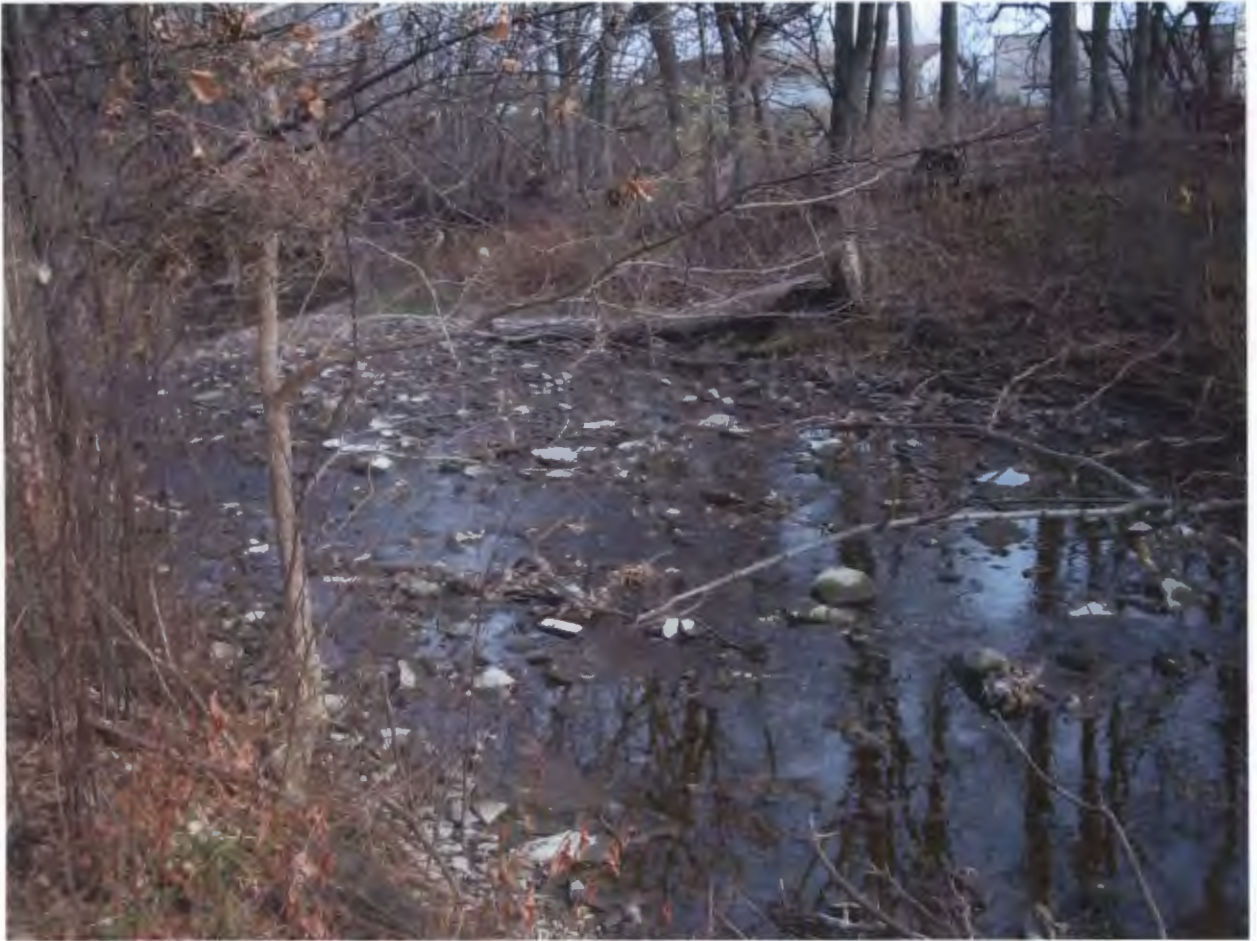
Figure 16. Stretch W10

Figure 16 represents the conditions at W10 and W11. Both had a BEHI rating of Low, and were located in a rural area. W10 was primarily composed of clay/silt, but also contained some limestone float. W11 was composed of clay/silt, but had more rock coverage on its banks resulting in higher surface protection than W10. Both had bank angles of 21-60°, root density of 55-79%, and root depth 90-100%.

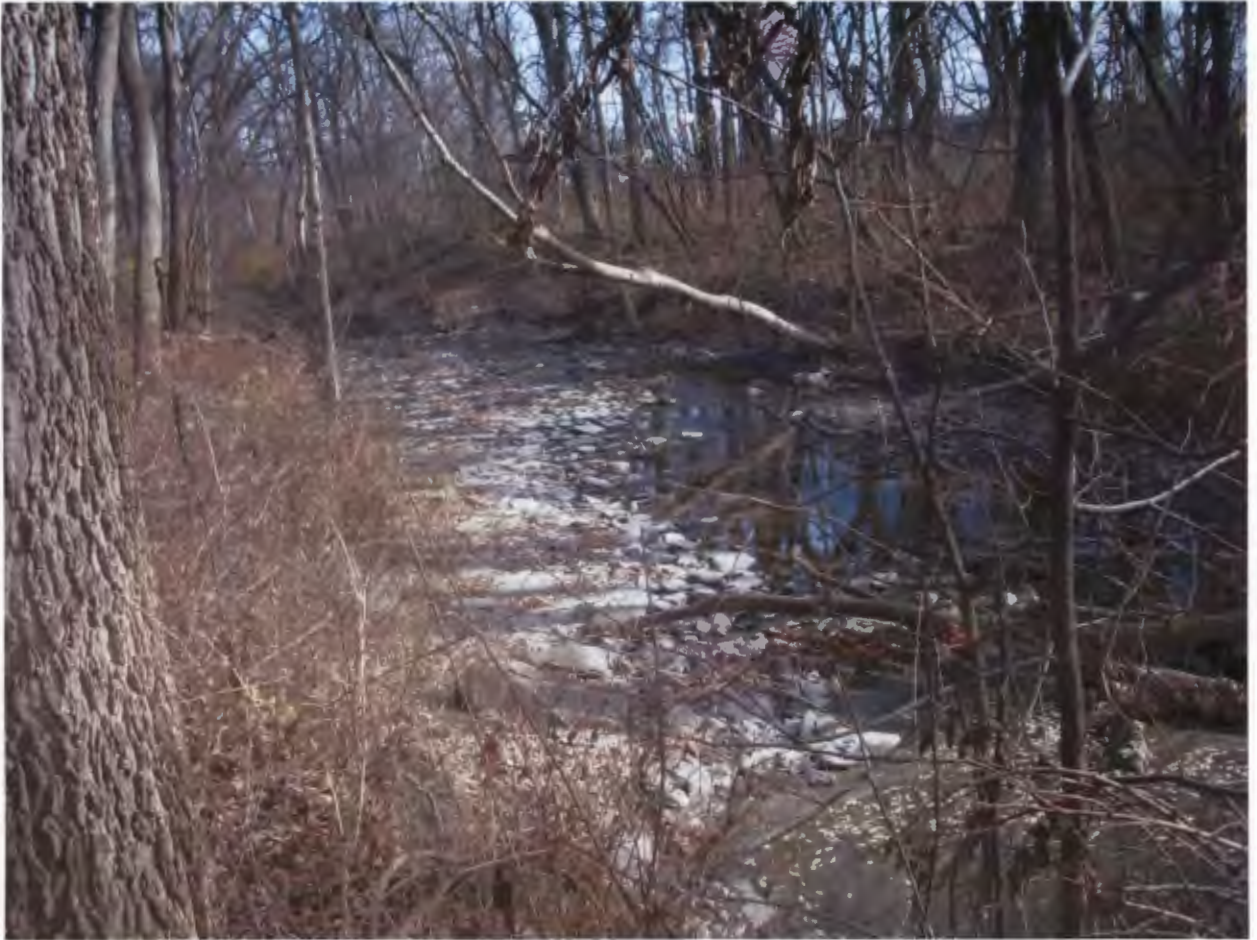
Figure 17. Stretch W12

W12 had a Low BEHI score, and was located in a rural area. The bank was composed primarily of clay/silt and contained a small amount of sand. As can be seen in Figure 17, the bank angle was 21-60°, root depth 90-100%, and it had surface protection and root density of 55-79%.

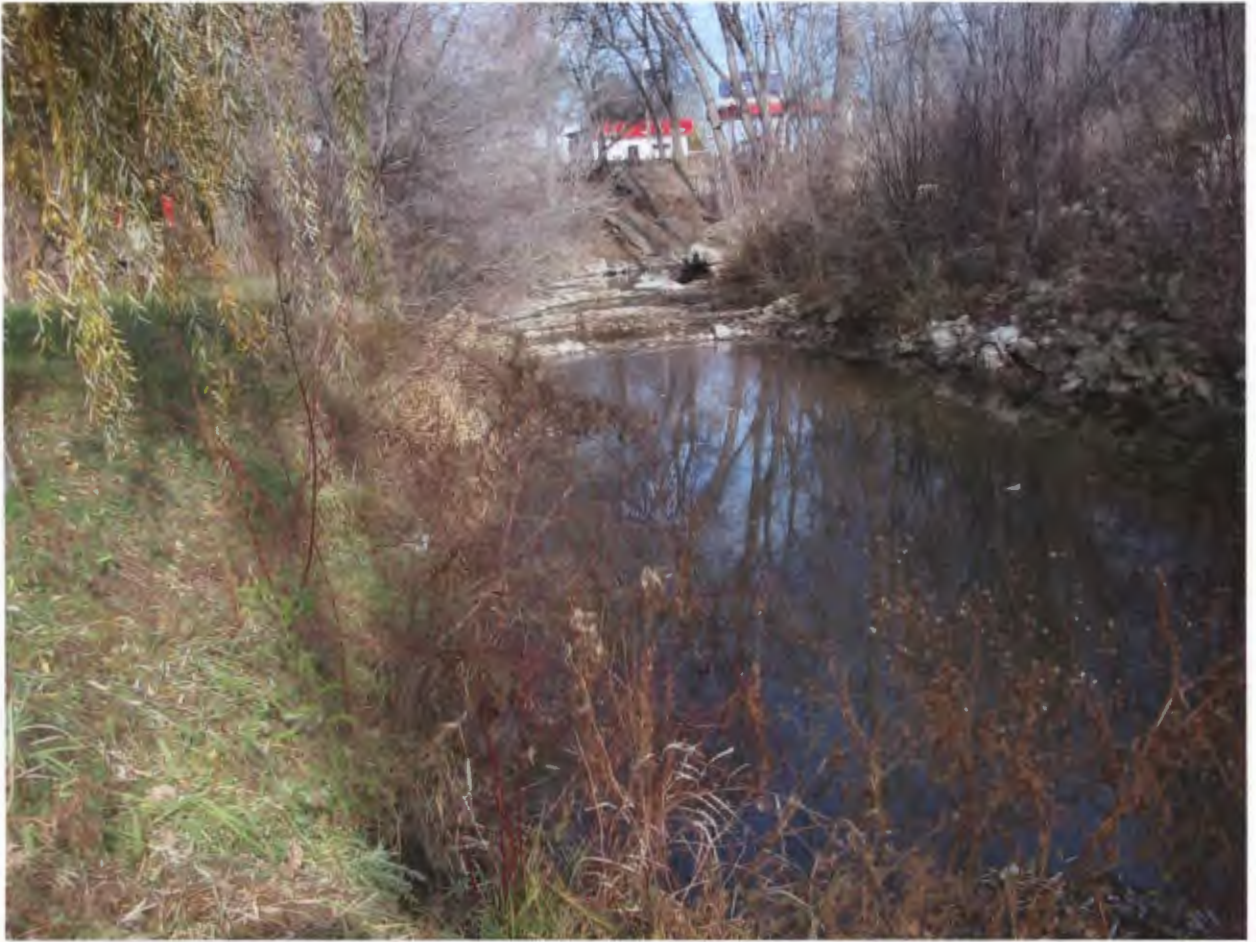
Figure 18. Stretch W13

W13 was located in a more urban area, and had a Low BEHI score. It had surface protection and root density of 80-100%, bank angle of 21-60°, and root depth 90-100%. Only the left bank could be considered as the right bank was covered with rip rap to stabilize it artificially.

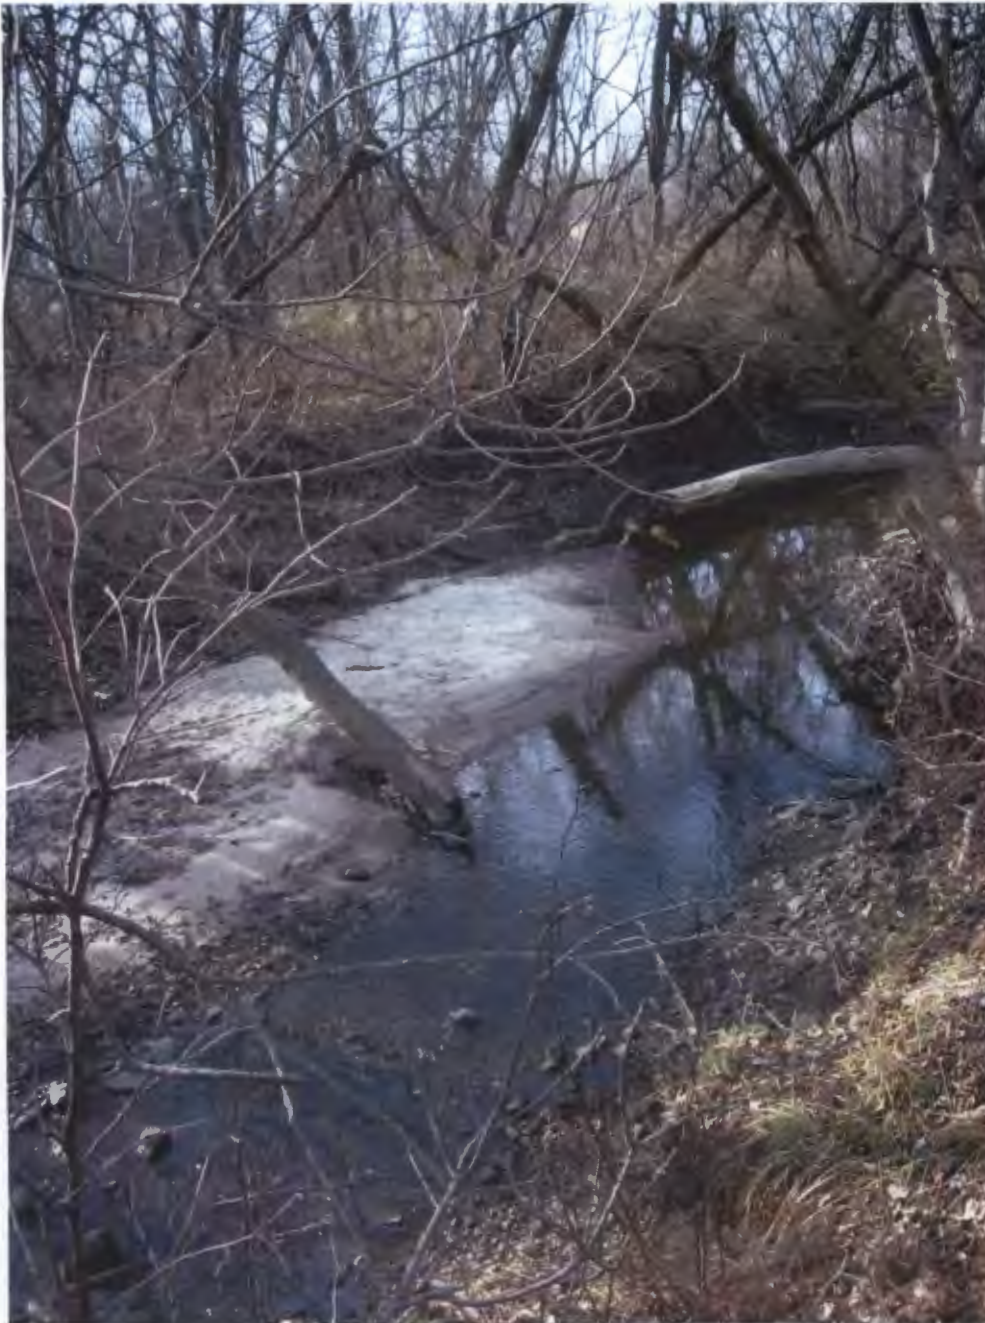
Figure 19. Stretch E1

Due to the high sand content of the banks and the low surface protection and root density of 30-54%, E1 was determined to have a BEHI rating of High. The root depth was 50-89% and bank angle was 21-60° at this location. E1 was in a rural area.

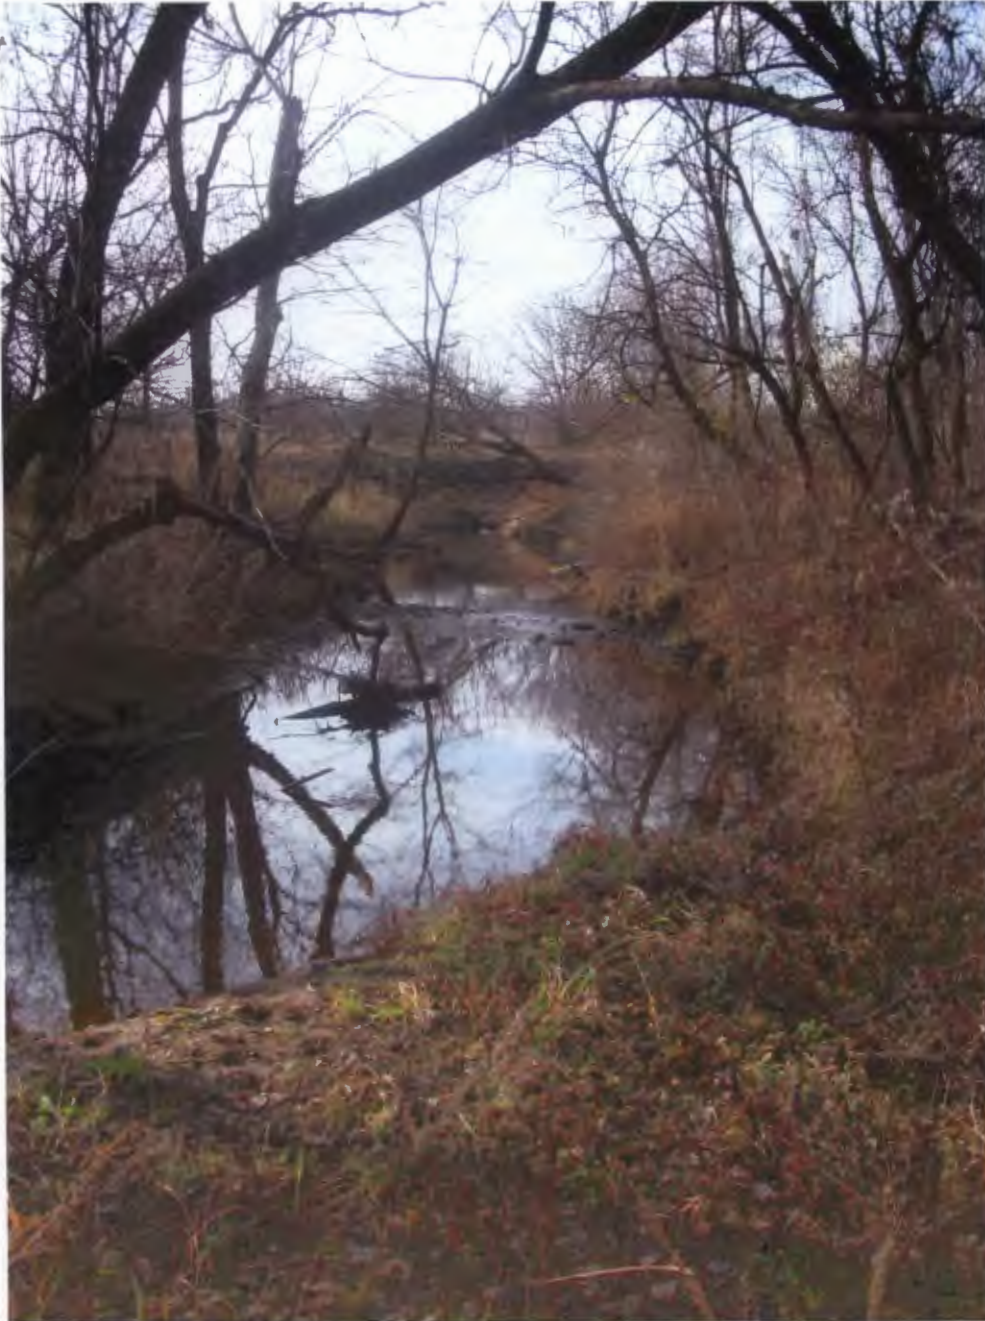
Figure 20. Stretch E2/E3

Figure 20 represents the conditions of E2 and E3, which were adjacent stretches. As can be seen in Figure 20, they have a root depth of 90-100%, bank angle of 21-60°, and surface protection and root density of 55-79%. They had a BEHI score of Low, and were located in a rural area. The composition of the banks was clay/silt.

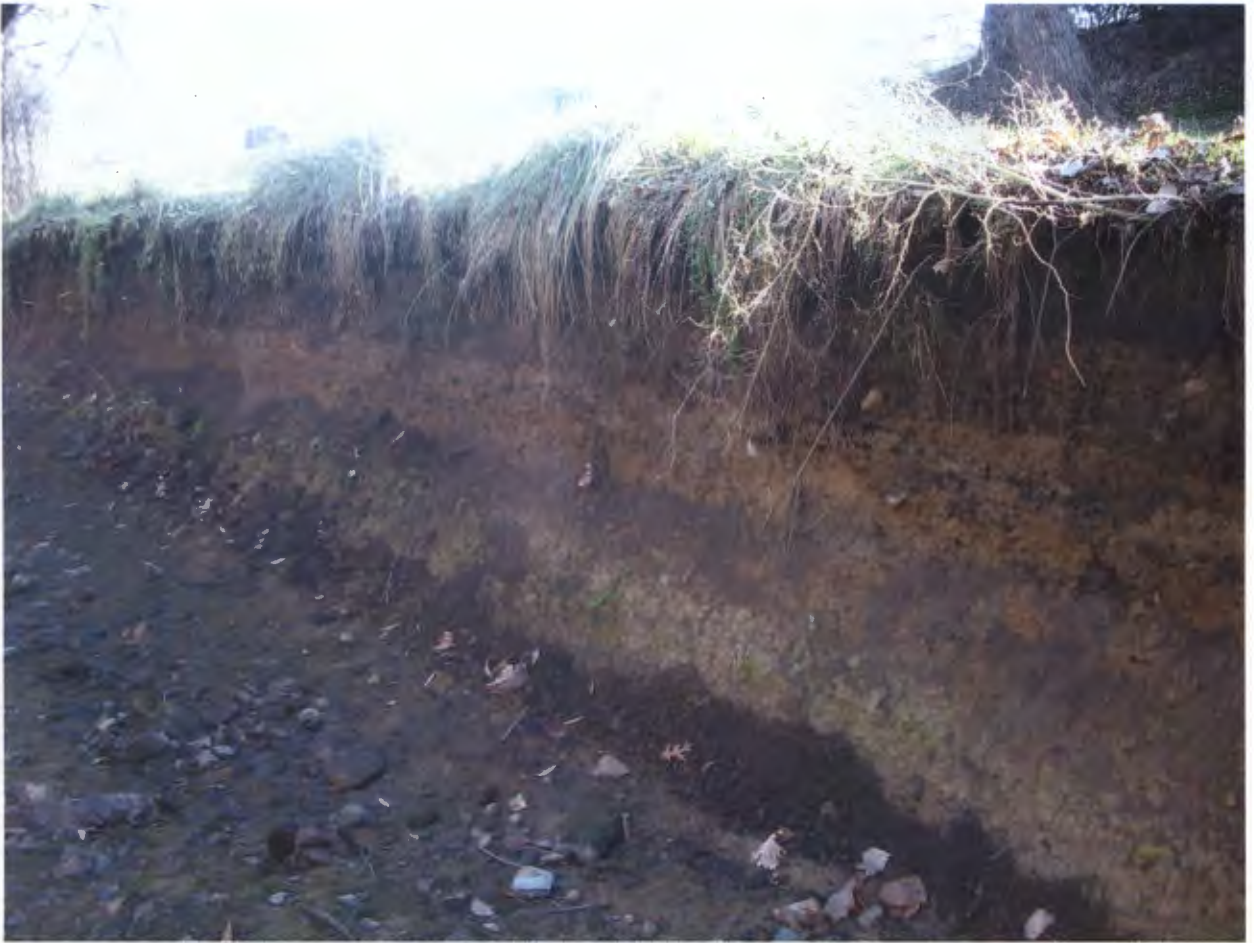
Figure 21. Stretch E6

E6 was unique in that the bank was nearly vertical at 81-90°. The vertical nature of the bank can be seen in Figure 21. The root density and surface protection for the rest of the bank was 30-54%, but the roots were 90-100%. The bank was approximately 5-10% sand, but it was composed primarily of clay/silt. The overall BEHI rating was Moderate.

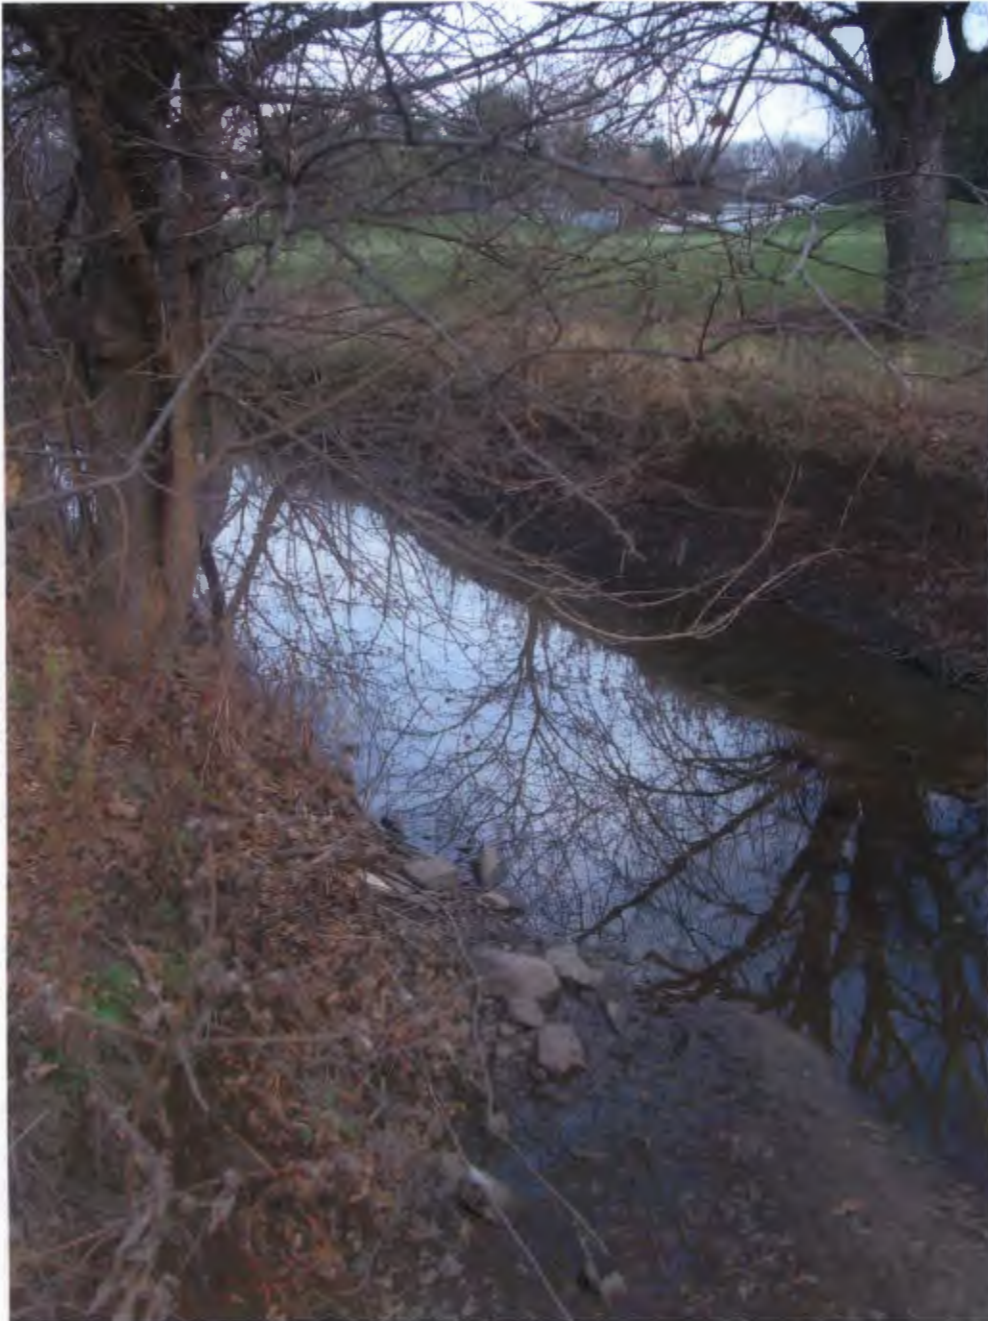
Figure 22. Stretch E9

Figure 22 represents all of the Low BEHI score stretches between E7 and E13. These stretches all had root depth of 90-100% and root density and surface protection of 55-79%. E10 had a considerable amount of sand, but not enough to affect its BEHI. The rest of the bank stretches were composed of clay/silt. E11 had a bank angle of 81-90°, and the rest were 21-60°. Most of the stretches were in a semi-urban or urban area.
