A Bank Erosion Hazard Index (BEHI) Study of Dry Run Creek, Cedar Falls, Iowa

A BANK EROSION HAZARD INDEX (BEHI) STUDY
OF DRY RUN CREEK, CEDAR FALLS, IOWA

May 2013

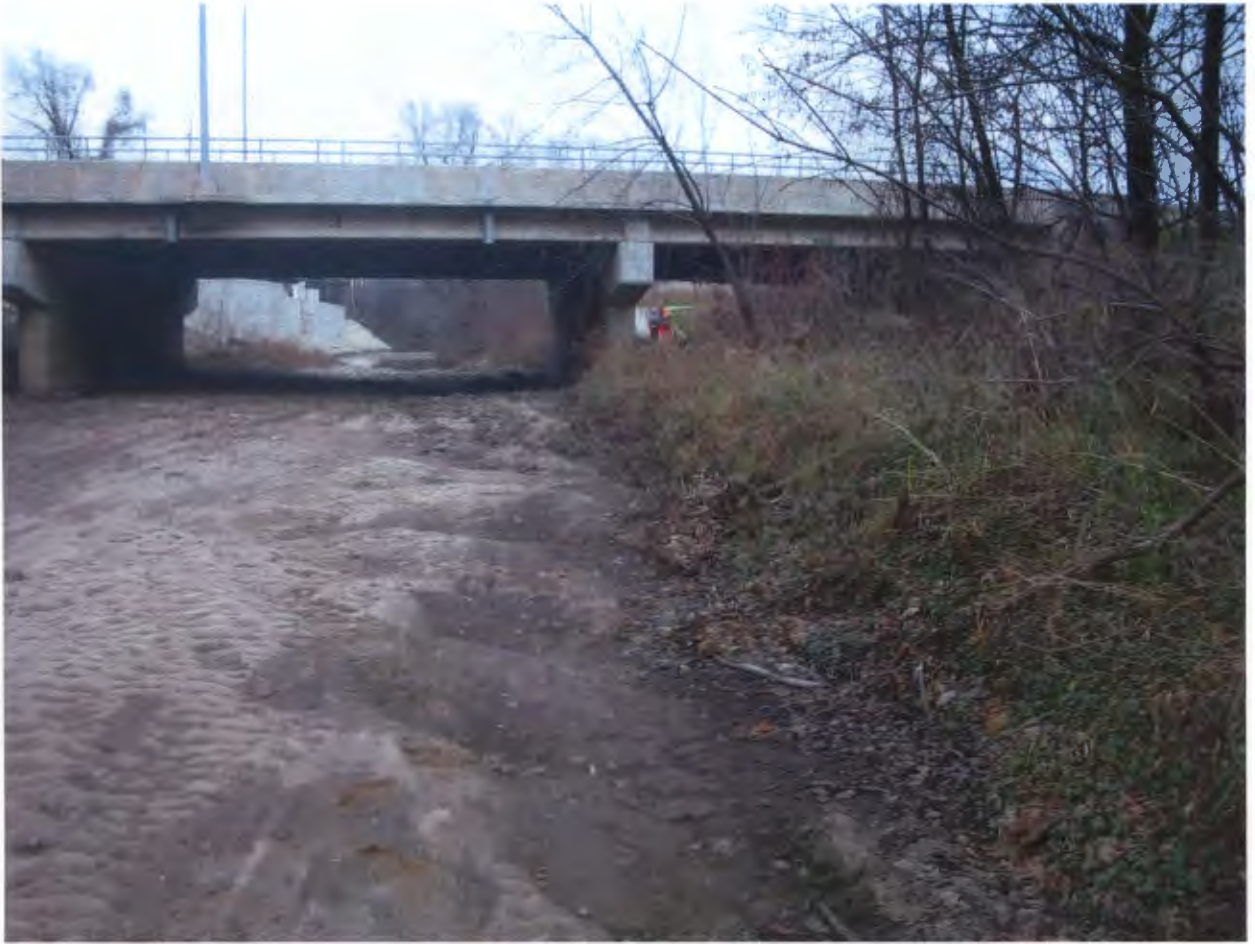
Figure 23. Stretch E14

Figure 23 shows the dry bed conditions that were encountered in many stretches of the stream due to the dry fall conditions. E14 had a Low BEHI score, and was in an urban area. The root density and surface protection were 80-100%, the bank angle 21-60°, and the root depth 90-100%. The bank was composed of clay/silt.

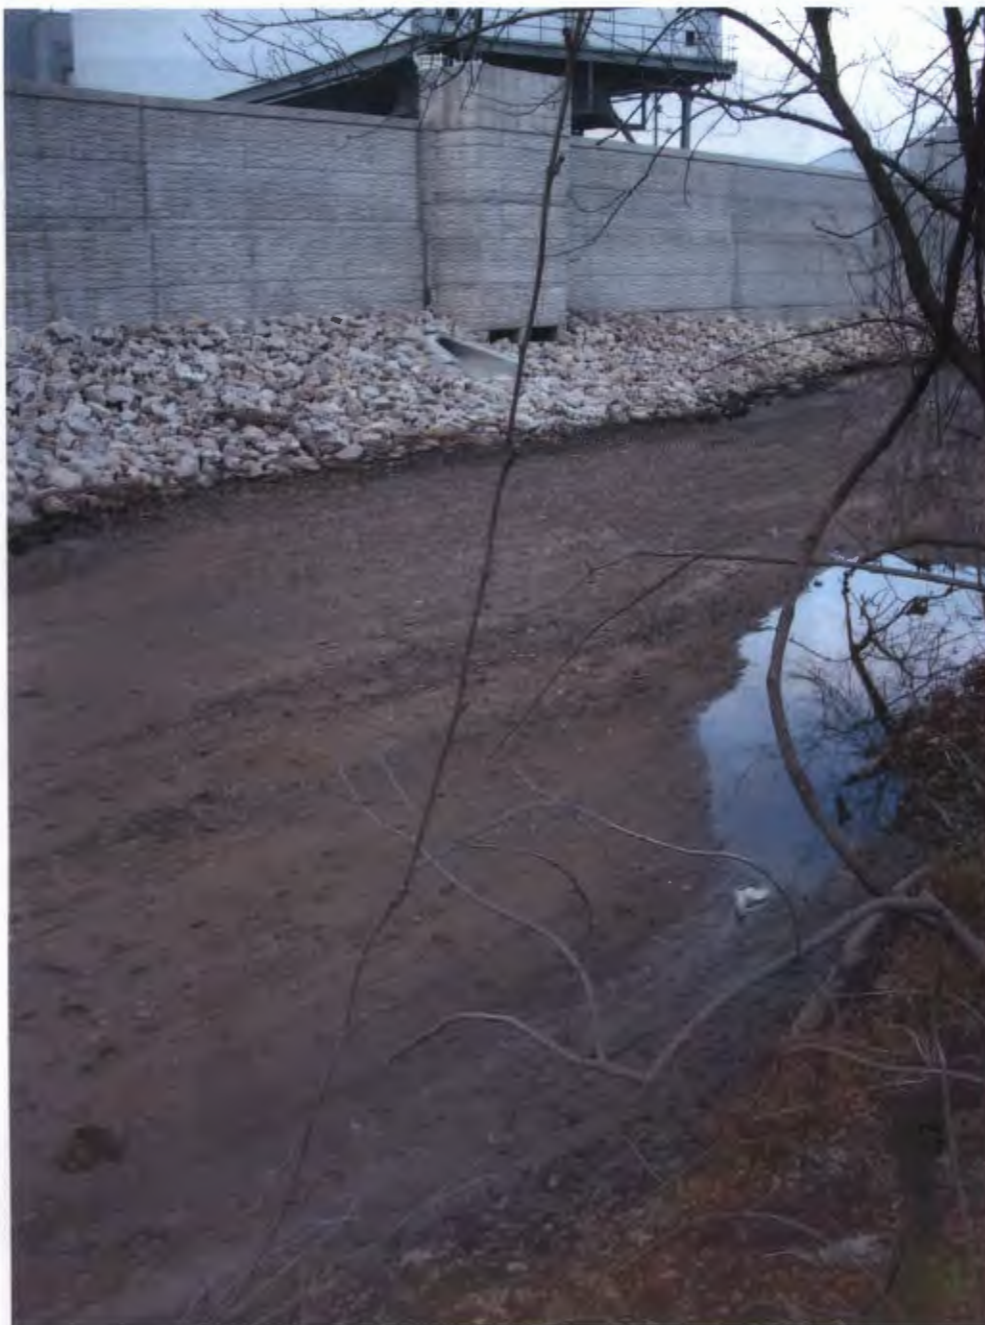
Figure 24. Stretch E15

E15 had a Low BEHI score, and was located in an urban area. The bank was composed of clay/silt and the root depth was 90-100%. The root density and surface protection were 55-79% and the bank angle was 21-60°. As can be seen in Figure 24, the left bank was covered in rip rap, so only the right bank was considered.

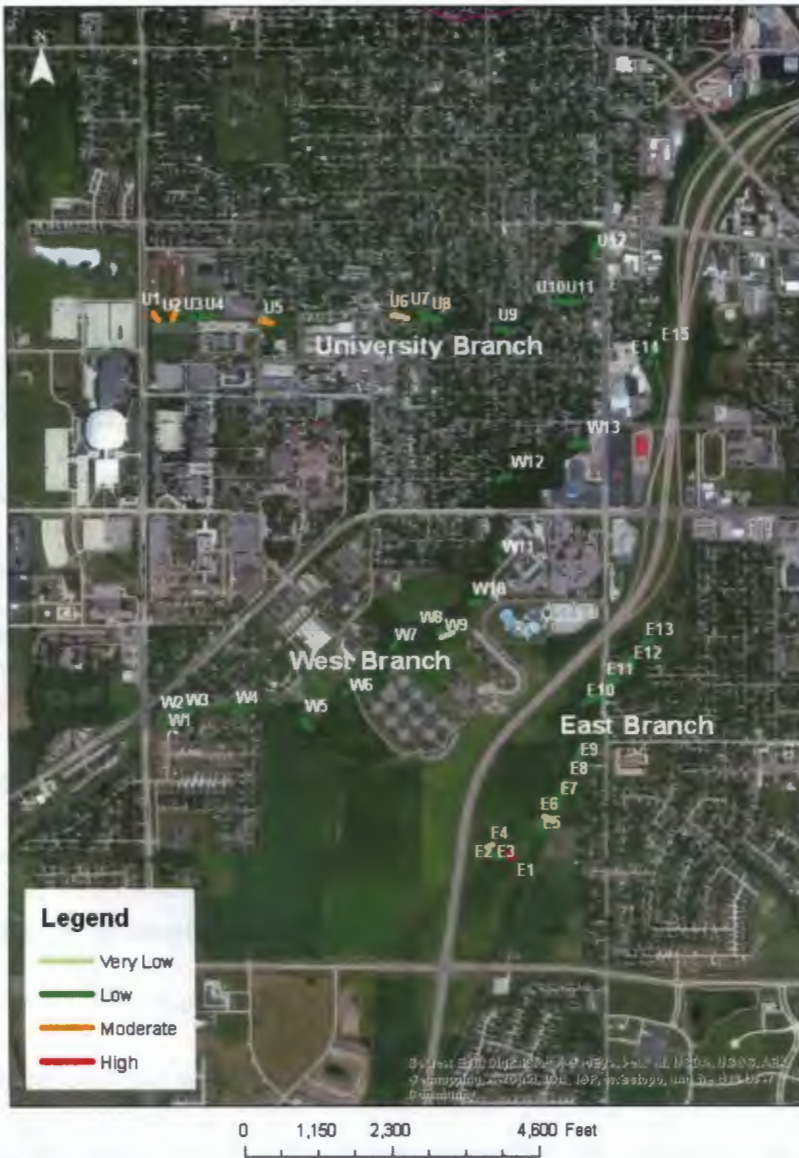
Figure 25. Locations of assessed stretches and the BEHI represented by color.

Figure 25 shows the locations of the assessed stretches on a map of Cedar Falls. Ratings are represented by color. Green stretches have a Low BEHI, orange stretches have a Moderate BEHI, and red stretches have a High rating.
