Civilian Conservation Corps Rubble and Masonry Dams and Gully Morphology in Northeastern Iowa

CIVILIAN CONSERVATION CORPS RUBBLE AND MASONRY DAMS AND
GULLY MORPHOLOGY IN NORTHEASTERN IOWA

An Abstract of a Thesis
Submitted
in Partial Fulfillment
of the Requirements for the Degree
Master of Arts

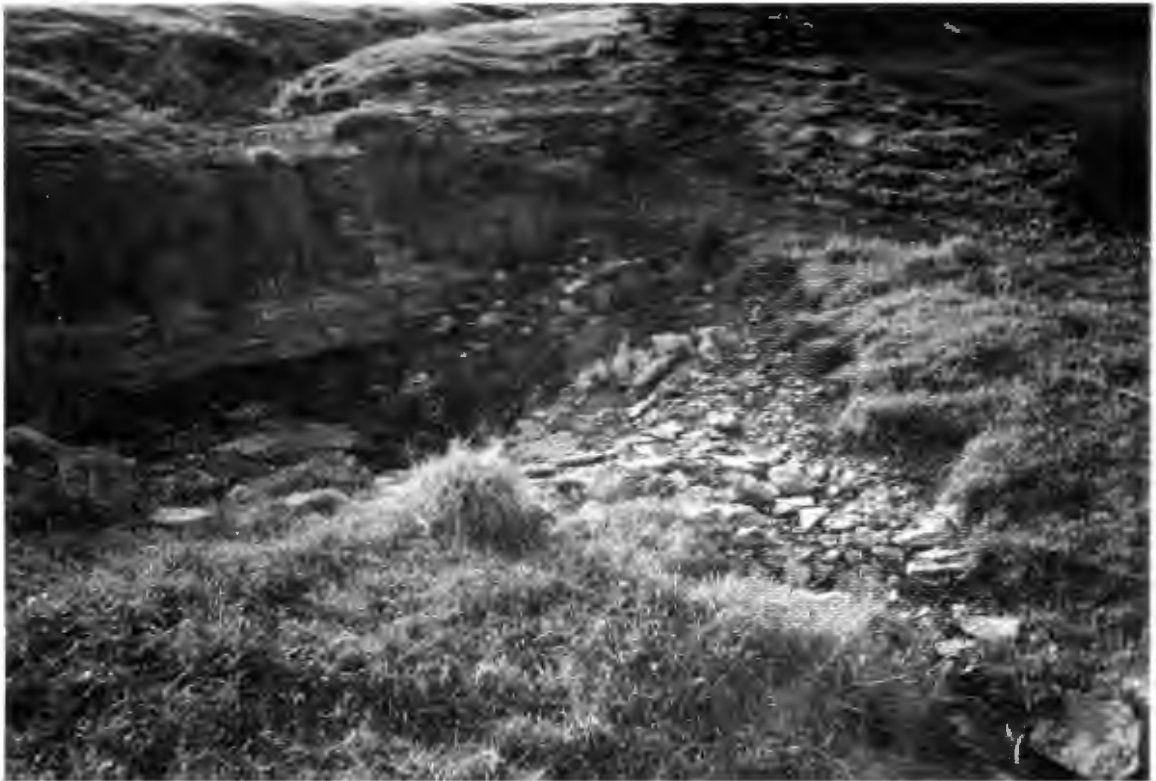
Figure 5. Undermining due to apron failure. This dam is located west of Kendallville. It will eventually be undermined due to the failure of the apron as the plunge pool enlarges.

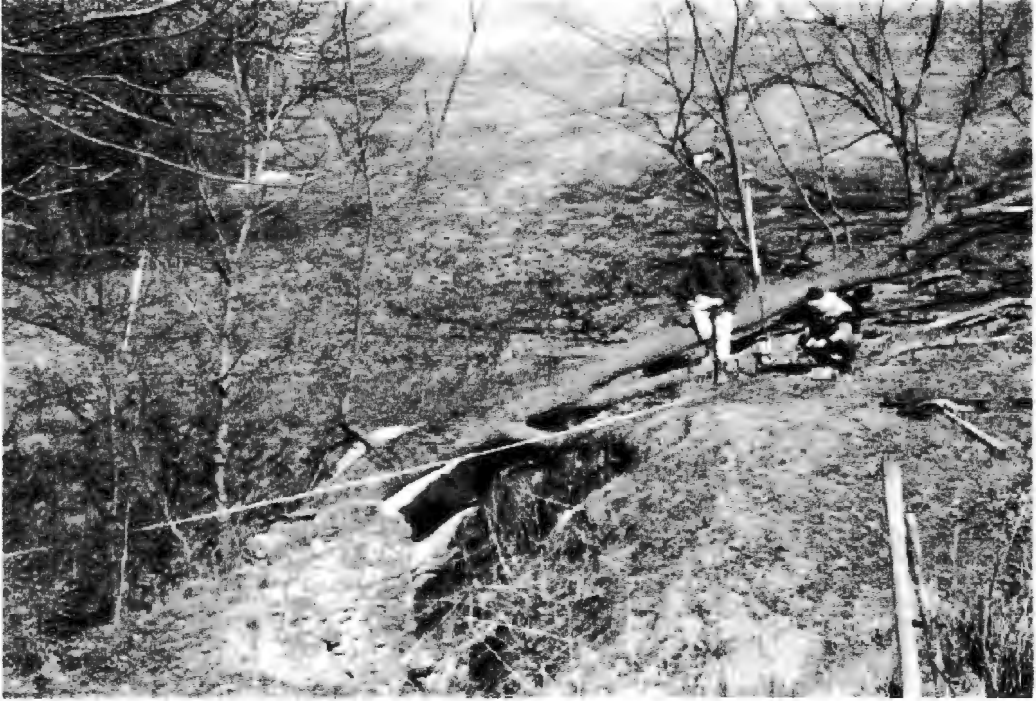
Three dams were built by the CCC in Johnson Gully in 1934. Dam 1 was built near the headscarp of the gully. Its failure within the last 5 years, which was caused by

the tipping of a tree along a sidewall of the dam, has led to renewed headward gully erosion around the side of the dam wall. Dam 2 was constructed one-quarter of the way down the gully. It is still working as an effective sediment trap today because of a modification of its spill way apron within the last 15 years by the landowner. Dam 3 is located in the lower reach of the gully near the floodplain of the Upper Iowa River. Dam 3 has trapped an enormous amount of alluvial sand behind it. Dam 3 is still an effective sediment trap, despite some solution of the limestone wall of the dam and a tunnel forming in the historical alluvium and the dam. Currently Dam 3 is in danger of being overwhelmed by alluvial sand.

Figure 7. Destruction of the north side of Dam 1. The collapse of this tree forced the north side of the Dam into the middle of the gully.

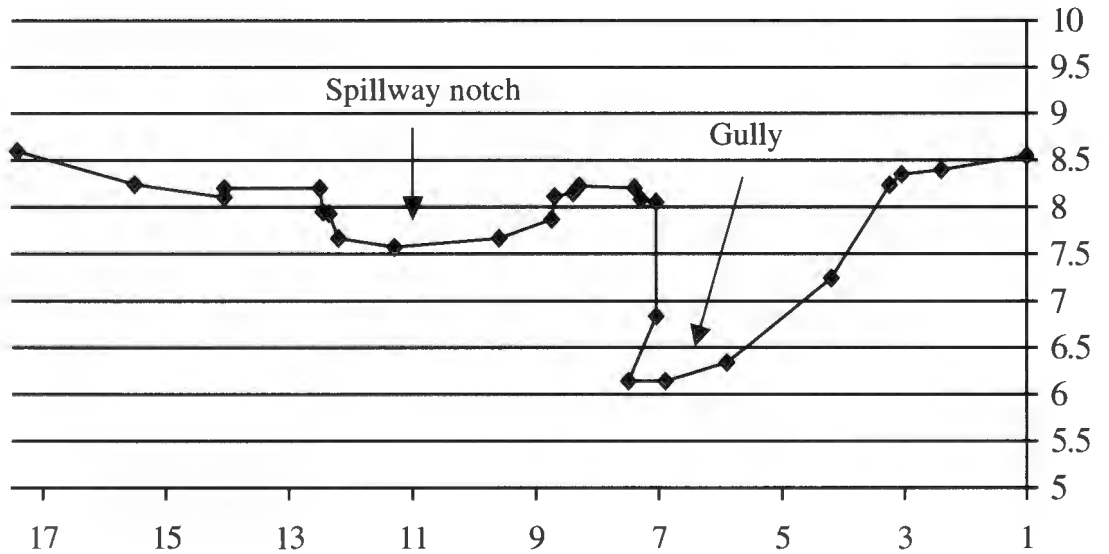
Due to its poor condition, I was not able to measure Dam 1 as thoroughly as the other dams. The length of the main wall of Dam 1 across the top is 4.51 meters. The notch of the dam starts 1.55 meters from the south end, and steps down vertically 0.26 meters. The notch extends 3.6 meters before it steps back up vertically 0.26 meters. The dam then extends an additional 0.65 meters north before it ends abruptly due to the failure on the north side (Figure 8). The thickness of the top of the dam is 0.4 meters. The spillway notch is now 2.5 meters above and .82 meters south of the current gully floor.

Figure 8. Cross section of Dam 1. North is to right. Horizontal and vertical units are meters.

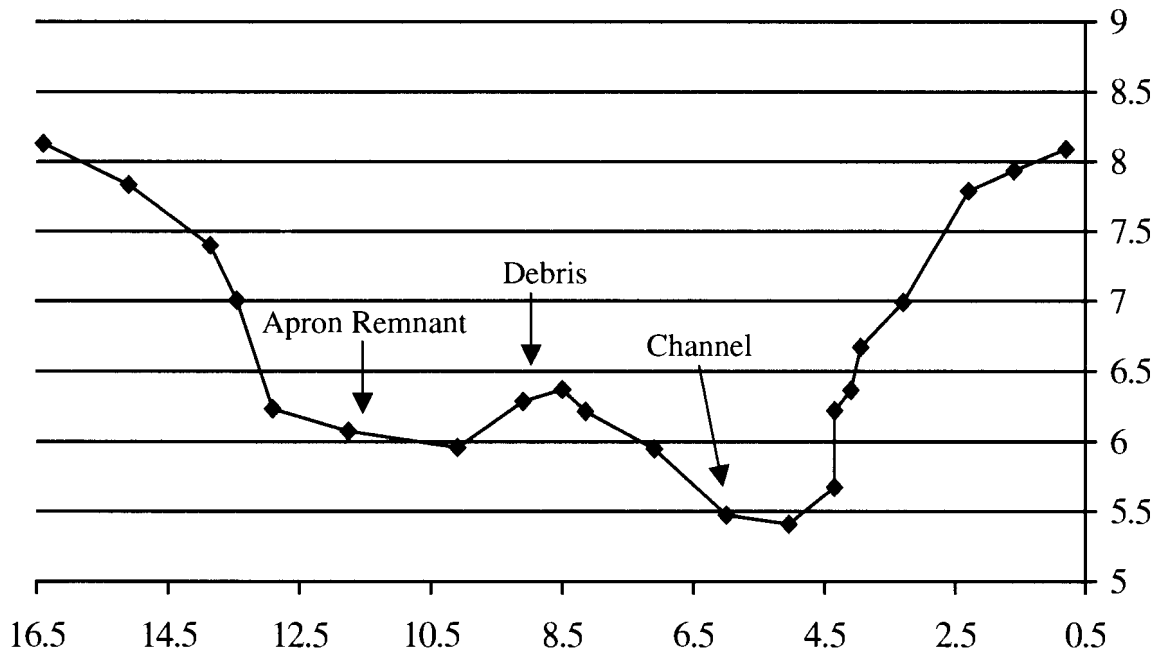
The apron area is full of debris from the collapse of the tree. A great deal of the limestone 'rubble' was pushed up into a heap along the northern part of the old apron area by the tipping of the tree and the leverage of its roots. This limestone consists of the old side wall to the north and the northern part of the apron. This mixture of rubble and other debris is such that small trees have been able to take root in this area. The apron is no longer the main discharge area for water coming down the gully, as the active gully has shifted northward and bypasses the notch in the dam (Figure 9).

Figure 9. Cross section of Johnson Gully across the apron of Dam 1 downstream of the main wall. Debris has been pushed into the center of the old apron. The active gully has shifted to the right (north) side of Dam 1.

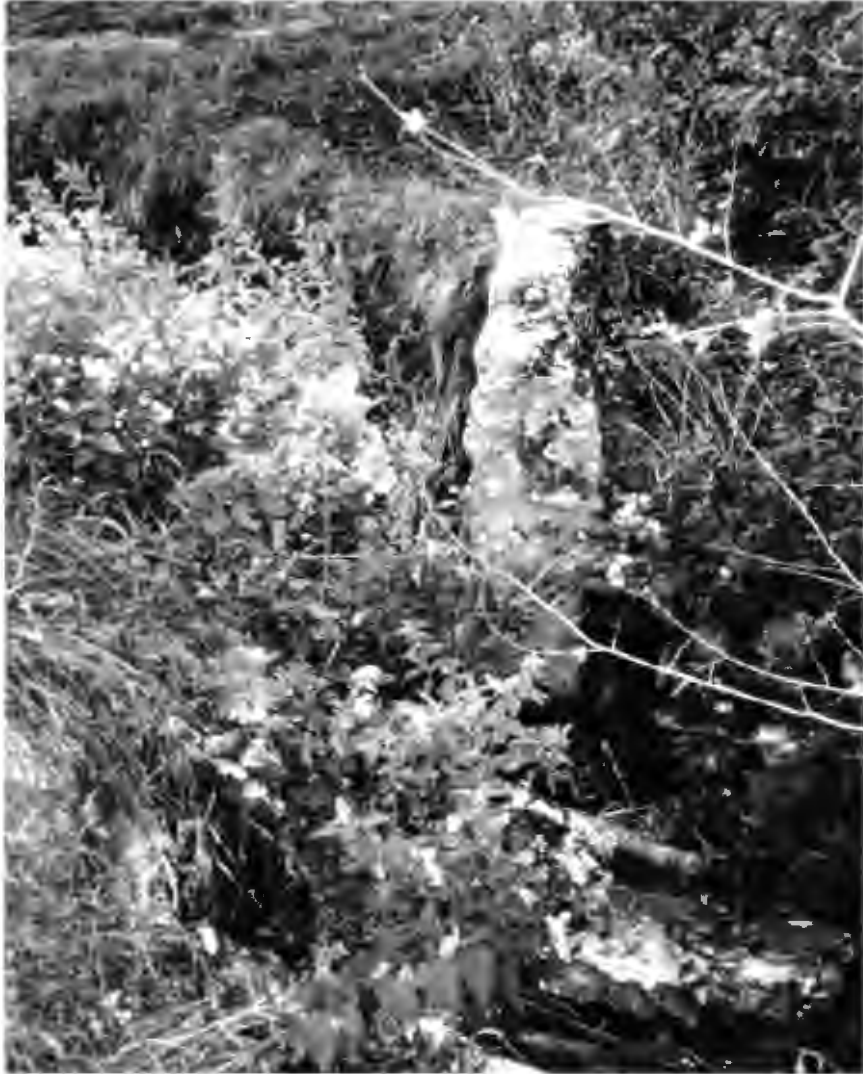
Because both the north end of the main wall and north side wall of Dam 1 have failed, the original north bank of the gully also has been laterally eroded by running water. This has led to the exposure of the portion of the dam base that was built in the trench along the gully's north bank. Currently, it projects into the air off of the current gully floor. This process has revealed the location of the pre-dam bank of the gully. A portion of the side wall that was built on the gully's north bank is still anchored into the main wall of the dam (Figure 10).

The portion of the north end of the dam that was built above the top lip of the gully and that was designed to funnel water toward the notch is now a long slab of limestone and concrete lying on the gully floor next to the dam wall. It fell into the gully after the dam failed.

Figure 10. The north end of Dam 1. The location of the old gully bank from when the dam was built can be seen about three-quarters of the way down the center of the photo where the main wall starts to slant inward. The remnant of the extension of the side wall that fell down in the gully as it formed around the dam can be seen to the lower right of the photo.

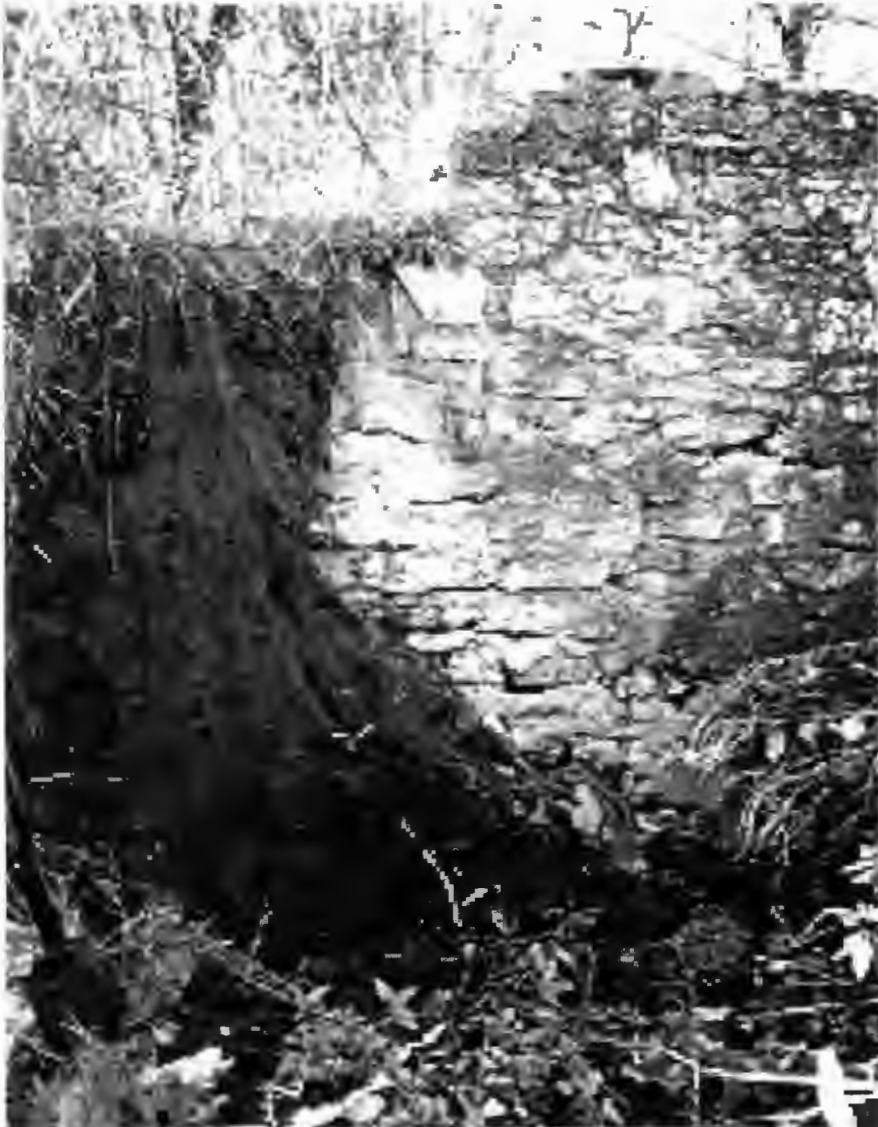
as a barrier that deflects running water toward the opening around the north end of the dam (Figure 11).

Figure 11. View behind Dam 1 facing downstream (west). Water is being deflected by the dam to the right of the figure (north) where it has eroded around the dam. Remnant historical fill can be seen to the left of the figure (south) underneath the abandoned spillway notch (top left of figure).

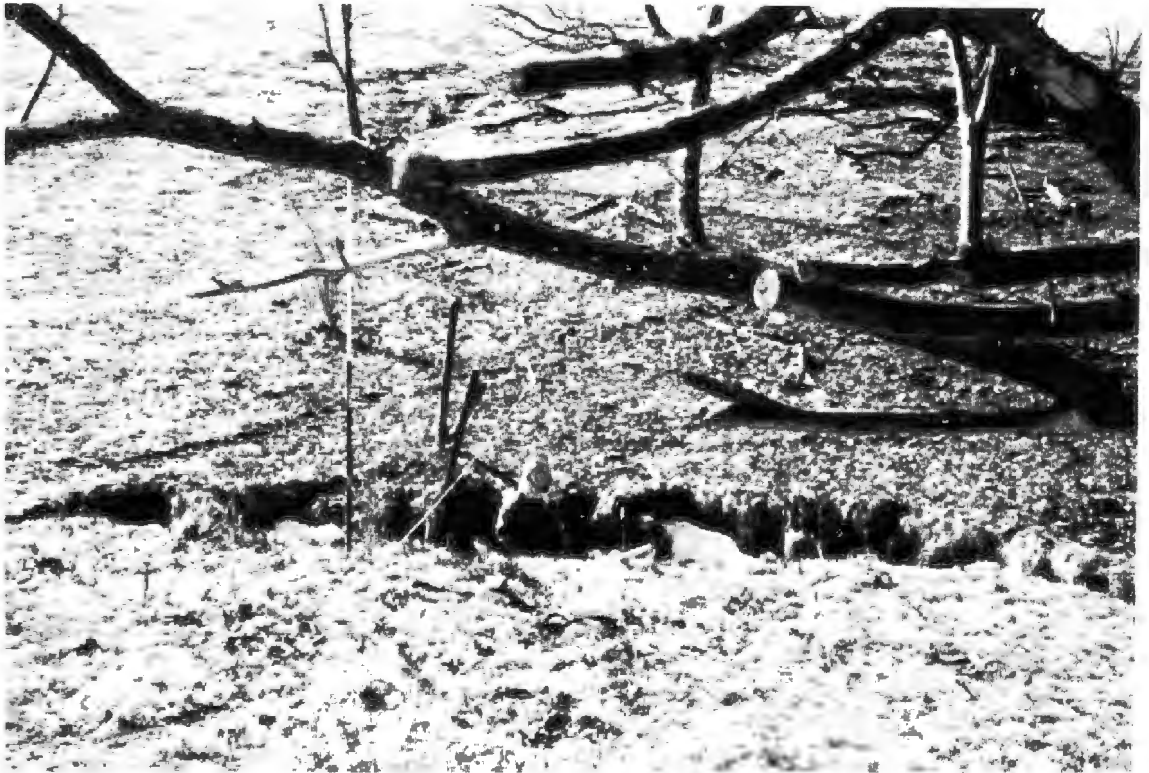
The creation of the new opening around the north end of the dam has resulted in the removal of the historical alluvium that was stored behind the dam and the retreat of the gully headscarp 9.5 meters upslope of the location of Dam 1 (Figure 12). The width

of the newly created gully upslope of Dam 1 varies from 1 meter wide near the gully headscarp to 4.9 meters wide near the dam. The depth of the gully upslope of the dam varies from .68 meters at the headscarp, to 1.54 meters deep in the remaining historical fill behind Dam 1. Thus, a great amount of sediment has been eroded away in response to the failure of this dam. The retreat of the gully headscarp upslope into the rill and swale up valley of the alluvium that has been stored behind the dam over the last 65 years will progress unabated as Dam 1 continues to be destroyed.

Figure 12. Extension of gully upslope of Dam 1. The headscarp of the gully is working its way upslope to the east (left). Dam 1 is just to the right of the photo.

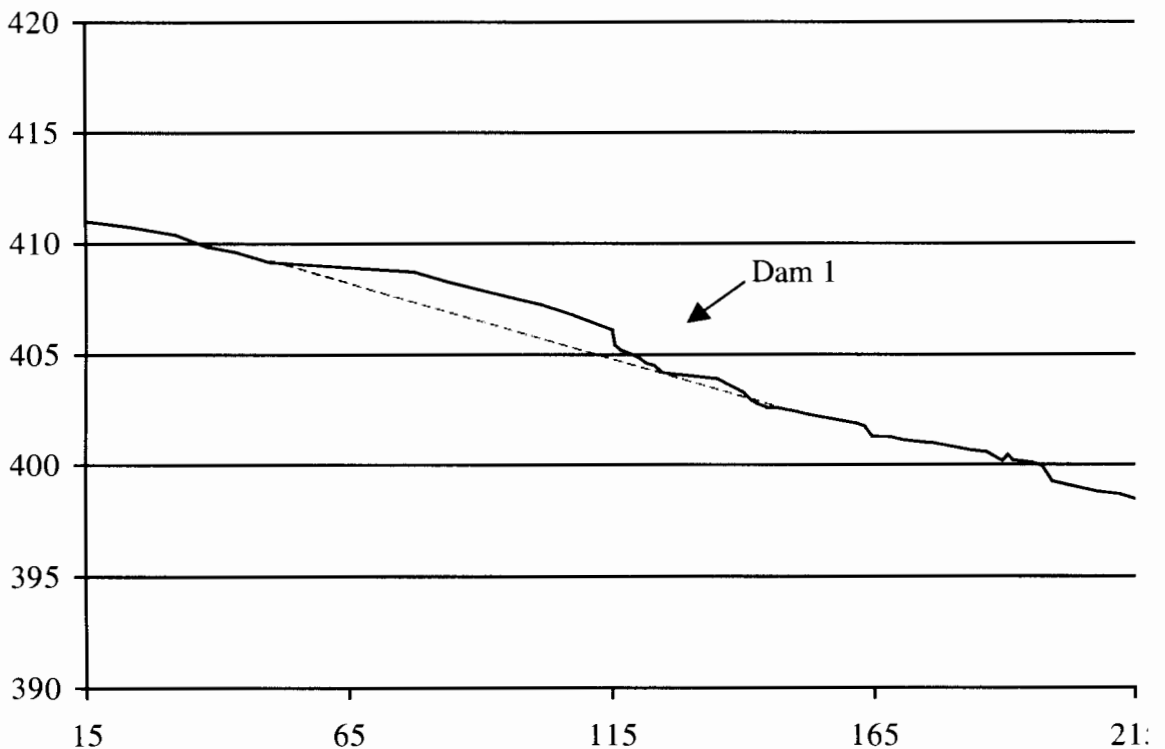
The area directly up-valley of Dam 1 now consists of a low, convex-upward bulge that represents the surface of sediment that has been stored behind Dam 1 since it was built (Figure 13). This bulge is flanked on both sides by very shallow rills. The rill to the north of this bulge was used for the longitudinal profile. This rill also bulges upward quite a bit behind Dam 1. The western portion of sediment immediately behind the dam has been eroded away due to the failure of the dam and the subsequent movement of the gully's headscarp 9.5 meters into this sediment.

Figure 13. Longitudinal profile of the first 200 meters of Johnson Gully. A dashed line has been added that connects the rill upstream of the convex-upward bulge to the gully floor immediately below the remnants of Dam 1's apron. The gully is sloping to the west.

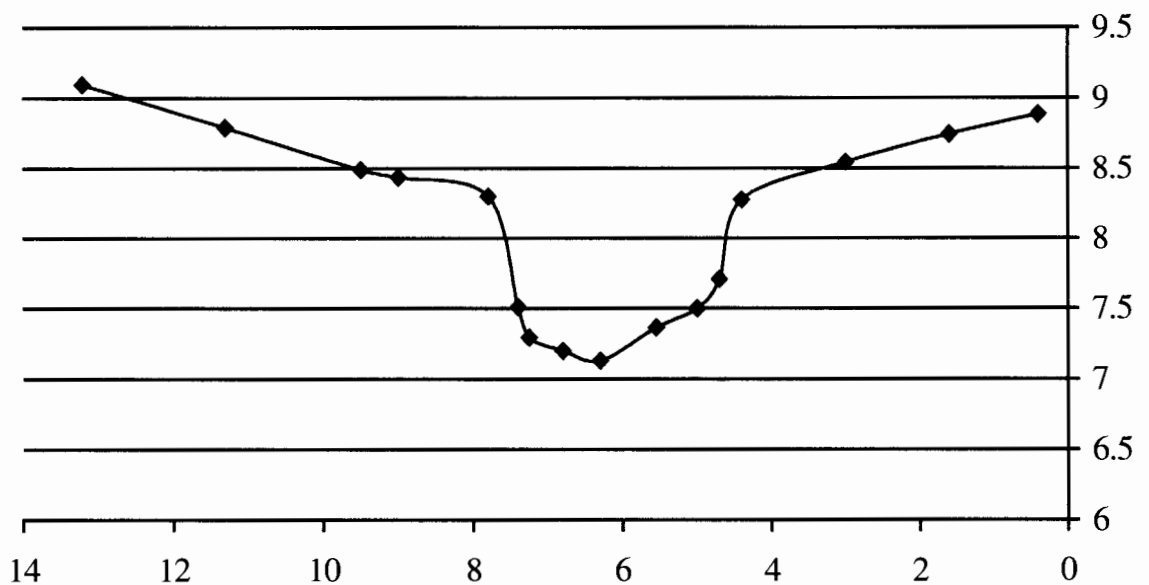
Since failure of Dam 1, the water that once drained over the dam through the spillway notch and pooled on the apron below now runs swiftly around the dam. The result of this has been incision of almost 1 meter (Figure 12 and Figure 14) to a distance of 9.5 meters behind the dam. Though the headscarp is currently stationary at the edge of a cow path (Figure 15), it will likely continue to retreat into the stored historical sediment.

Figure 14. Cross section upstream of Dam 1. This channel has developed in the historical alluvium that was trapped behind Dam 1 before its failure. Horizontal and vertical units are in meters.

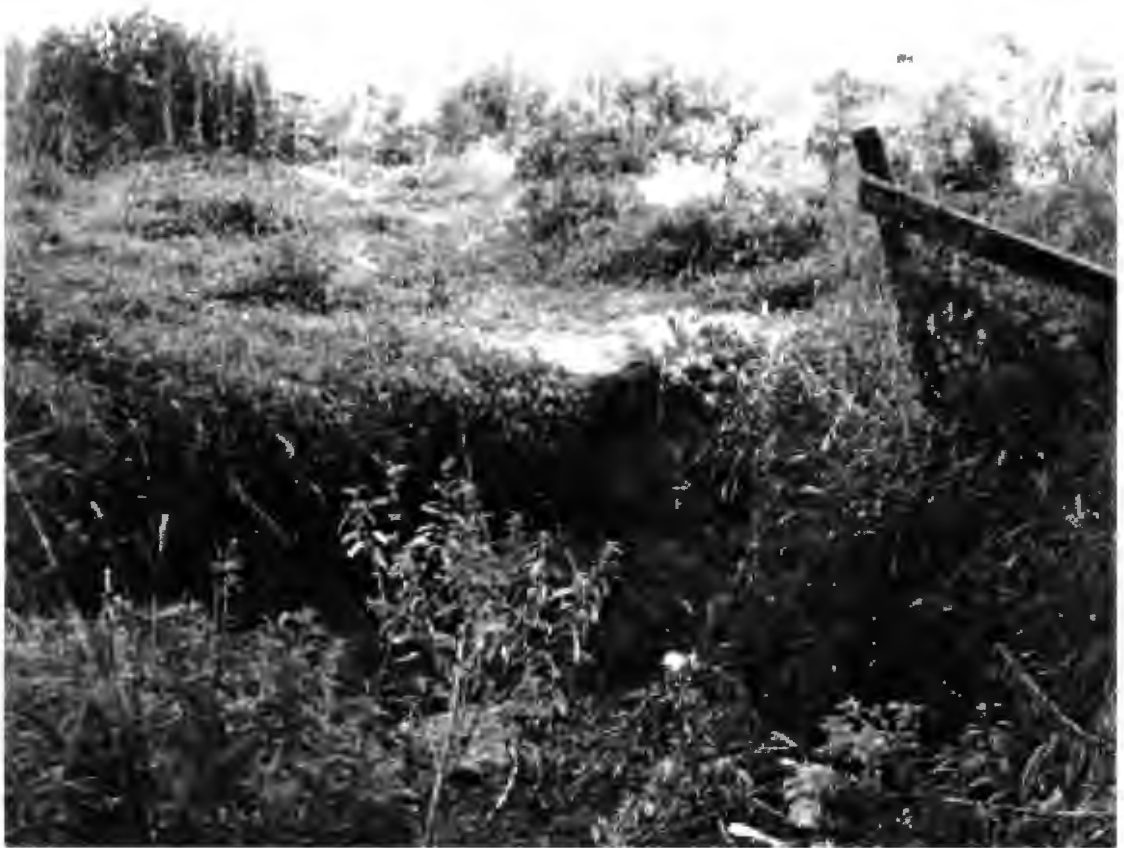
upslope. Thus, the failure of Dam 1 has altered the morphology of the gully in the vicinity of Dam 1. The failure of Dam 1 has resulted in the reactivation of the headscarp. Today the headscarp is slowly retreating up valley into the rill upslope of the dam.

Figure 15. Headscarp upstream of Dam 1.

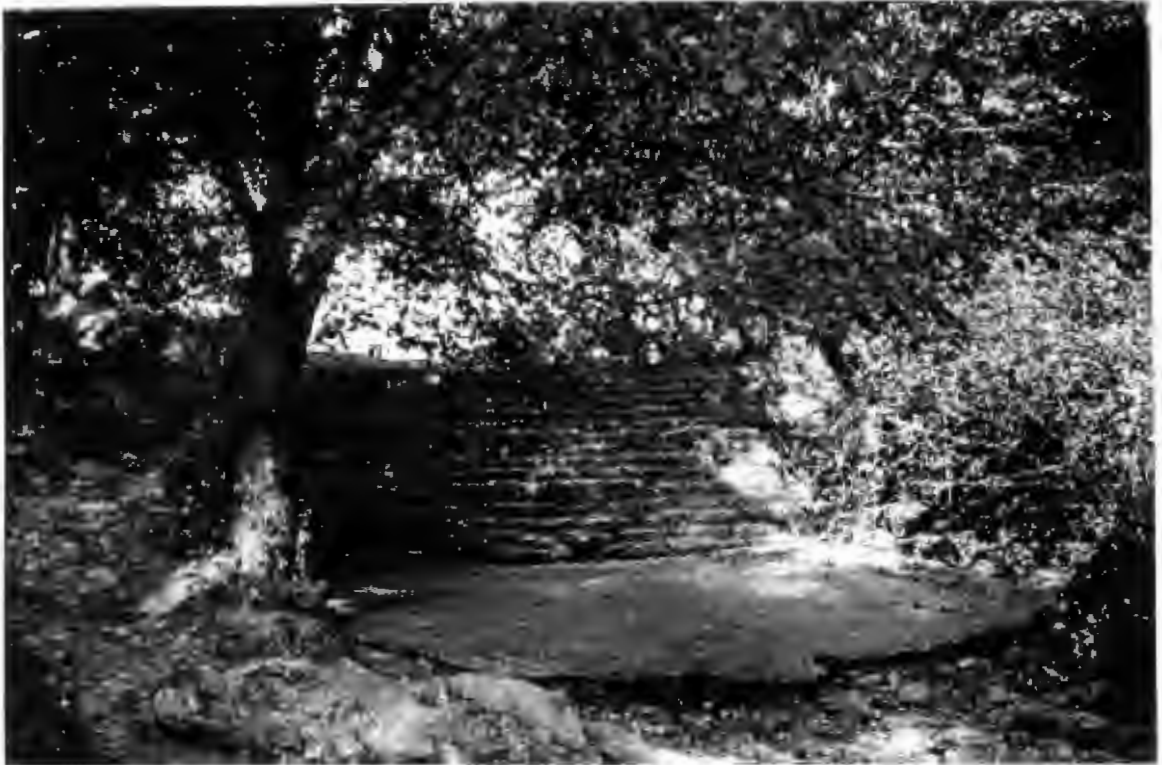
Figure 17. Dam 2. Note the concrete apron that has replaced the original apron. View is upstream.

The reason this dam has been maintained is because a road runs across the historical alluvium fill in the gully just upstream of the dam, and the road is needed by the landowner to move heavy equipment from the farm to the fields (Figure 18). The concrete apron has helped keep the dam stable. Remnants of the old baffle wall that was a part of the end of the old apron are still visible in the gully not very far downstream of the new apron. The new apron does not have a baffle wall. Portions of the new apron are being undercut, as the water is not slowed as it runs across the concrete apron and flows over its end into the gully. The concrete apron extends downstream 4.65 meters from the

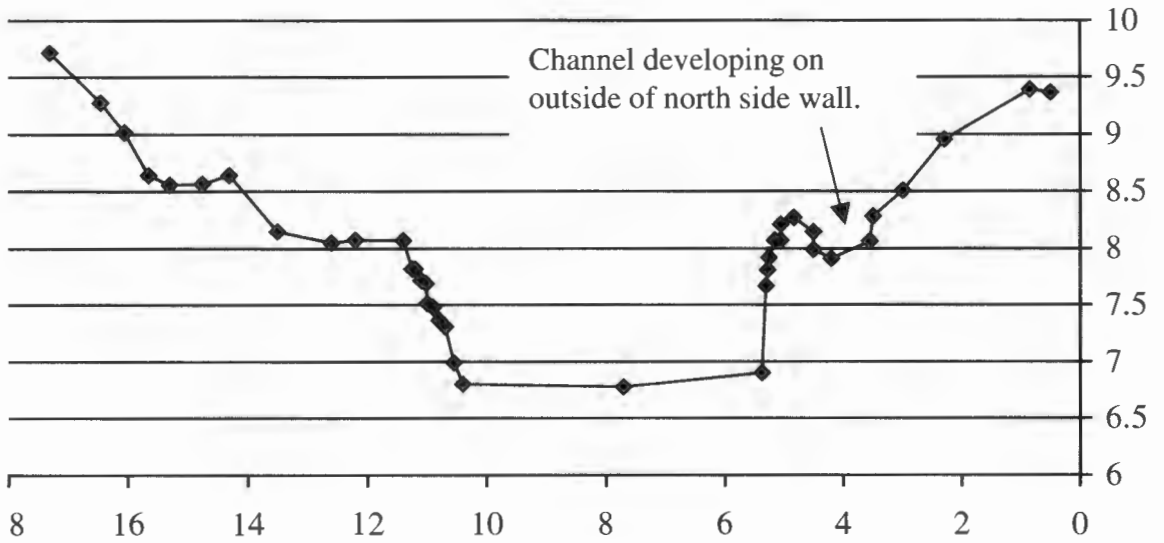
Running water has eroded the outside of the northern side wall so that it is only 0.28 meters thick at its top and 0.45 meters at its end. The channel averages about 1.7 meters wide and is about 0.8 meters deep from the bottom of the channel to the top of the remaining concrete cap that makes up the top of the side wall of the dam. If preventive measures are not taken, the northern side wall will eventually fail, and the gully will continue to deepen and widen around Dam 2 as it has at Dam 1.

Figure 19. Cross section directly downstream of Dam 2. This cross section runs from north (left) to south (right) over the side walls and apron of Dam 2. A channel has formed on the outside of the north side wall.

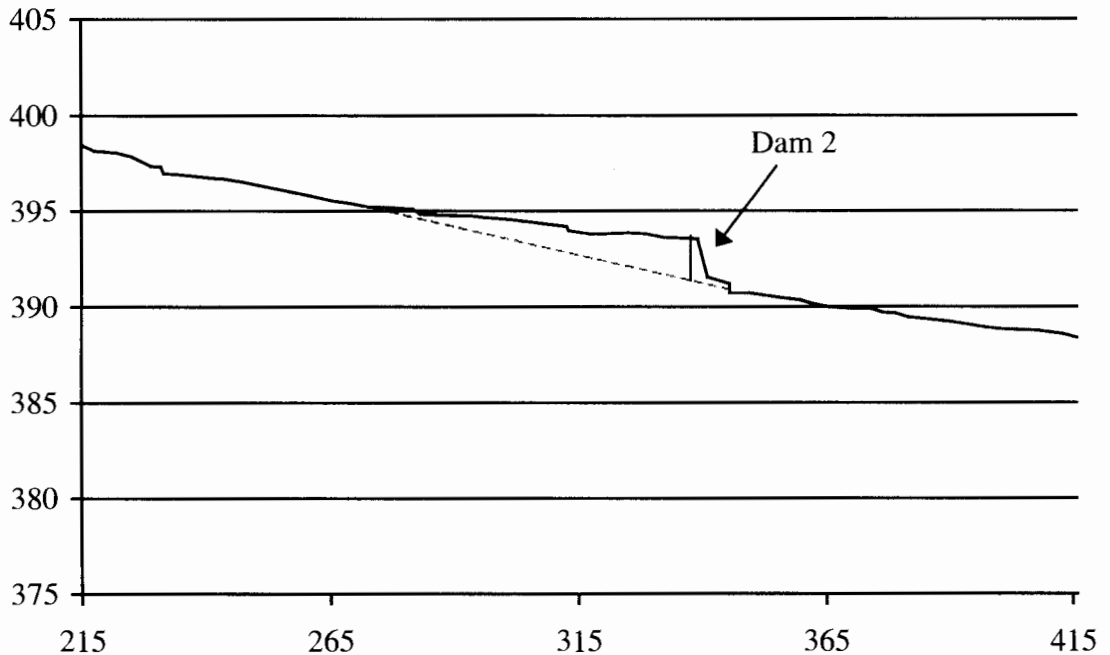
dam by rerouting water around the dam. This will eventually lead to the reestablishment of the pre-dam morphology at this point in Johnson Gully.

Figure 21. Longitudinal profile of Dam 2. A dashed line connects the gully floor from the start of the accumulated alluvium upstream of Dam 2 to the gully floor below the apron.

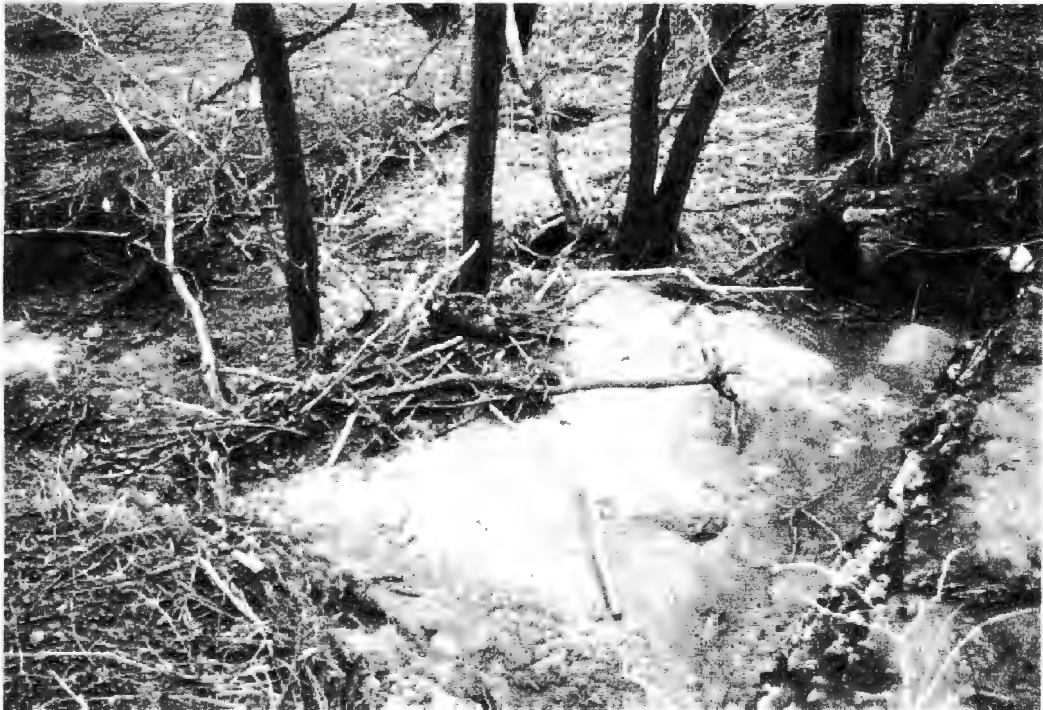
The distance from the top of the dam down to the apron was hard to determine because the apron area is covered with alluvial sand. The vertical distance downward from the top of the notch to the sand on the apron is 1.16 meters. This vertical drop is significantly smaller than those of Dams 1 and 2. The apron is virtually covered with alluvial sand because a tree that fell directly downstream of the apron has three very large branches growing upward that have collected woody debris. This woody debris has formed a small, natural dam at the end of the apron that is helping trap alluvium (Figure 23).

Figure 23. Debris on apron of Dam 3. Woody debris has formed a dam at the end of the apron that is trapping the large volumes of alluvial sand. View is from the southeast facing the northeast. Dam 3 is in the lower right portion of the figure.

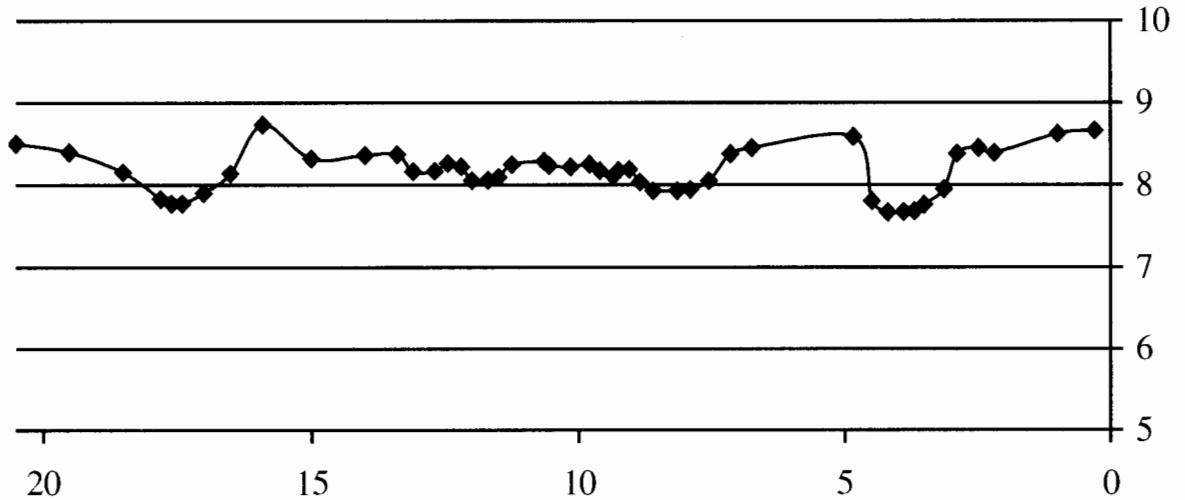
Figure 27. Cross section across the fill upstream of Dam 3. Braided channels have formed in this sandy historical fill. The main route of water is in the channel to the north (right). Horizontal and vertical units are meters.
