Developing rating curves in a small Iowa watershed to evaluate nutrient loading in streams

DEVELOPING RATING CURVES IN A SMALL IOWA
WATERSHED TO EVALUATE NUTRIENT
LOADING IN STREAMS

An Abstract of a Thesis
Submitted
in Partial Fulfillment
of the Requirements for the Degree
Master of Science

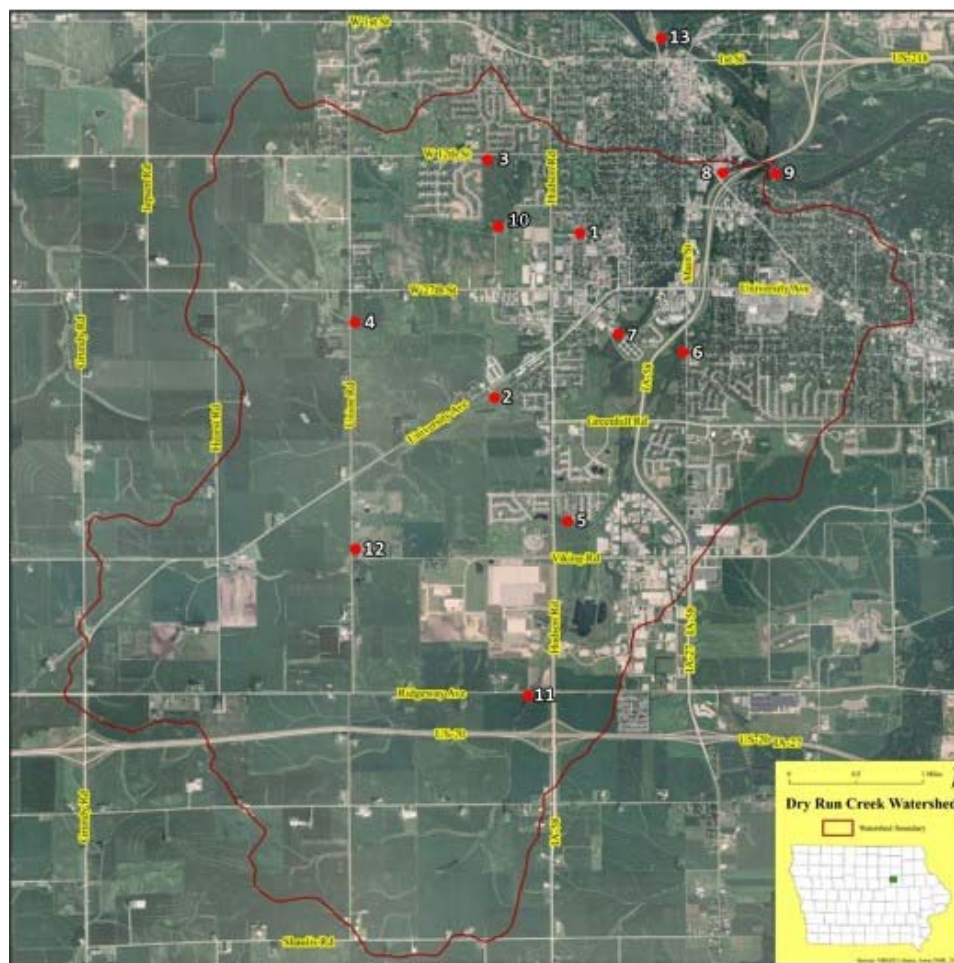
Figure 2. Map delineating Dry Run Creek Watershed and showing sites used.

A map of the Dry Run Creek Watershed is shown displaying the 11 sites used in this study (Figure 2). Ephemeral and intermittent branches begin in farm fields (like so many small Iowa watersheds) surrounding Cedar Falls and the stream empties into the Cedar River and then eventually into the Mississippi River. The Upper Mississippi River Basin includes an expanse of approximately 190,000 square miles that begins in northern Minnesota at Lake Itasca and ends at the confluence of the Mississippi River and the Ohio River at the southern tip of Illinois. The basin includes large portions of Iowa, Illinois, Minnesota, Wisconsin, and Missouri, as well as parts of Indiana, Michigan, and South Dakota. Within the Upper Mississippi River Basin the highest concentrations of cropland are in northeastern and central Iowa and southern Minnesota where it is greater than 80% of the land use in many counties (UMRBA, 2013).

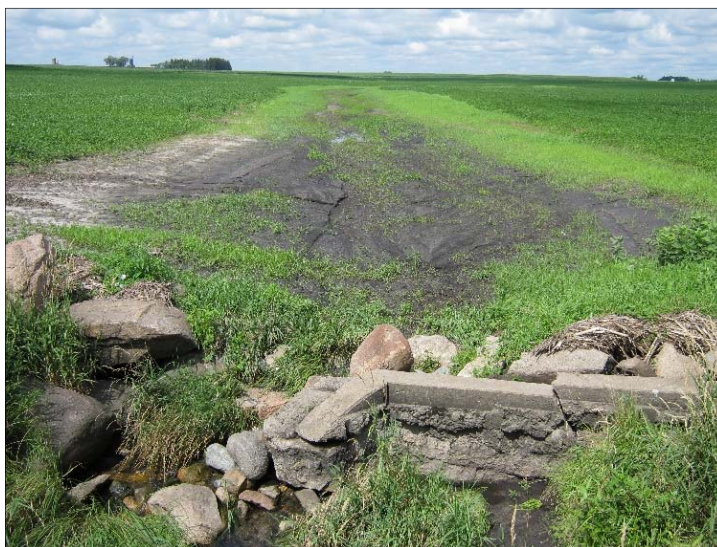
Figure 3. Since this photo was taken looking upstream the farmer has row-cropped what used to be the greenway and ephemeral headwaters for Dry Run Creek.

According to the Iowa Department of Natural Resources in a 2011 publication there has been a 200%+ increase in urbanization of the watershed. Row crops with narrow riparian strips in the upper reaches of Dry Run Creek make up approximately 55% of the land use and grazed grasslands make up 4% (Palmer & Buyck, 2011). While studying Dry Run Creek it was observed that the headwaters of the watershed are almost entirely unnatural, many beginning as draintile outlets (Figure 3).

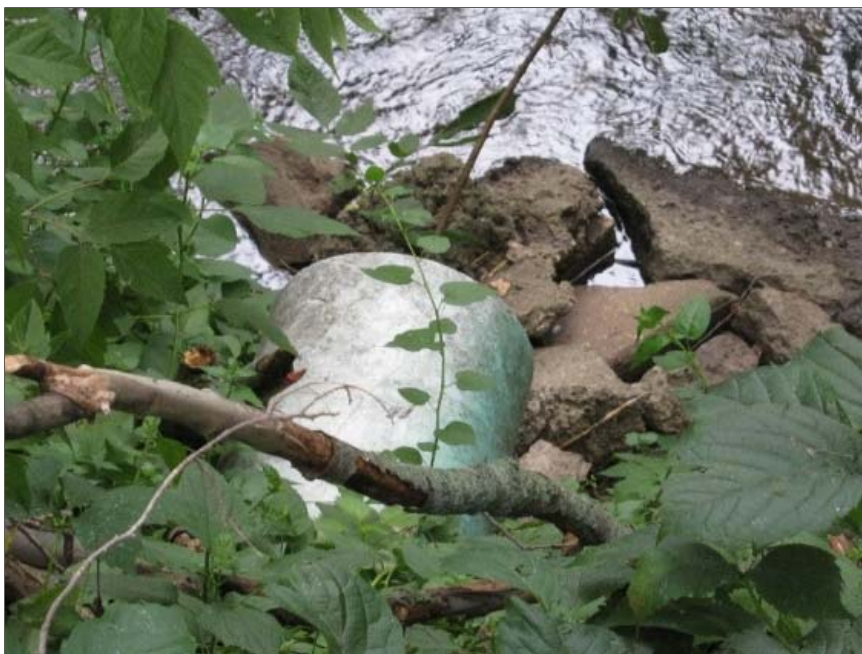
Figure 5. Photo taken in 2009 of a storm drain emptying into Dry Run Creek just downstream of Site 6 near the Cedar Falls dog park.

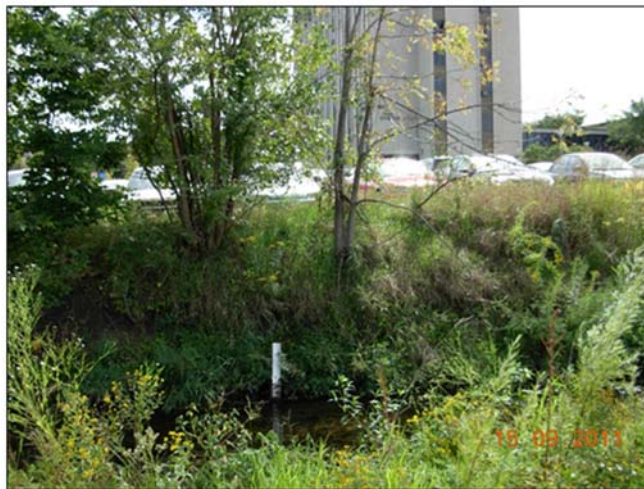
Figure 6. Photo of Site 1

Site 1 (Figure 6) is located just to the west of Campus Street to the north of the University of Northern Iowa's "Towers" dormitories (Figure 2). An existing stream gauge from a previous stream study is utilized in this study and measurements are converted to centimeters from feet. To the right of the stream (when looking upstream at this site and other sites) is a large paved parking lot for Price Lab School that drains directly into the stream. To the left of the stream (when looking upstream at this site and at all other sites) there is a large parking lot for students. A portion of this parking lot drains into a small catchment area before entering the stream.

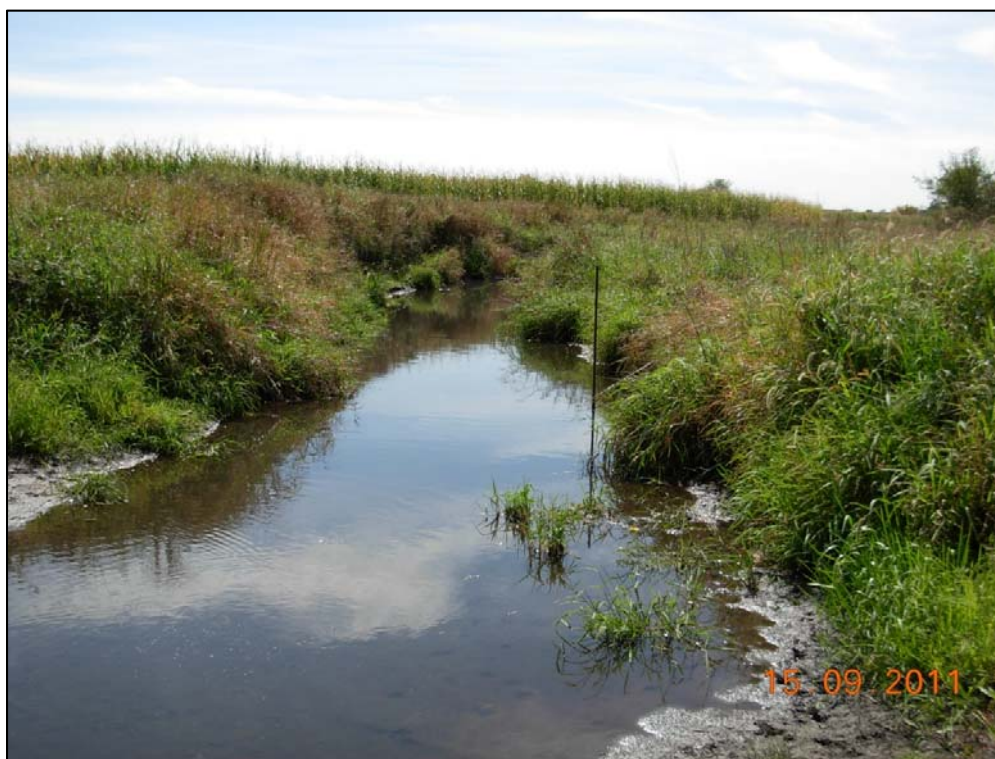
Figure 7. Photo of Site 2

Site 2 (Figure 7) is located just to the south of University Avenue and to the west of Hudson Road in Cedar Falls, IA (Figure 2). A constructed stream gauge for this study, measuring in centimeters, was installed along a run in the stream. To the right of the stream is an area of overgrown grass and University Avenue. To the left of the stream are row crops up to the bank of the stream. Just downstream of the gauge is a makeshift road with a concrete pad to allow for farm machinery to cross. After rain events this section of stream is extremely turbid and there is an extreme influx of sediment on the base of the stream. Muskrats were often seen at this site.

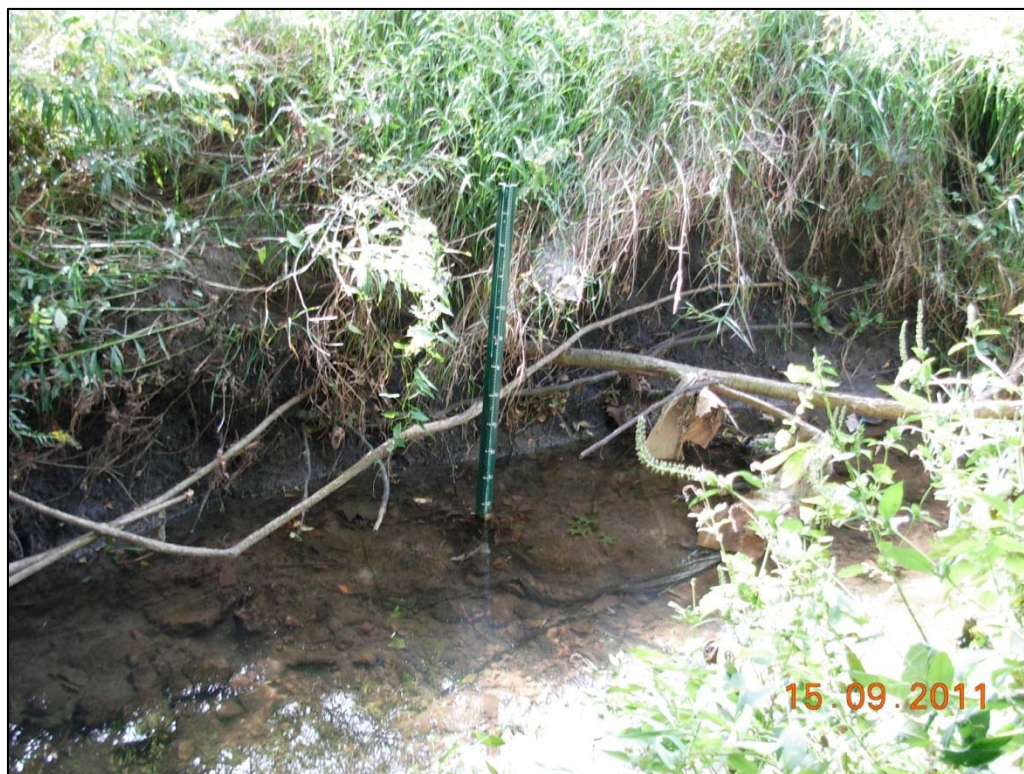
Figure 8. Photo of Site 3

Site 3 (Figure 8) is located just to the south of the intersection of W 12th Street and Barnett Drive in Cedar Falls, IA (Figure 2). A constructed stream gauge for this study, measuring in centimeters, was installed along a run in the stream. To the right of the stream is a thin strip of riparian zone and row crops. To the left of the stream there is a very thin strip of riparian zone, an area of overgrown grass, and then a residential development. This site often had garbage debris in and around the stream.

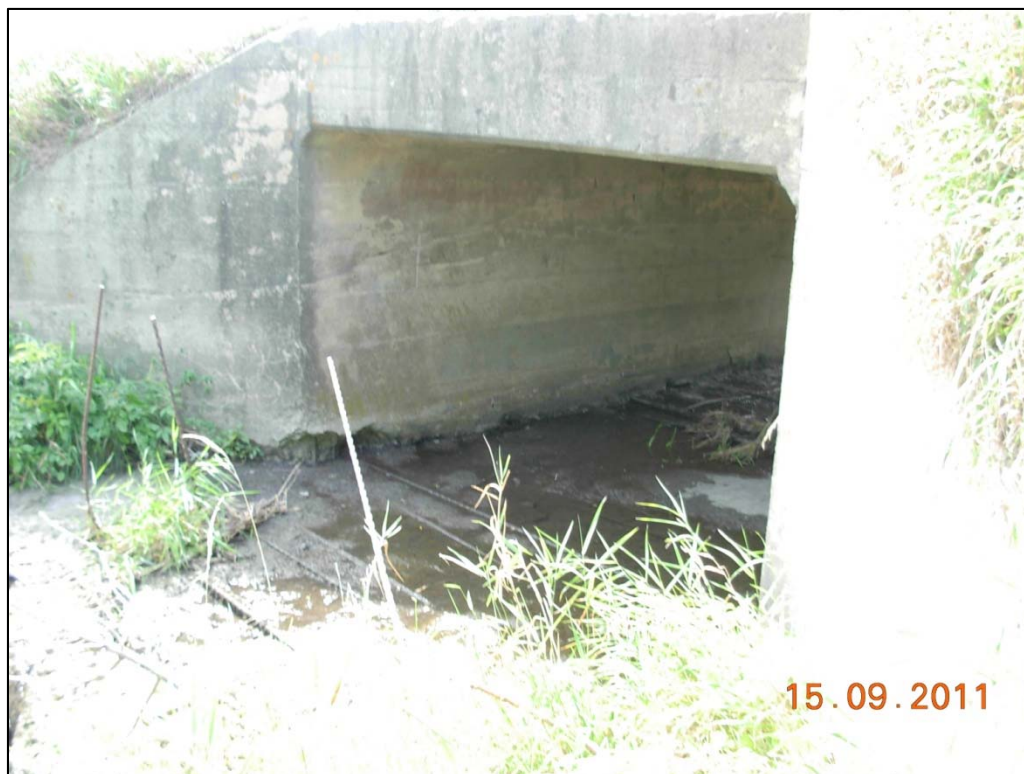
Figure 9. Photo of Site 4.

Site 4 (Figure 9) is located at the outlet of the square culvert underneath North Union Road in Cedar Falls, IA (Figure 2). A stream gauge was painted directly on the concrete of the square culvert for this study, measuring in centimeters. To the right of the stream is a narrow strip of riparian zone and row crops. To the left of the stream there is a narrow strip of riparian zone and row crops. Downstream of this site individuals have constructed a dam creating a deep pool.

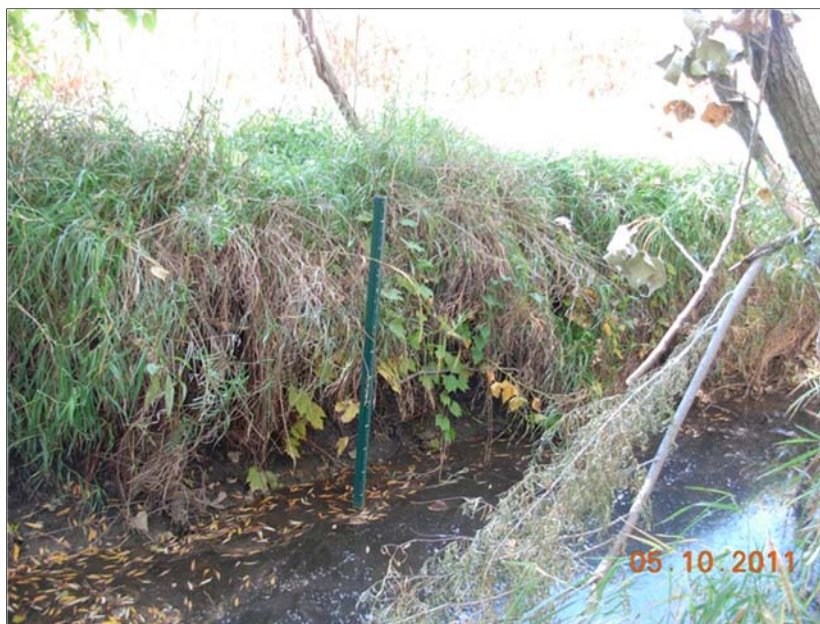
Figure 10. Photo of Site 5.

Site 5 (Figure 10) is located in the Viking Hills subdivision to the south of where Fjord Drive terminates in Cedar Falls, IA (Figure 2). A constructed stream gauge for this study, measuring in centimeters, was installed along a run in the stream. To the right of the stream is residential housing. To the left of the stream are row crops. Children often play in this portion of the stream and move rocks.

Site 5 was selected for ease of access. In other studies this section of stream was accessed downstream but due to neighborhood development a new locale was needed. This site was chosen due to a road ending ~30yds from the stream-bank and a trail leading down to the stream next to a storm water drain.

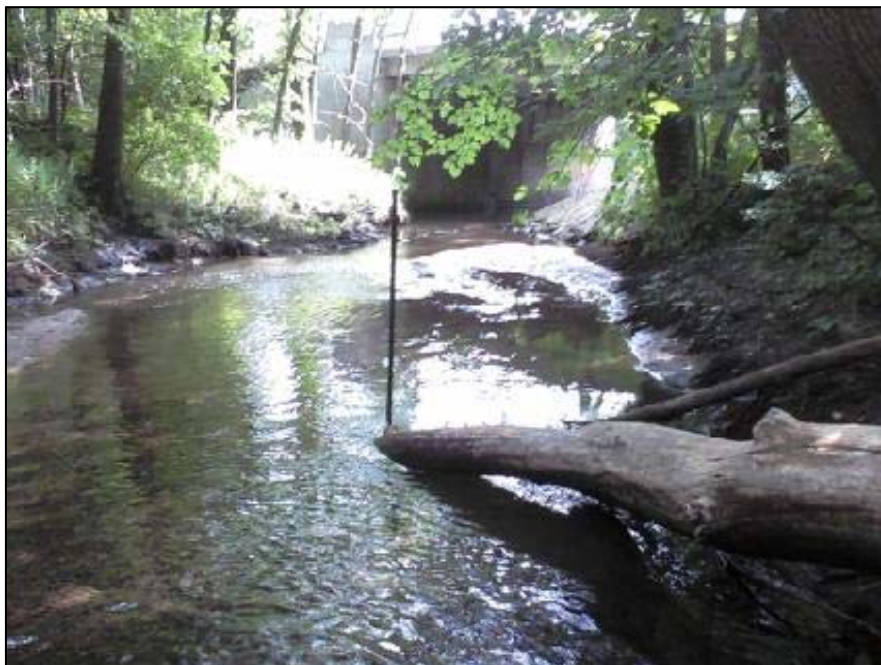
Figure 11. Photo of Site 6.

During rain events this portion, just as most of the watershed, experiences flash flooding and large amounts of debris traveling downstream. After one storm event this gauge was twisted and bent over causing the gauge to need to be replaced.

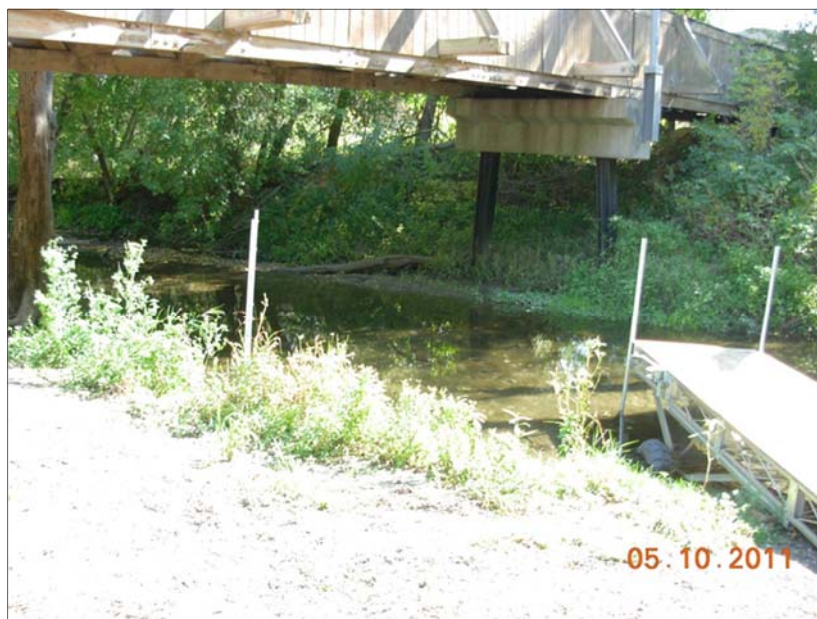
Figure 12. Photo of Site 7.

Site 7 (Figure 12) is located on the University of Northern Iowa campus in Cedar Falls, IA on the north side of the non-traditional student housing complex next to the on-campus testing wells. (Figure 2). A permanent stream gauge measuring in feet was installed along a run in the stream; the measurements are converted to centimeters for this study. To the right of the stream is a thin strip of riparian zone, mowed grass, and buildings. To the left of the stream there is a narrow strip of riparian zone, mowed grass, and then the non-traditional student housing complex and parking lot. Next to the site is a foot bridge connecting student housing to campus.

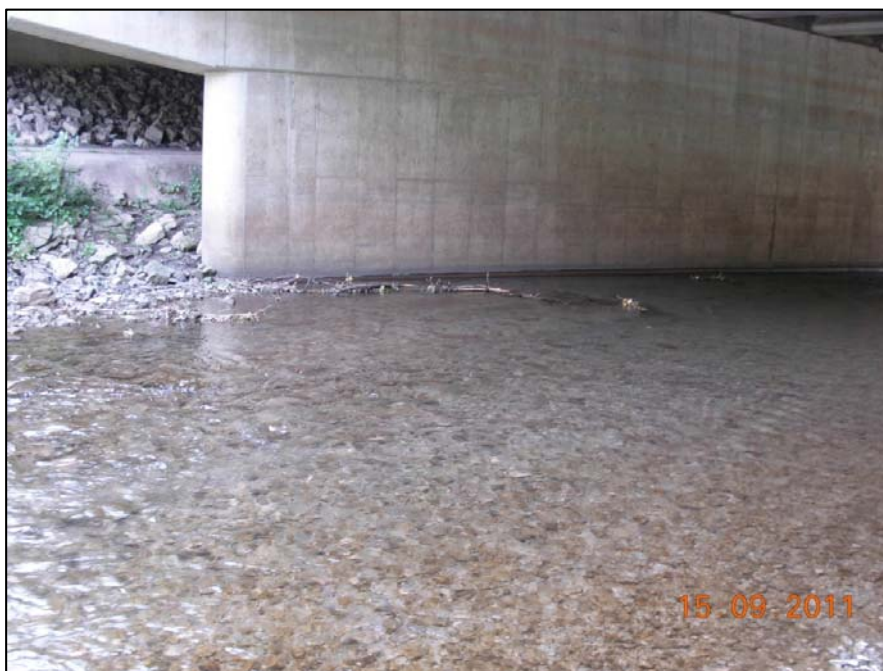
Figure 13. Photo of Site 8.

Site 8 (Figure 13) is located along Waterloo Road near the overpass of Highway 58 next to Cedar Falls Utilities in Cedar Falls, IA (Figure 2). A stream gauge was painted directly on the concrete of the square culvert for this study, measuring in centimeters. To the right of the stream there is a very thin strip of riparian zone and Cedar Falls Utilities. To the left of the stream is a paved bike path and Highway 58. This site is just upstream of the confluence with the Cedar River and is often utilized in studies to represent the total flow of Dry Run Creek.

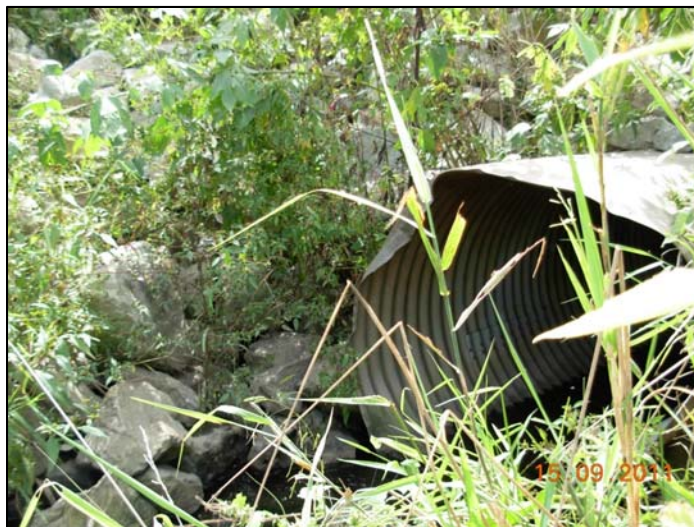
Figure 14. Photo of Site 10.

Site 10 was chosen to represent a stream section upstream of the newly developed UNI wetlands. The towers site off of Campus St. is just downstream of the wetlands. In addition, both of those sites have undergone streambank stabilization projects in recent years. At site 10 the gauge location is the mouth of a round culvert that the stream passes through because of a class c road. The advantage to this site is that it is permanent until the road structure is changed someday. The metal culvert won't change shape as a natural streambed would and therefore it has the advantage of long-term data sets at this site. To measure discharge at this site the velocity meter was used to take 3 velocity measurements that were then averaged out and utilized to estimate discharge.

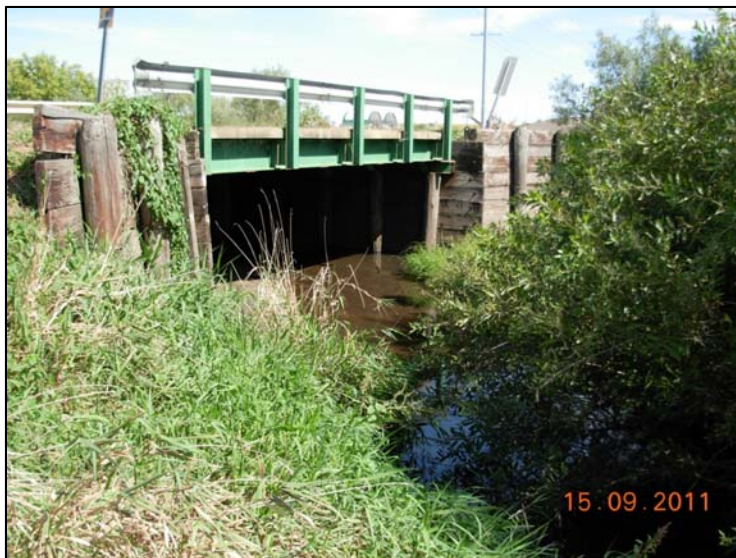
Figure 15. Photo of Site 11.

Site 11 (Figure 15) is located along Ridgeway Avenue just west of Hudson Road in Cedar Falls, IA (Figure 2). There is no stream gauge installed at this site. Measurements were taken using a depth sensor measuring from the bridge base down. To the right and left of the stream there is a very thin strip of riparian zone and row crops.

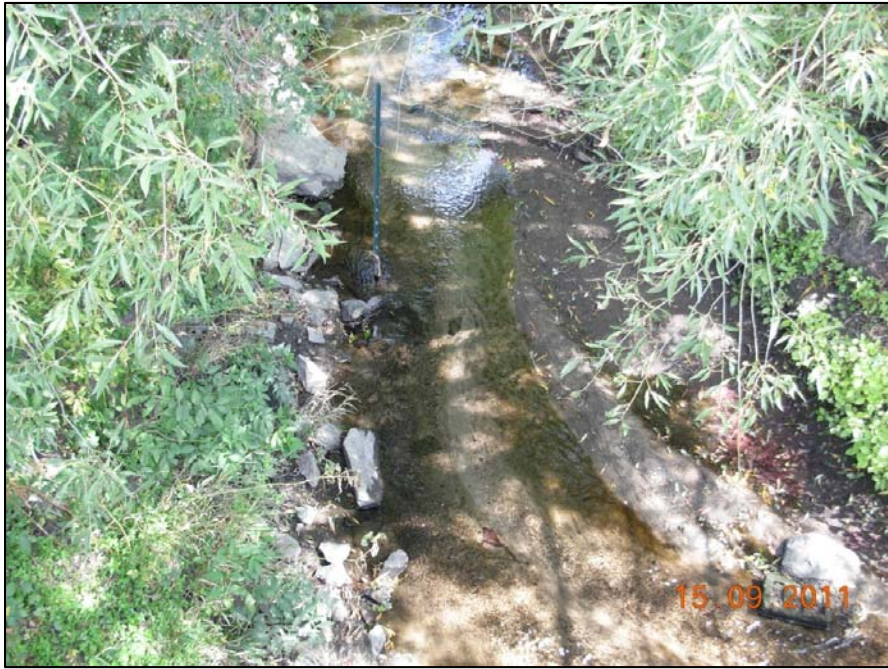
Figure 16. Photo of Site 12.

Site 12 (Figure 16) is located along Union Road near its intersection with Viking Road in Cedar Falls, IA (Figure 2). A constructed stream gauge for this study, measuring in centimeters, was installed along a run in the stream. To the right of the stream there is a very thin strip of riparian zone and row crops. To the left of the stream are a very thin strip of riparian zone and the backyard of a home. Upstream of this site is surrounded by row crops with minimal grassed riparian zones. This section of stream has an influx of sediment after rain events but not to the degree as site 2. Frogs were often seen at this site as well as once a mink.

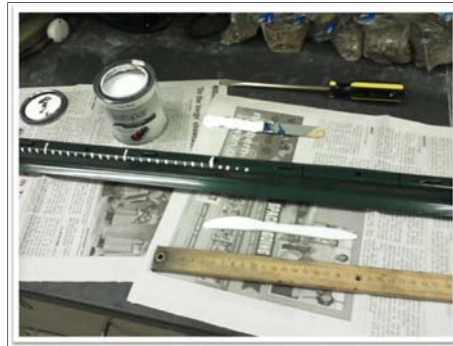
For the study period (May 11- August 9, 2011), the location and type of gauge utilized at each site depended on the site. Sites 2, 3, 5, 6, and 12 gauges were created by painting metal fence posts (Figure 17) and installing them in the stream channels. These gauges are very inexpensive, costing less than \$20 per site for materials. Existing concrete structures were utilized at sites 4 and 8 by painting gauges on them. These sites are even less expensive than the constructed gauges because they only cost involved is the paint. This is assuming that the person developing the site has a meter stick to use to mark increments to paint.

Figure 17. Photo of painted fence post gauge mid-construction.

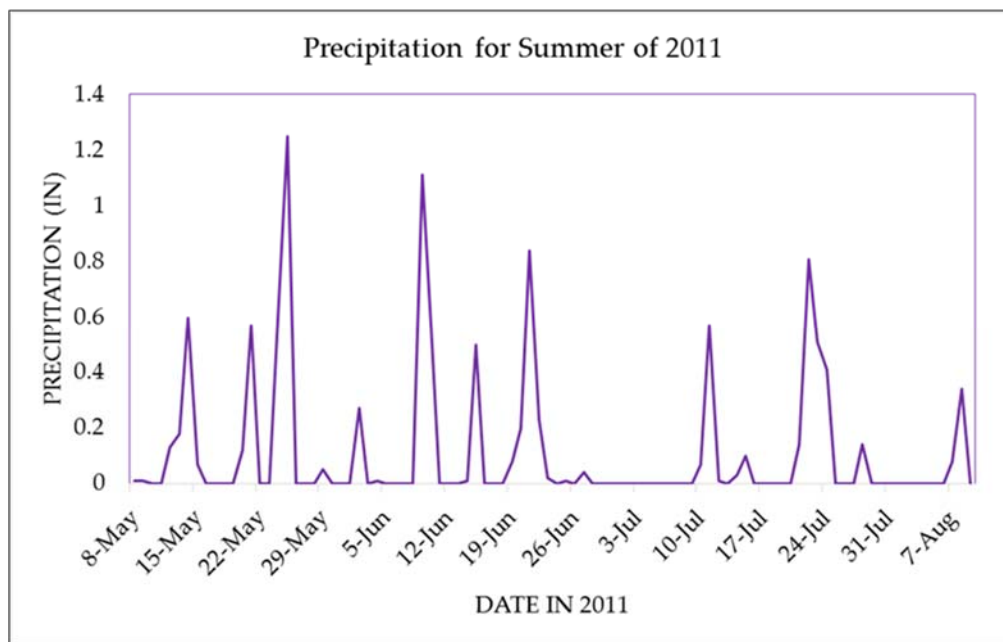
The total precipitation during the study period (May 11- August 9, 2011) was 10.67 inches (Weather Underground, 2014). Figure 19 shows the dates and amounts of rainfall during the study period.

Figure 19: Precipitation for Waterloo, IA May 8- August 8, 2011
(Weather Underground, 2014)

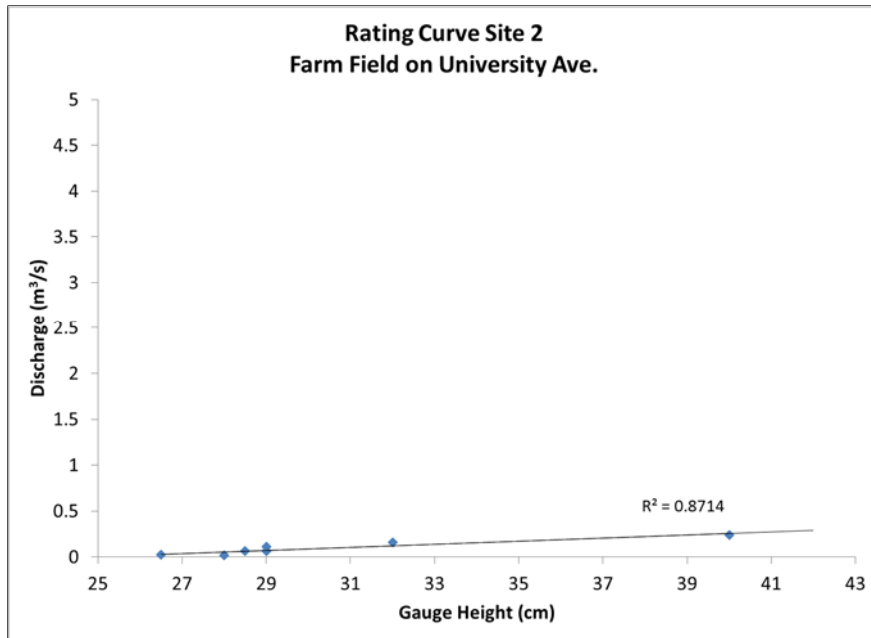
Figure 22: Site 2 Rating Curve.

During the study period (May 11- August 9, 2011), the highest gauge height occurred on June 13 at 40 cm with a discharge of 0.24 m³/s. The lowest observed gauge height occurred on August 4 at 26.5 cm with a discharge of 0.02 m³/s (Figure 22). This site is the most unstable site due to its constant change in the amount of organic sediments, mainly silts, on the streambed. Every week the stream gauge needed to be recalibrated for depth based on the amount of sediments being conveyed through the channel. In order to create a rating curve for this site all depth measurements had a correction factor figured in that changed each week due to organic sediment depth (Appendix A). A correction factor was made to accommodate the changing depth to the bottom of the streambed on the gauge. This site is unsuitable for further studies using the gauge and calculated rating curve.

The rating curves at the various sites vary in reliability. Site 2, located along row crops, is prone to high fluctuations in silt deposits making the gauge unreliable for stream depth. Site 2 is not suitable for using its rating curve. Sites 3, 5, 6, and 12 are all vulnerable to damage in high flow conditions. The stream gauge at site 6, located upstream of the Cedar Falls dog park, was damaged and had to be replaced mid-study from floating debris during a high flow rain event. The instability of the gauges make these sites questionable for use in future studies. However, if a permanent gauge were installed at site 6, it could be useful as it represents the entire flow from the East branch of Dry Run Creek. Sites 1 and 7, located along Campus St. and near the campus wells respectively, have permanent gauges installed and will be excellent for future studies. Sites 4, 8, 10, and 11 all utilize existing structures in some way, making them all very useful for future studies. Site 11 may be the shortest lived of these 4 sites because it may have a change in siltation on the streambed after a major storm event. Sites 4 and 8 can be used long term if a more permanent gauge is installed. These 2 sites had the gauges painted onto the concrete structures and the paint is worn away during higher flow. Sites 4 and 10 are not going to change until their culverts are damaged or destroyed. Site 8 is perhaps the most important site because it is the site that represents the entire flow of Dry Run Creek and is located just before the confluence with the Cedar River. This site requires some work to obtain reliable flow readings during high flows but it has a very stable streambed and will be extremely useful in many future studies.

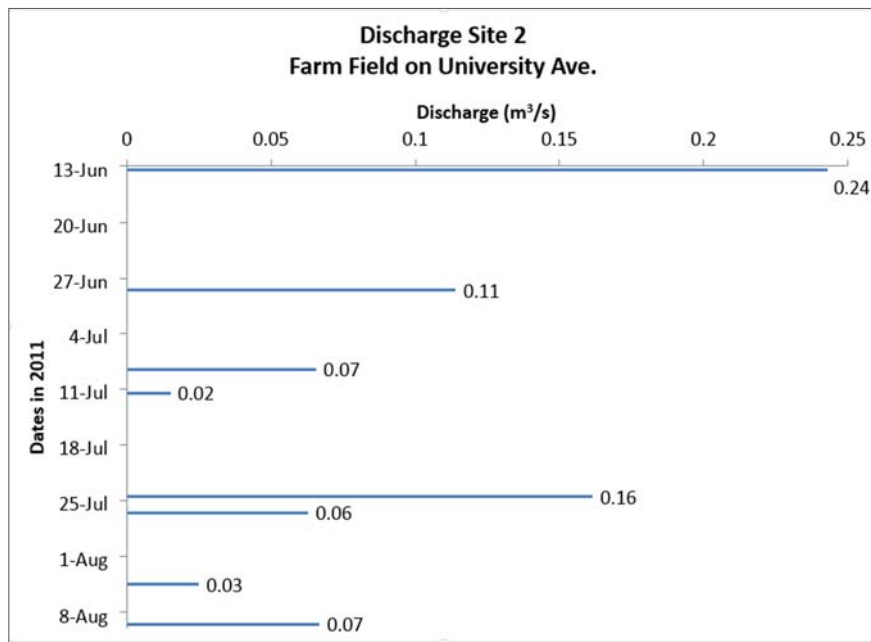
Figure 23: Site 2 Discharge.

Discharge at site 2 fluctuates rapidly depending on precipitation and there is a general trend of decreasing flow as summer progresses. A gradual decline in overland flow from the adjacent crop fields occurs as summer progresses and the drain tiles have less flow to add to the creek (Figure 23) (Appendix B).

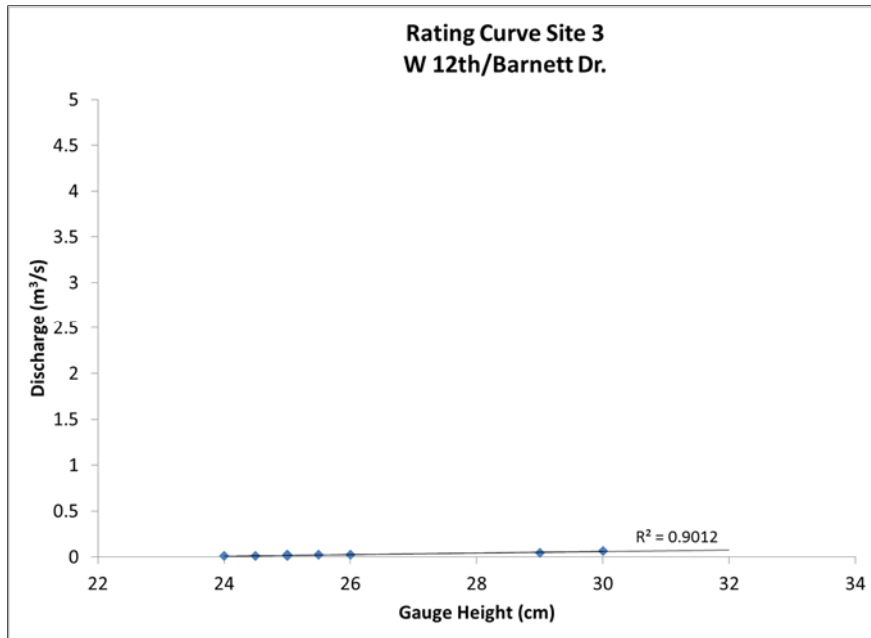
Figure 24: Site 3 Rating Curve.

During the study period (May 11- August 9, 2011), the highest gauge height occurred on July 24 at 30 cm with a discharge of 0.06 m³/s. The lowest observed gauge height occurred on July 11 at 24 cm with a discharge of 0.01 m³/s (Figure 24). This site often had garbage debris due to its proximity to a busy residential area and street. The headwaters in this area have been altered into drainage ditches in a neighborhood (Appendix A). This site could be used to examine fertilizer runoff from the residential area located upstream.

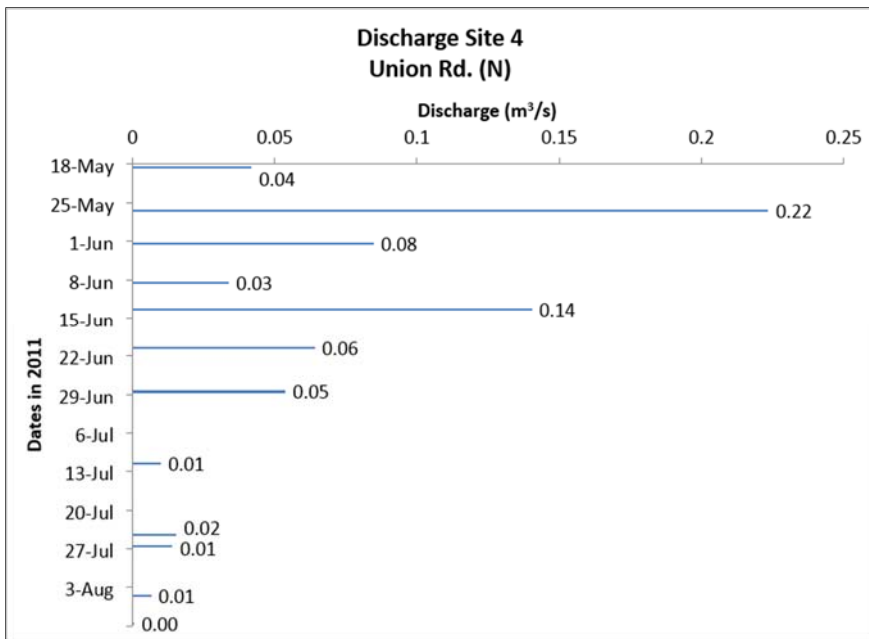
Figure 27: Site 4 Discharge.

Much like site 3, in drier conditions there is no flow in this site. This site is near the headwaters of this branch and is mainly fed by drain tiles from agricultural fields (Figure 27)

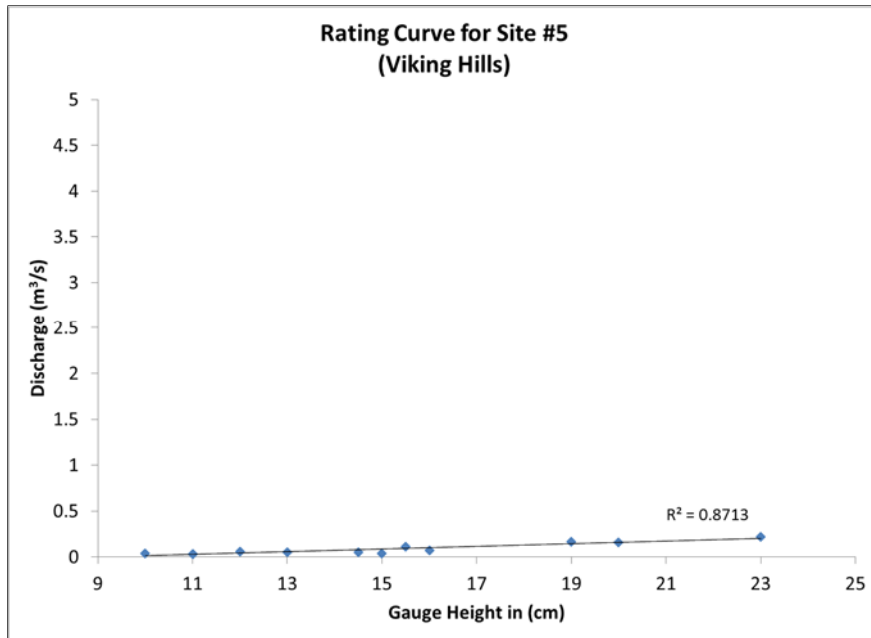
Figure 28: Site 5 Rating Curve.

The highest gauge height in this site occurred on May 26 at 20 cm with a discharge of 0.16 m³/s. The lowest observed gauge height occurred on July 11 at 10 cm with a discharge of 0.04 m³/s (Figure 28). The gauge at this site is vulnerable because it is located in a residential area and there is evidence (a make-shift bridge and other signs) that children often play in this stream section. This site is useful because it is just downstream of the catchment pond for a residential area (Appendix A). Studies could be done in examining the ability of the catchment pond on slowing the influx of discharge during rain events and the ponds ability to precipitate out sediments and fertilizer before entering the creek.

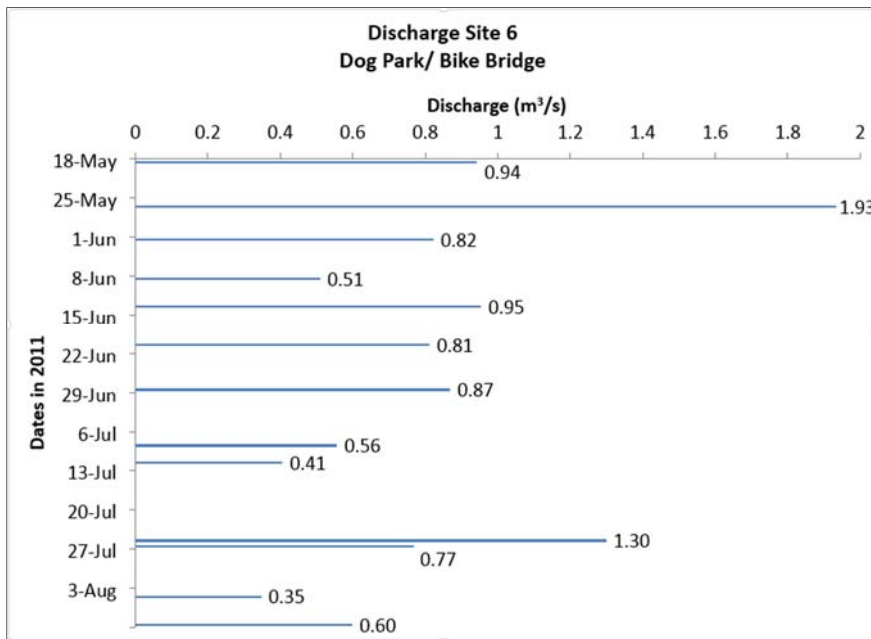
Figure 31: Site 6 Discharge.

Site 6 readily fluctuates in flow based on precipitation. It is fed by several small ephemeral tributaries and has a low base flow of approximately 0.5 m³/s (Figure 31). After large rain events flow is too high to safely obtain velocity readings across the stream, therefore, peak flows are not measured accurately. Discharge was calculated based on velocity measurements taken near shore (Appendix B).

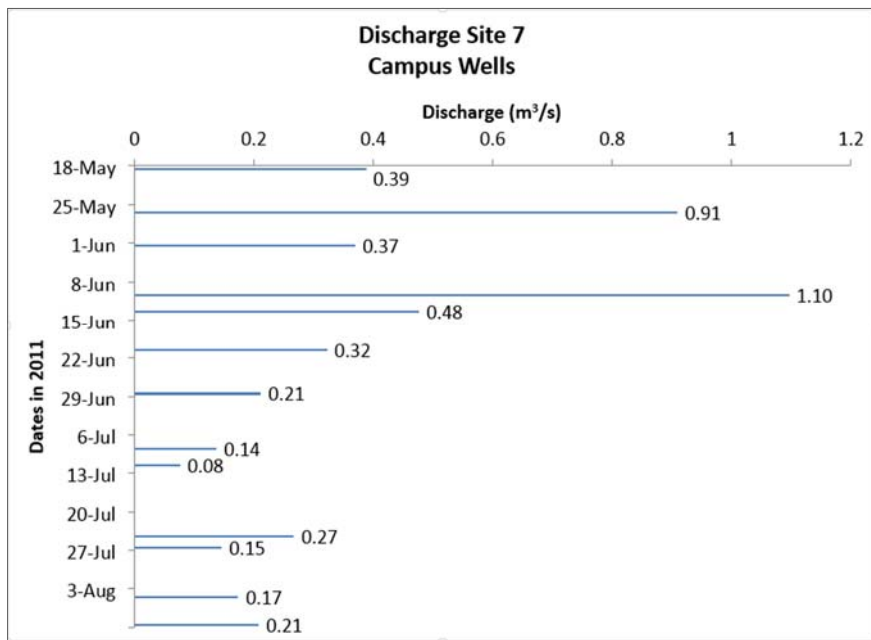
Figure 33: Site 7 Discharge.

During periods of high flow, this site is too deep and turbulent to safely take velocity measurements across the stream. Therefore, high peak flows were calculated based on velocity measurements taken near shore. Base flow is quite low in this stream section, sometimes being almost dry (Figure 33) (Appendix B).

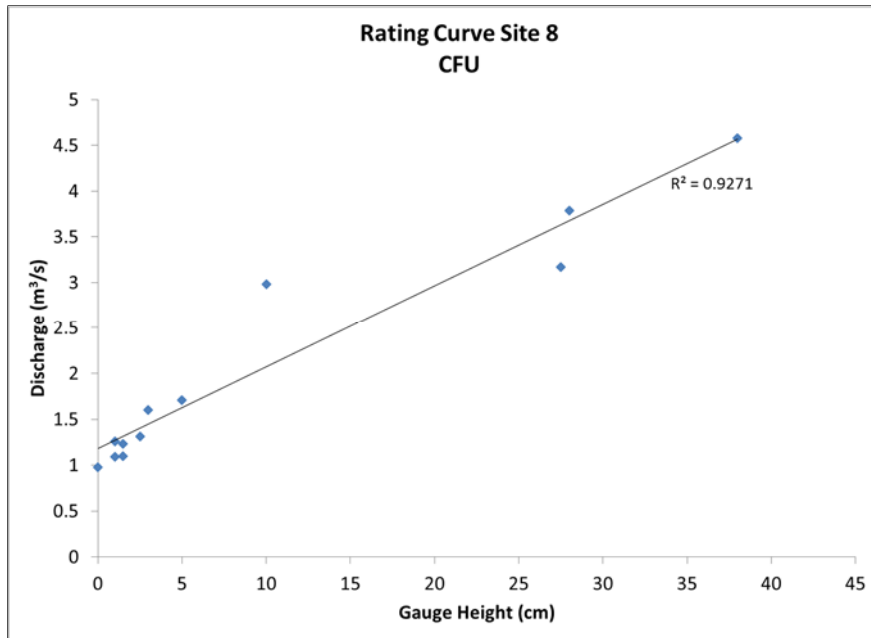
Figure 34: Site 8 Rating Curve.

The highest gauge height at this site occurred on June 20 at 38 cm with a discharge of 4.6 m³/s. The discharge rate for this date is not accurate because there were no velocity measurements taken from mid-stream due to the water being too deep and rapid to wade into. May 26 and June 28 velocities are inaccurate as well due to the water being too deep and turbid. The lowest observed gauge height occurred on August 4 at 0.0 cm with a discharge of 0.98 m³/s (Figure 34). On this date, 3.5 m of the streambed was dry on the right bank of the stream, making the stream narrower in periods of low flow. The gauge at this site will need to be repainted often due to it wearing off during periods of higher flow. This site represents the entire watershed and is located just upstream of the confluence with the Cedar River (Appendix A). Site 8 is extremely important because it is located just upstream of the confluence with the Cedar River. This site however does change in total stream width depending on discharge and is unsafe to enter during high flow. Further work needs to be performed on this site to develop a reliable or more valid rating curve. Equipment to measure from the bridge above needs to be utilized.

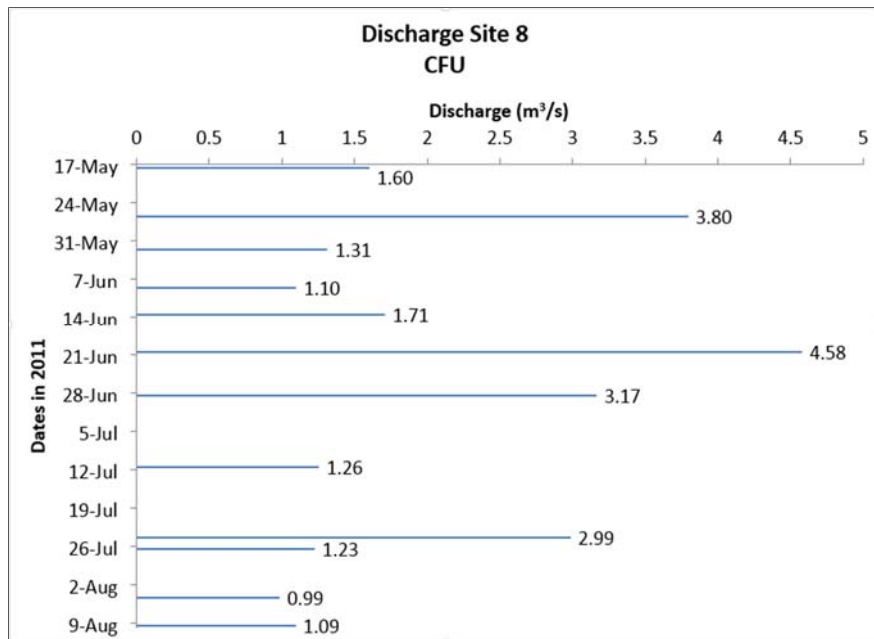
Figure 35: Site 8 Discharge.

Site 8 represents the entire discharge of Dry Run Creek flowing into the Cedar River. Its base flow is approximately 1.0 m³/s (Figure 35). During peak flows it is too deep and fast to safely take velocity measurements across the stream. Therefore, discharge is based on velocity measurements taken near shore (Appendix B).

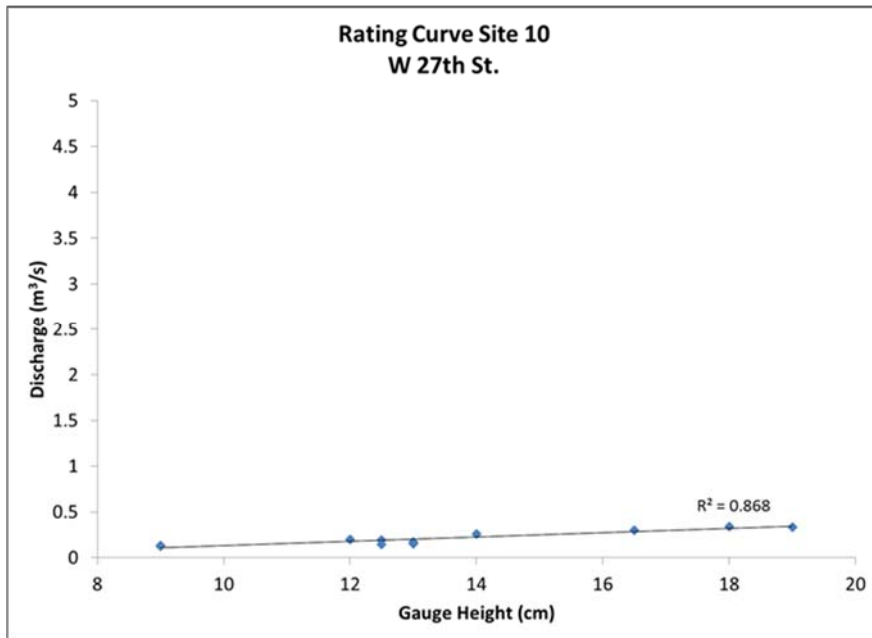
Figure 36: Site 10 Rating Curve.

The highest gauge height at this site occurred on May 26 at 19 cm with a discharge of 0.33 m³/s. The lowest observed gauge height occurred on June 1 and August 4 at 9 cm with a discharge of 0.13 m³/s (Figure 36). The gauge at this site is just upstream of the UNI constructed wetlands. This site will be useful for several years because it is a permanent structure and easy to access (Appendix A). This site could be used to compare nitrate concentrations between it and site 1 to observe the filtration of the constructed wetland located between the sites.

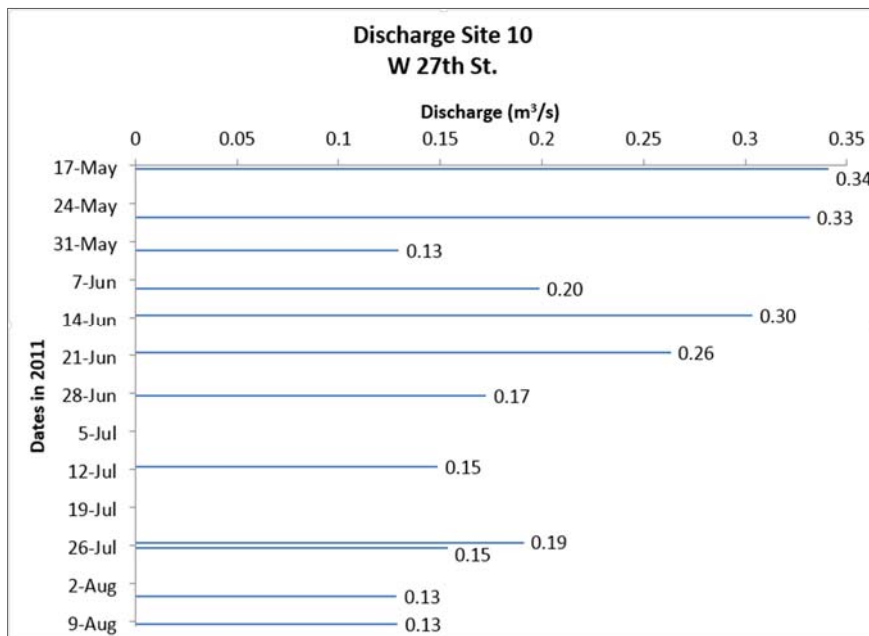
Figure 37: Site 10 Discharge.

Site 10 appears to have a base flow of approximately 0.13 m³/s (Figure 37). This site was gaged at the point of discharge of a primitive road culvert. The entire stream is funneled through a round metal culvert (Appendix B). Discharge is very easily taken and is considered very accurate.

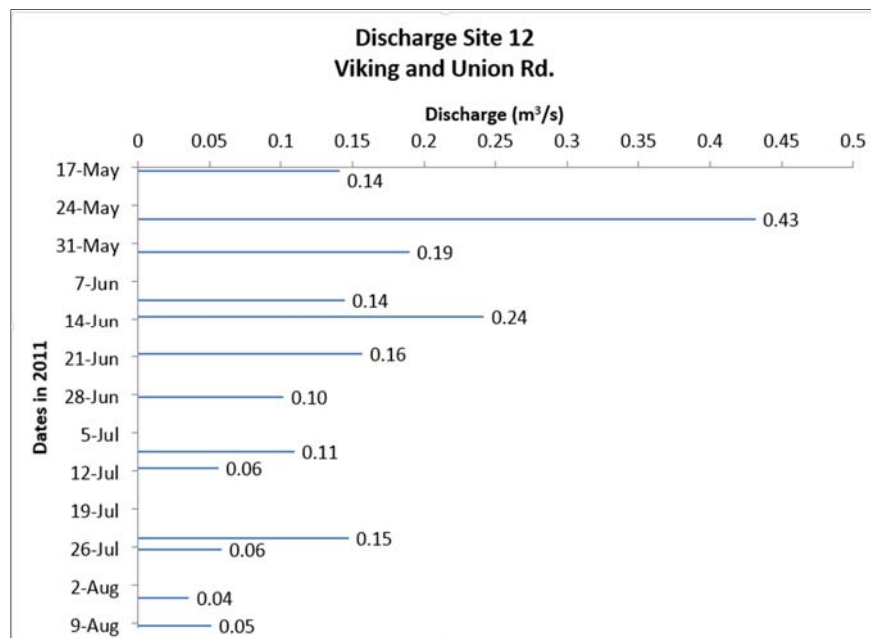
Figure 41: Site 12 Discharge.

Site 12 has an extremely low to almost no base flow. During periods of drought this stream section along with many others in Dry Run Creek become dry. This stream section shows the expected fluctuations in flow depending upon precipitation events and moisture conditions in the soil (Figure 41) (Appendix B). The headwaters are primarily fed by drain tiles on agricultural fields.
