Developing rating curves in a small Iowa watershed to evaluate nutrient loading in streams

DEVELOPING RATING CURVES IN A SMALL IOWA
WATERSHED TO EVALUATE NUTRIENT
LOADING IN STREAMS

An Abstract of a Thesis
Submitted
in Partial Fulfillment
of the Requirements for the Degree
Master of Science

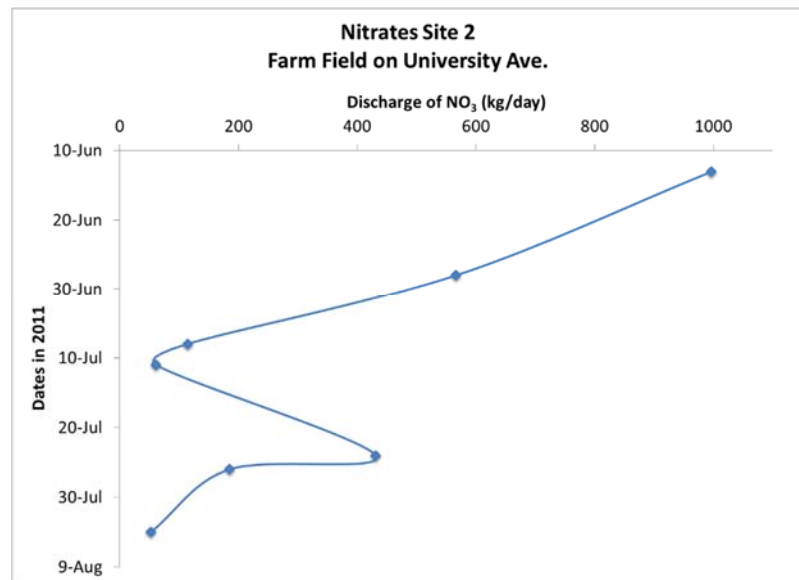
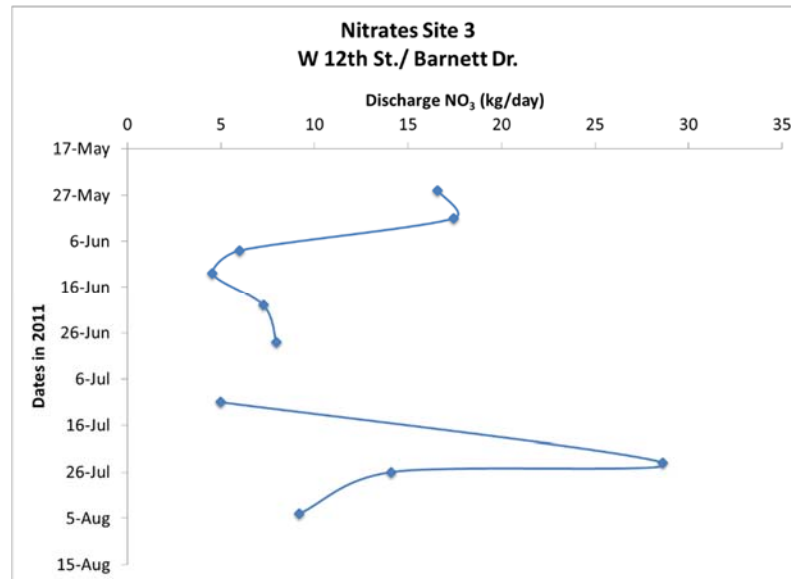
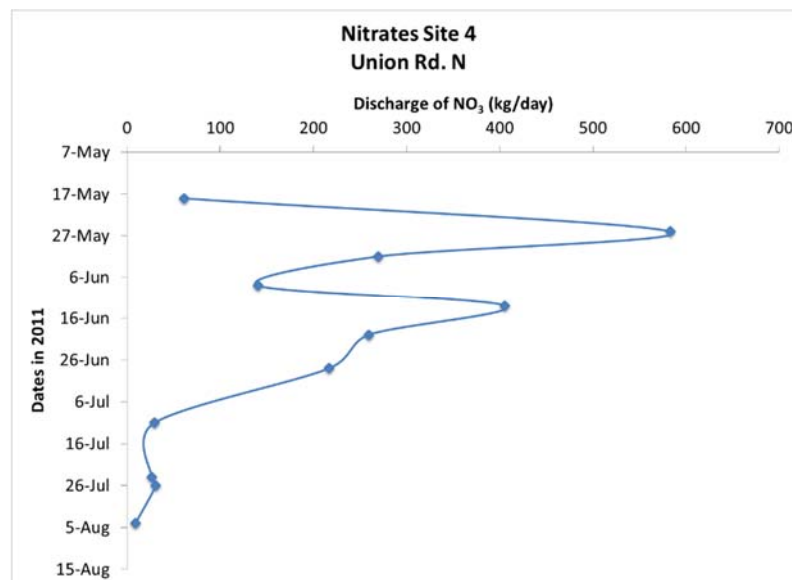
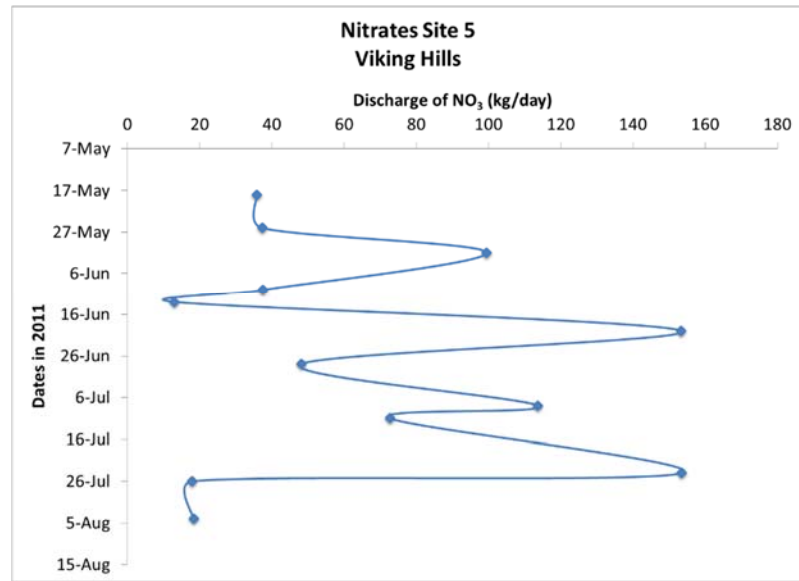
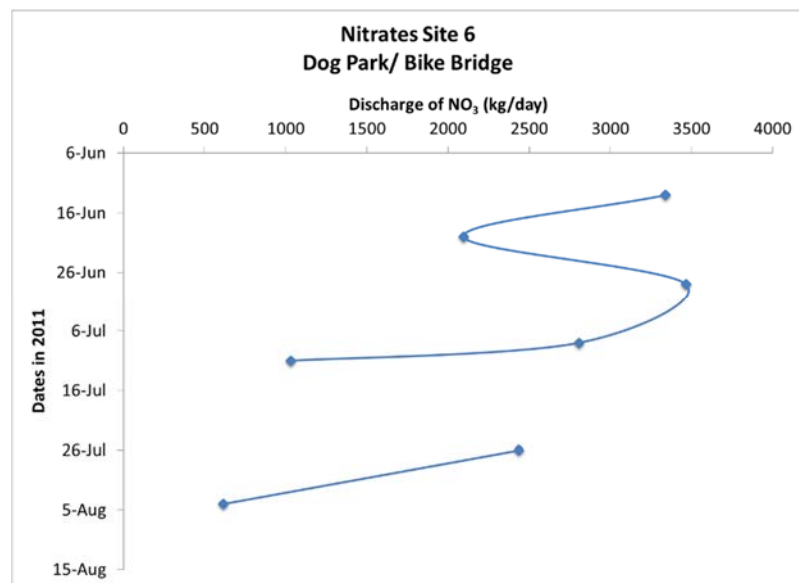
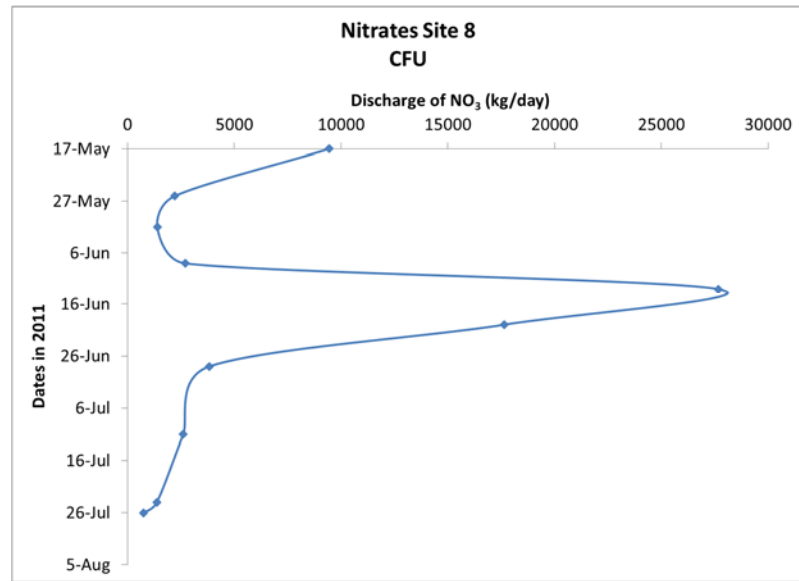
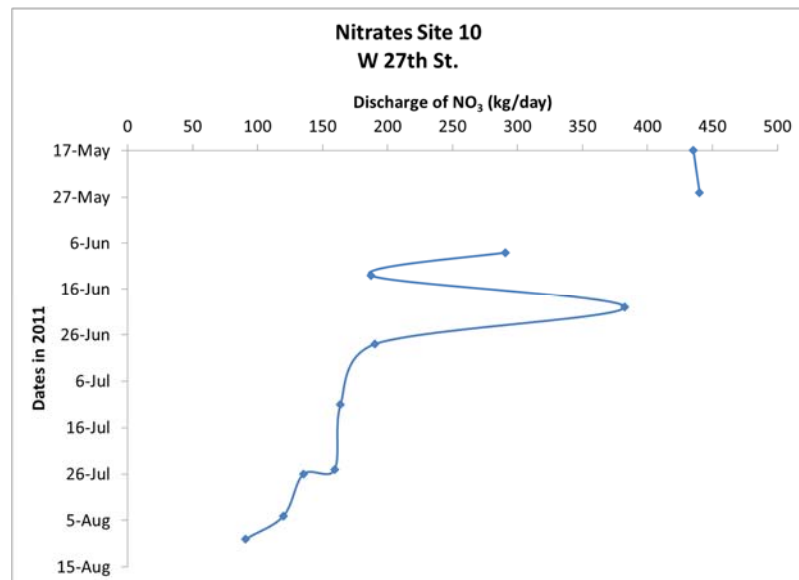
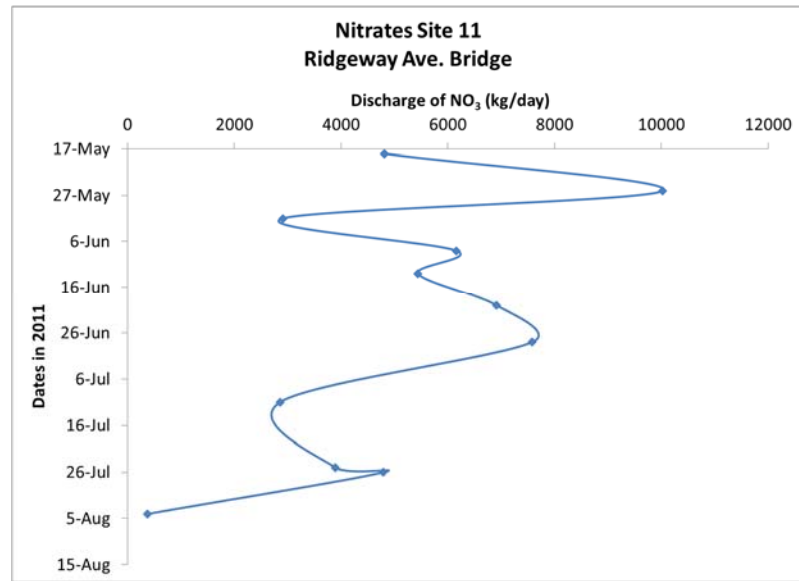
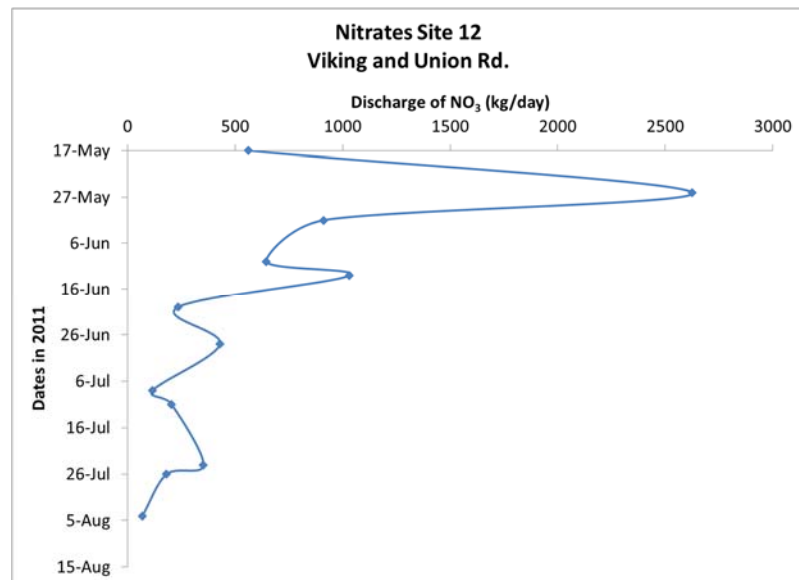
Figure 42: Site 1 nitrate discharges.

Figure 43: Site 2 nitrate discharges.

Figure 44: Site 3 nitrate discharges.

Figure 45: Site 4 nitrate discharges.

Figure 46: Site 5 nitrate discharges.

Figure 47: Site 6 nitrate discharges.

Figure 48: Site 8 nitrate discharges.

Figure 49: Site 10 nitrate discharges.

Figure 50: Site 11 nitrate discharges.

Figure 51: Site 12 nitrate discharges.

EPA standards for nitrate concentration for safe drinking water is 10 mg/l as NO_3^- -N (Lande, 2011). Only site 1 and site 3 were consistently in compliance with these standards (Appendix C).

Sites 1, 3, 5, 6, and 8 are considered more urban locations and nitrates show different peaks in concentration compared to the more rural locations of sites 2, 4, 10, 11, and 12 (Figure 4). Sites 1, 3, and 5 all have peak nitrate discharges recorded on July 24, 2011 of 119.75 kg/day, 28.62 kg/day, and 153.55 kg/day respectively. Sites 5 and 8 also have peak nitrate discharges on June 20, 2011 of 153.35 kg/day and 27677.01 kg/day respectively. Site 5 peaks twice at basically the same discharge and Site 8 shows the highest discharge of all the sites because it represents the entire watershed. Sites 4, 10, 11, and 12 have their peak nitrate discharge on May 26, 2011 of 583.16 kg/day, 440.08 kg/day, 10024.48 kg/day, and 2625.96 kg/day respectively. Sites 2 and 6 have peak nitrate discharge on June 13, 2011 of 996.50 kg/day and 3339.80 kg/day respectively.
