Excavation and stratigraphic analysis of a late nineteenth century boiler house

Ariel Marie Williams
University of Northern Iowa

EXCAVATION AND STRATIGRAPHIC ANALYSIS OF A LATE NINETEENTH
CENTURY BOILER HOUSE

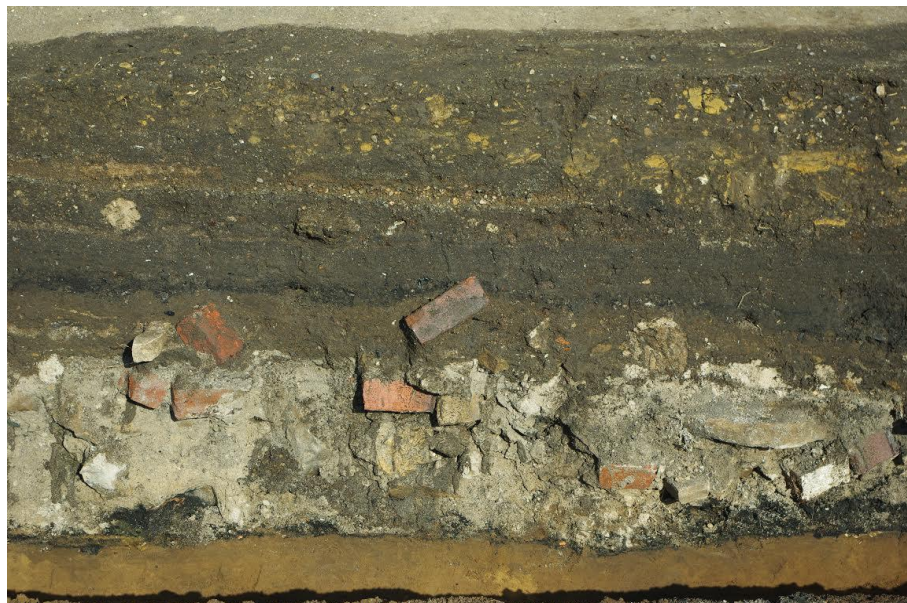
Layers A through G likely represent discrete filling episodes.

Figure 5. Profiles of boiler house excavation units. (A) Photograph of profile for Unit 1. (B) Scaled profile map of Unit 1. (C) Photograph of profile for Unit 2. (D) Scaled profile map of Unit 2. Photos courtesy of Donald Gaff.

As stated previously, profiles were created for each of the two units (Figure 5). The colors were determined using a Munsell soil color chart and texture was determined with the thumb test, in which one attempts to create a ribbon by pinching a clump of soil between the thumb and index finger. Soil colors in Unit One ranged from 10 YR 4/4 (dark yellowish brown) to 10 YR 2/2 (very dark brown) and texturally, the soils were a combination of sand and sandy loams. Significantly, layer J of Unit One and layer D of Unit Two were much lighter than any of the soil layers above the debris. Presumably, these two layers represent naturally occurring

subsoil, which is typically sand, and both were found to be sterile (containing no artifacts).

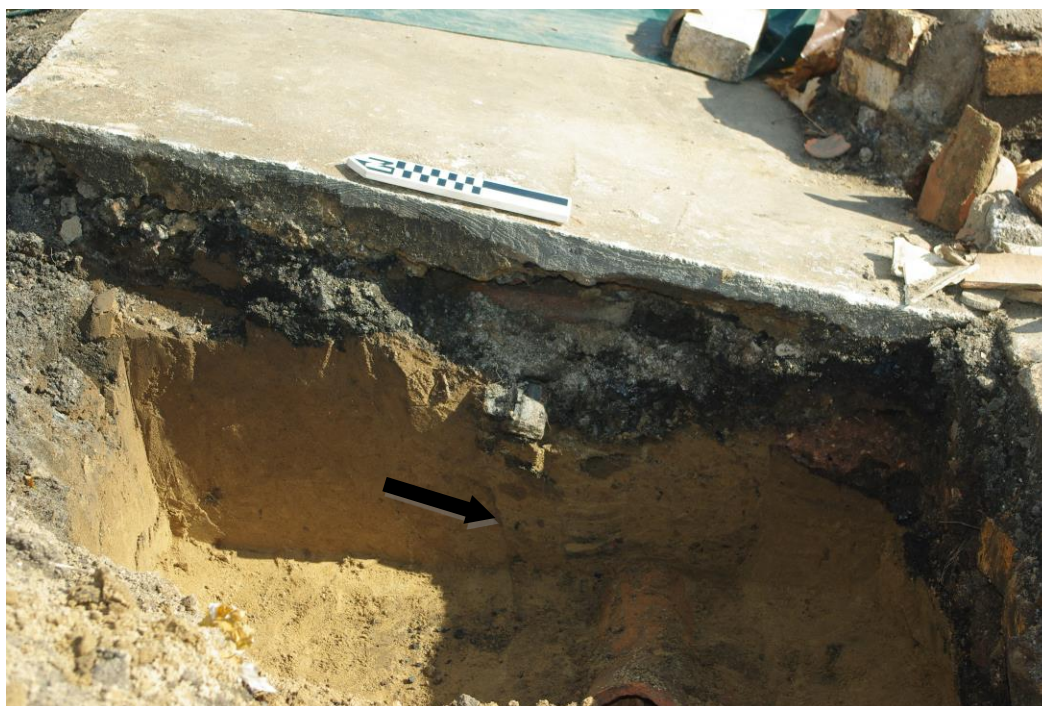
Figure 6. East wall of Unit Two (the soil in this wall was not tested). The arrow in the center is pointing to the border between the trench and pristine subsoil. (Photo courtesy of Donald Gaff)

As stated previously, this layer is almost certainly naturally occurring subsoil. The lightness of color with respect to the soil above the debris and rubble reflects the fact that there is almost no dark humus. Texturally, subsoil is typically a variable mixture of sand, silt and/or clay. However, it may not be definitive to say that these layers are in fact subsoil. According to results of the Blackhawk County Soil Survey, up to a depth of about 80 inches, the soil is largely of a loamy texture. For those who study soils, it may seem unusual that sand was encountered after reaching a depth of only about one meter, or about 40 inches; this raises the question of whether or not the sand was brought in from an outside source. Further soil probing may provide answers to such questions. Despite these contentions, I am relatively certain that layer J is subsoil for two reasons. First, close examination of the eastern wall of Unit Two shows a clay pipe running through the sand that correlates to layer J in Unit One. Immediately surrounding the pipe, the soil is mottled and mixed where builders would have dug a trench for the pipe to go through. Yet there is a distinct delineation between this trench fill and the rest of the soil, which is nearly pristine (Figure 6). Second, units one and two are much lower in elevation than the northernmost part of the block; erosion would have brought topsoil down the hill, and exposed the sand such that it would appear much closer to the surface than was observed.
