## The Environmental Implications of Aggradation in Major Braided Rivers at Mount Rainier National Park, Washington

An Abstract of a Thesis  
Submitted  
in Partial Fulfillment  
of the Requirements for the Degree  
Master of Science

Scott Robert Beason

May 2007

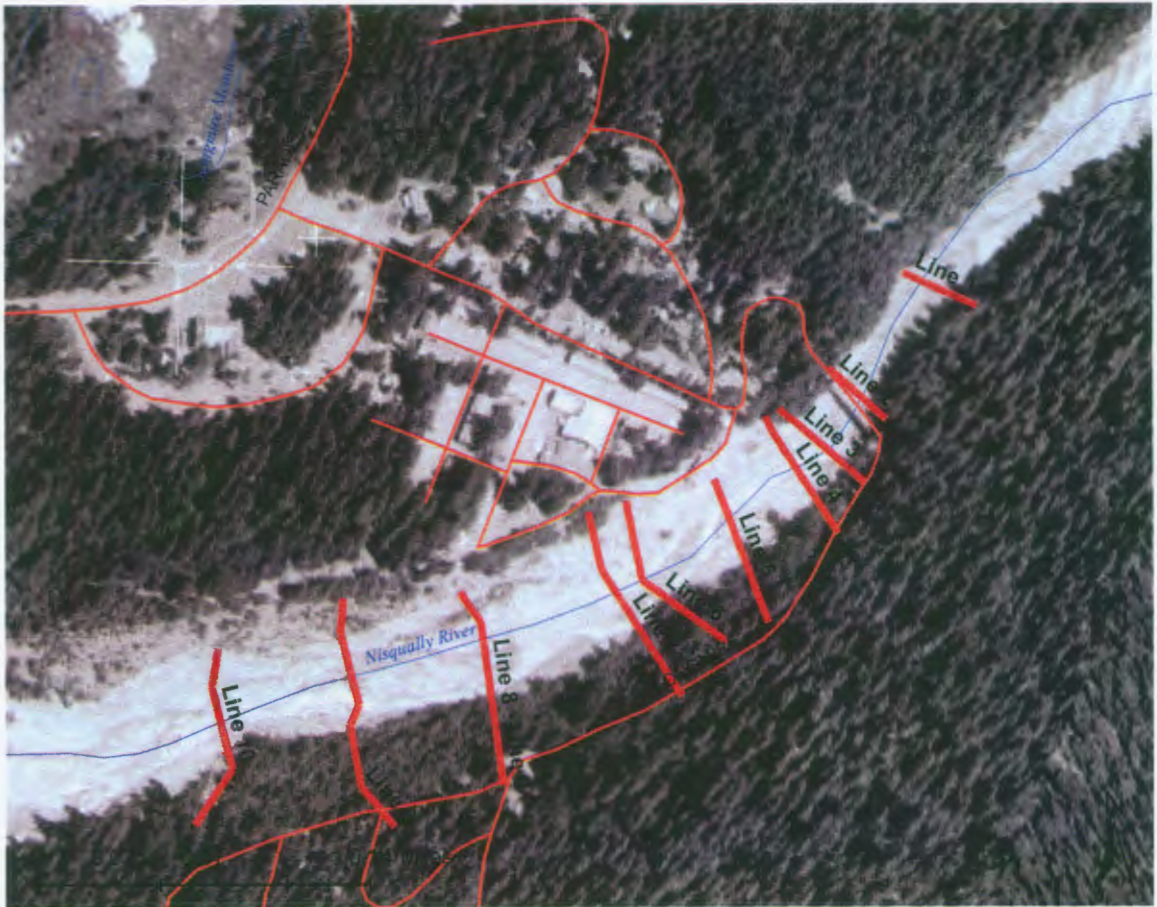
▲ FIGURE 1.8

Overview of cross sections at Longmire (Nisqually River). River flow is from upper right to lower left.

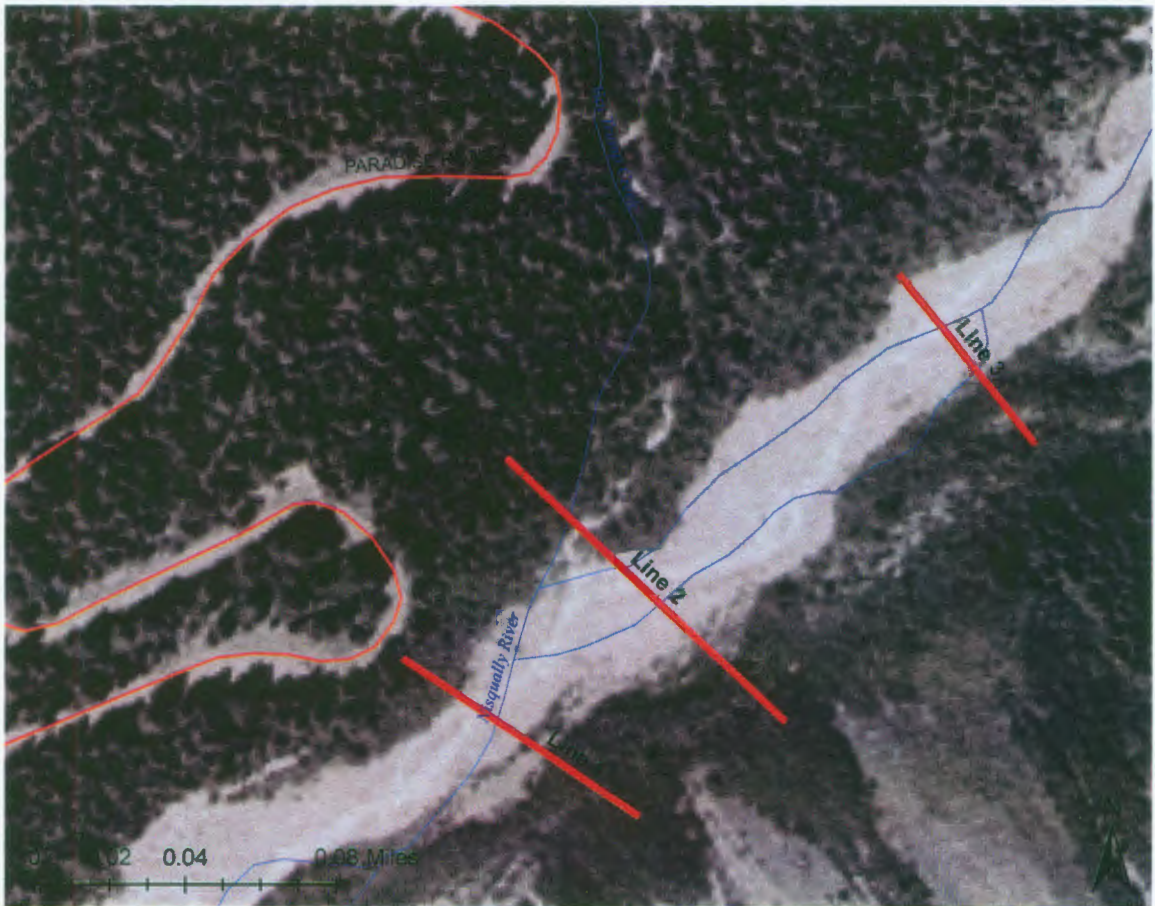
▲ FIGURE 1.10  
Overview of cross sections at Lower Van Trump Hairpin (Nisqually River/Van Trump Creek). River flow is from upper right to lower left.

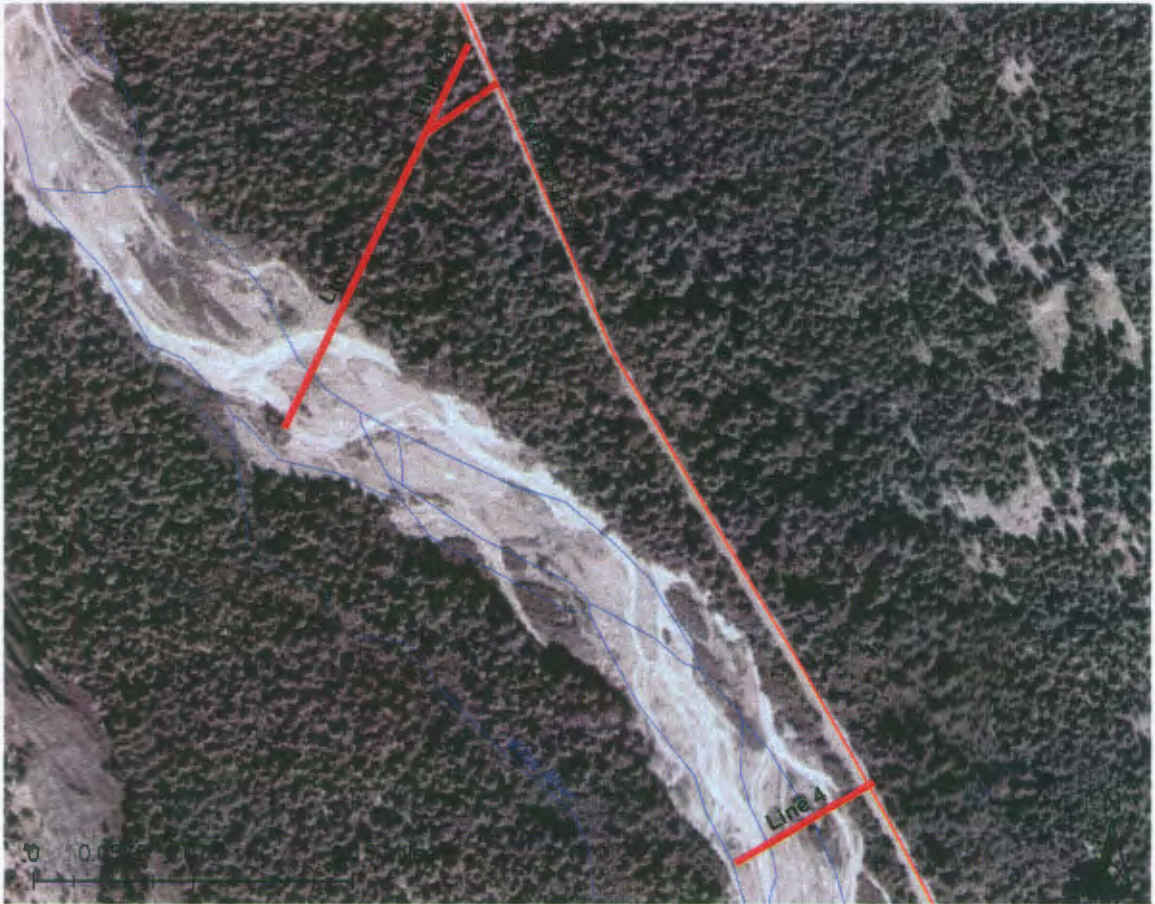
▲ FIGURE 1.11  
Overview of cross sections along Highway 410 (White River). Line 1 has a bend; Line 1a is straight.  
River flow is from lower right to upper left.

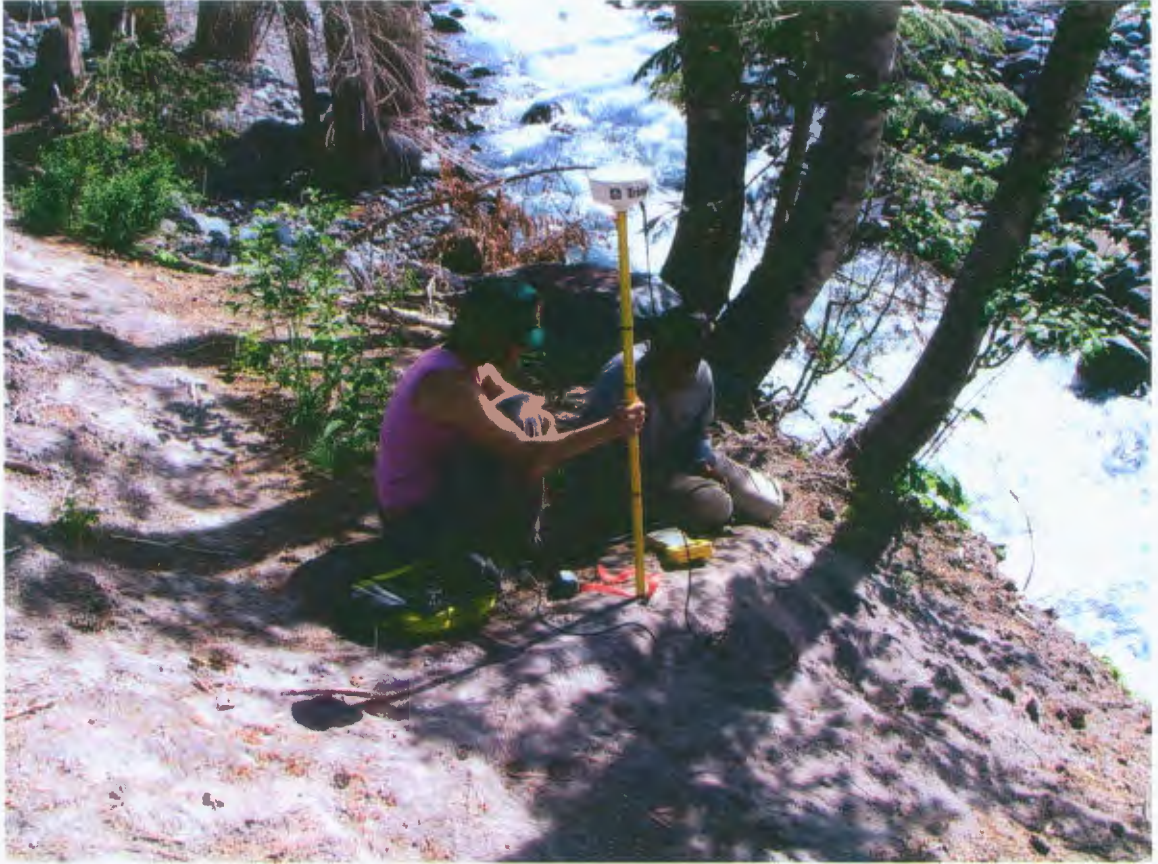
▲ FIGURE 3.3  
Trimble Pathfinder Pro XR GPS shown mapping a control point (Photo: Scott Beason, 7/20/2006)

The Trimble was also used in several areas to map locations where benchmarks were absent (Figure 3.3). The height of the receiver above the ground (mounted to a rod) is entered into the handheld computer. Then, several (usually more than 200) individual positions are taken in the same spot. These locations are downloaded and post-processed. Post processing of the data involves rectifying the locations and retrieving the average X, Y, and Z position of the location. This X, Y, and Z location was used as a control point benchmark. A rectified position has accuracies of around 0.5 m horizontally, and less than 1 m vertically (Trimble, 2004).

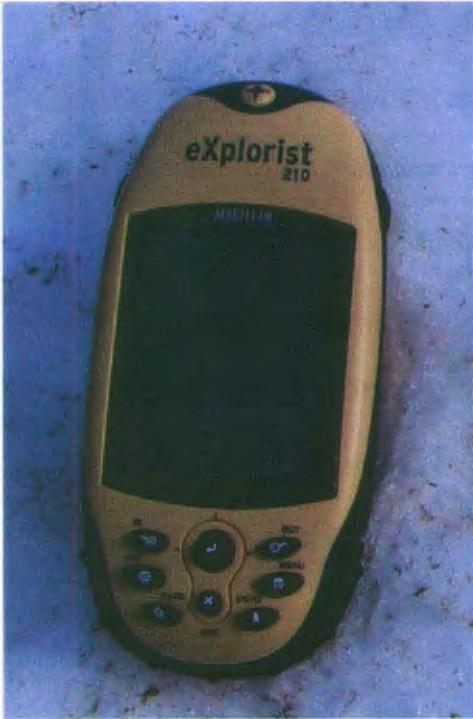
▲ FIGURE 3.4  
Magellan eXplorist 210 handheld GPS (Photo: Scott Beason).

Handheld GPS units were extremely useful for this study; however, they were not used for the determination of critical position measurements. The GPS this study used was a Magellan eXplorist 210 (Figure 3.4). This GPS was primarily used to find control points and critical cross section points (endpoints and midpoints) in the active channel. One of the first things the study team noted in the braided river channel was how nearly impossible it was to find a nail with flagging tape in a boulder-dominated braided river channel. Despite position accuracies ranging between 7 and 30 feet on good days, the handheld GPS allowed us to find the control points much easier than wandering around the river channel looking for the point. The handheld GPS was also used to document locations of peculiar findings and to document locations of water samples taken for analysis for this study.

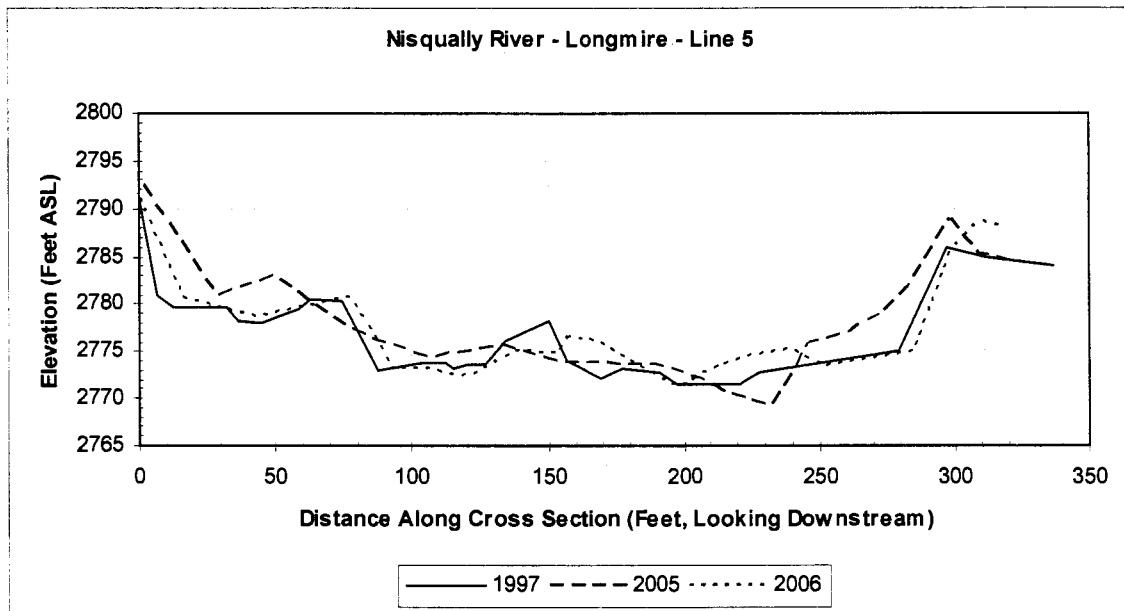
▲ **FIGURE 4.5**  
Cross Section 5 at Longmire (Nisqually River). Vertical Exaggeration  $\approx 3.3x$ .

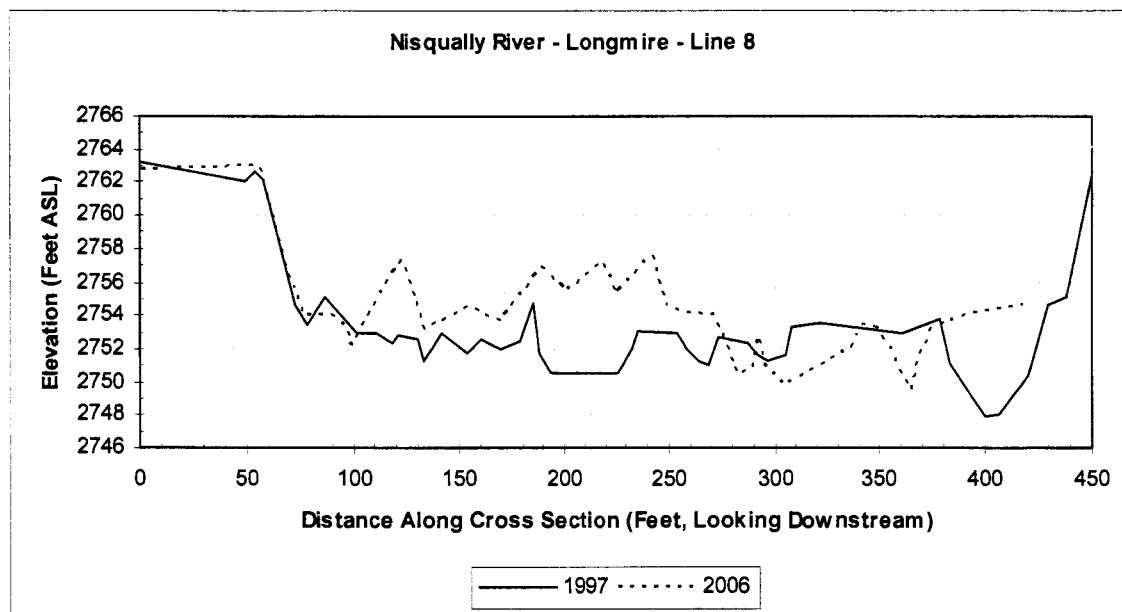
▲ **FIGURE 4.8**  
Cross Section 8 at Longmire (Nisqually River). Vertical Exaggeration  $\approx 7.7x$ .

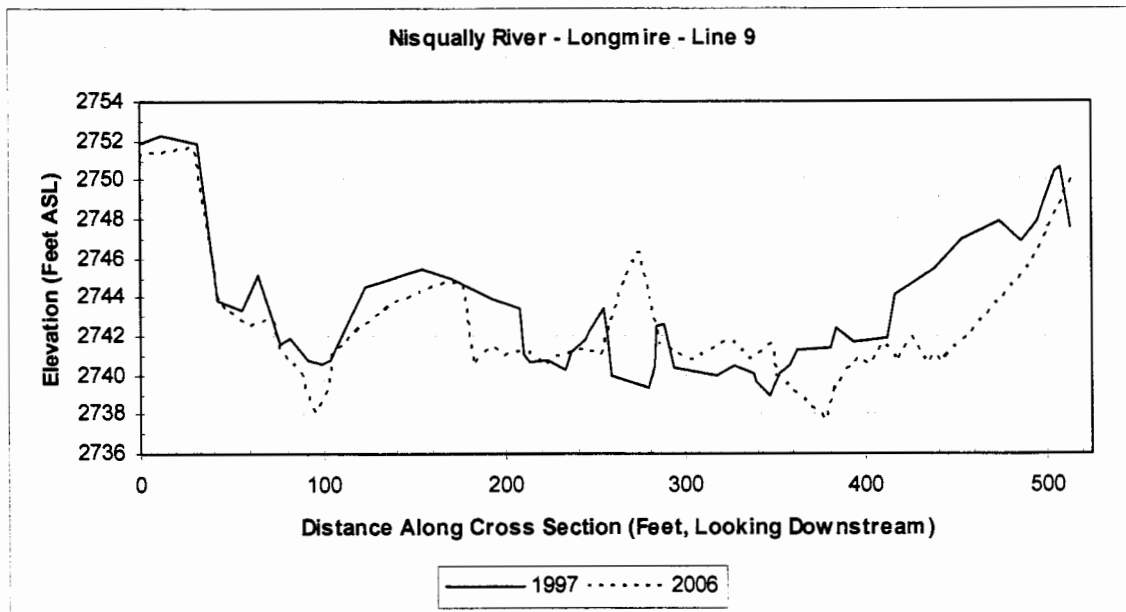
▲ **FIGURE 4.9**  
Cross Section 9 at Longmire (Nisqually River). Vertical Exaggeration  $\approx 10.6x$ .

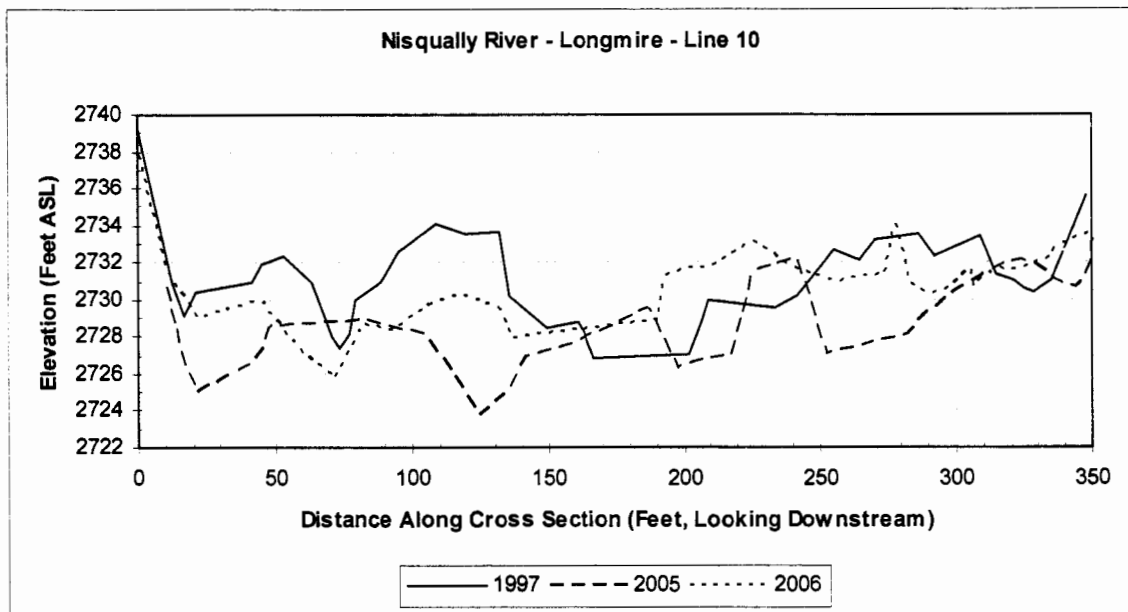
▲ **FIGURE 4.10**  
Cross Section 10 at Longmire (Nisqually River). Vertical Exaggeration  $\approx 6.6x$ .

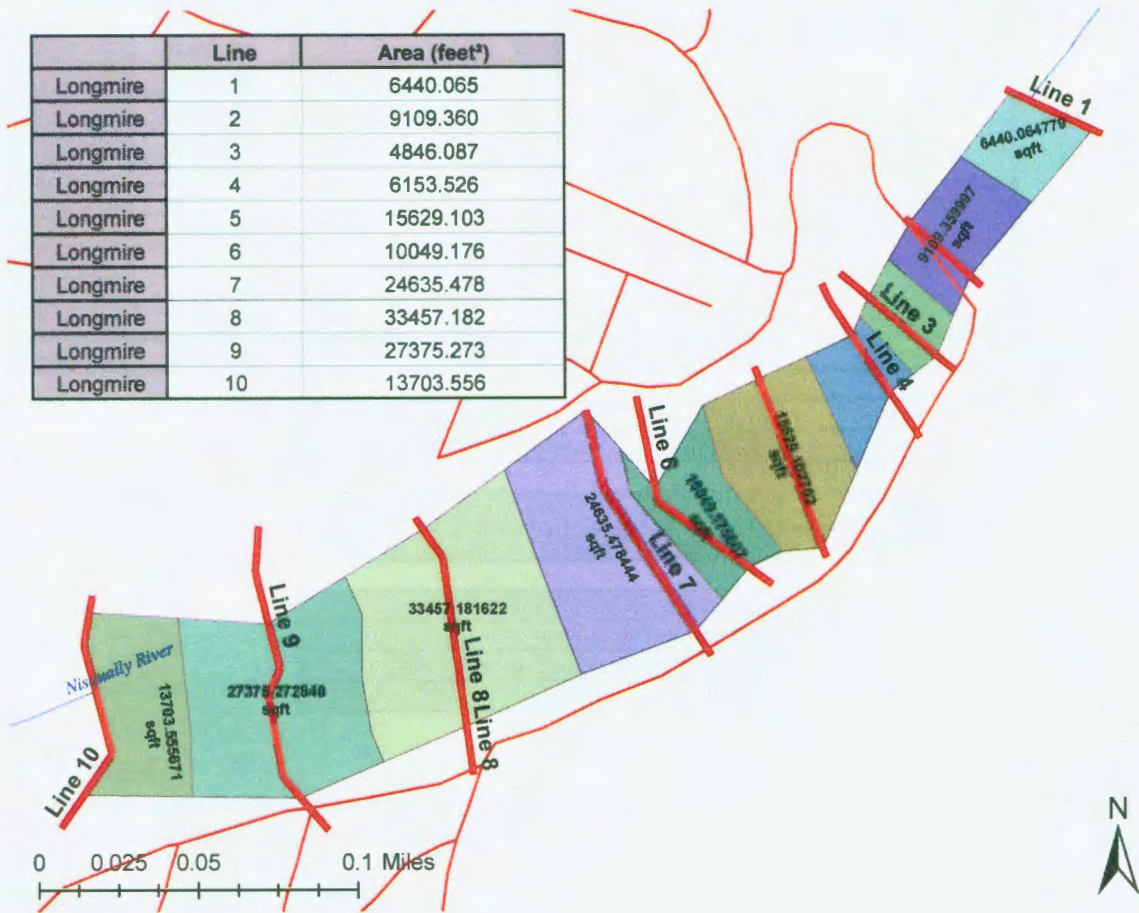
▲ FIGURE 4.11  
Area represented by individual cross sections at Longmire.

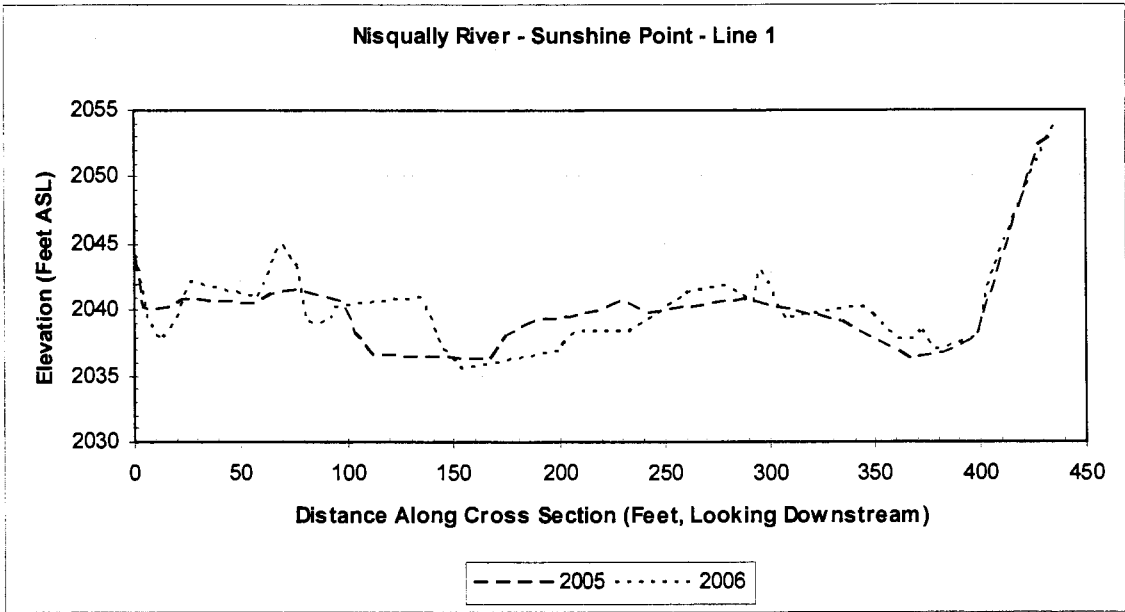
▲ **FIGURE 4.12**  
 Cross Section 1 at Sunshine Point (Nisqually River). Vertical Exaggeration  $\approx 6.1x$ .

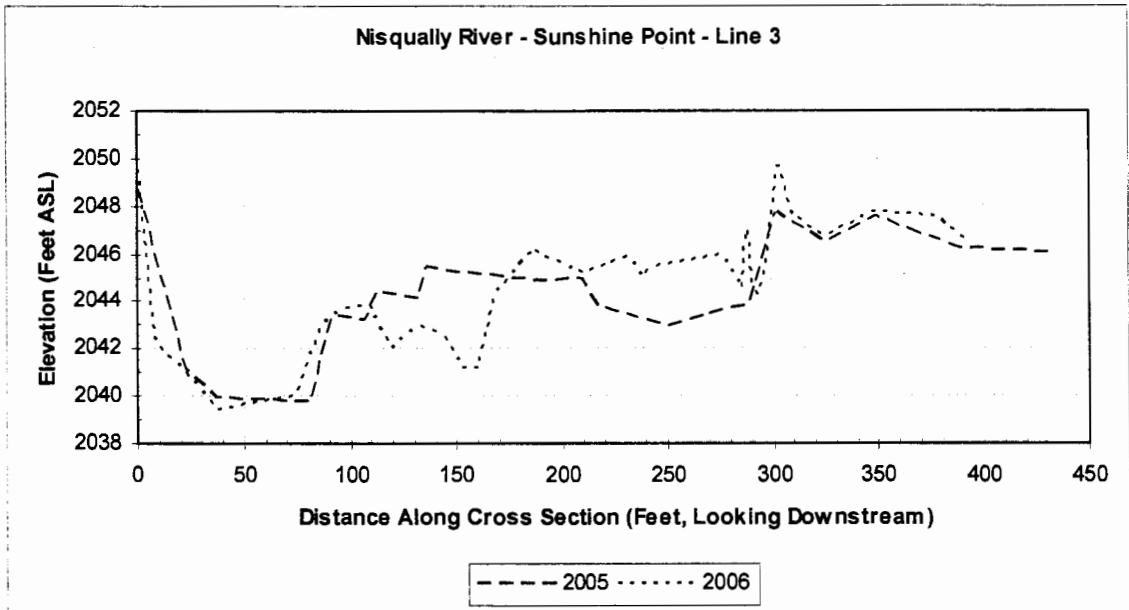
▲ FIGURE 4.14  
Cross Section 3 at Sunshine Point (Nisqually River). Vertical Exaggeration  $\approx 11.3x$ .

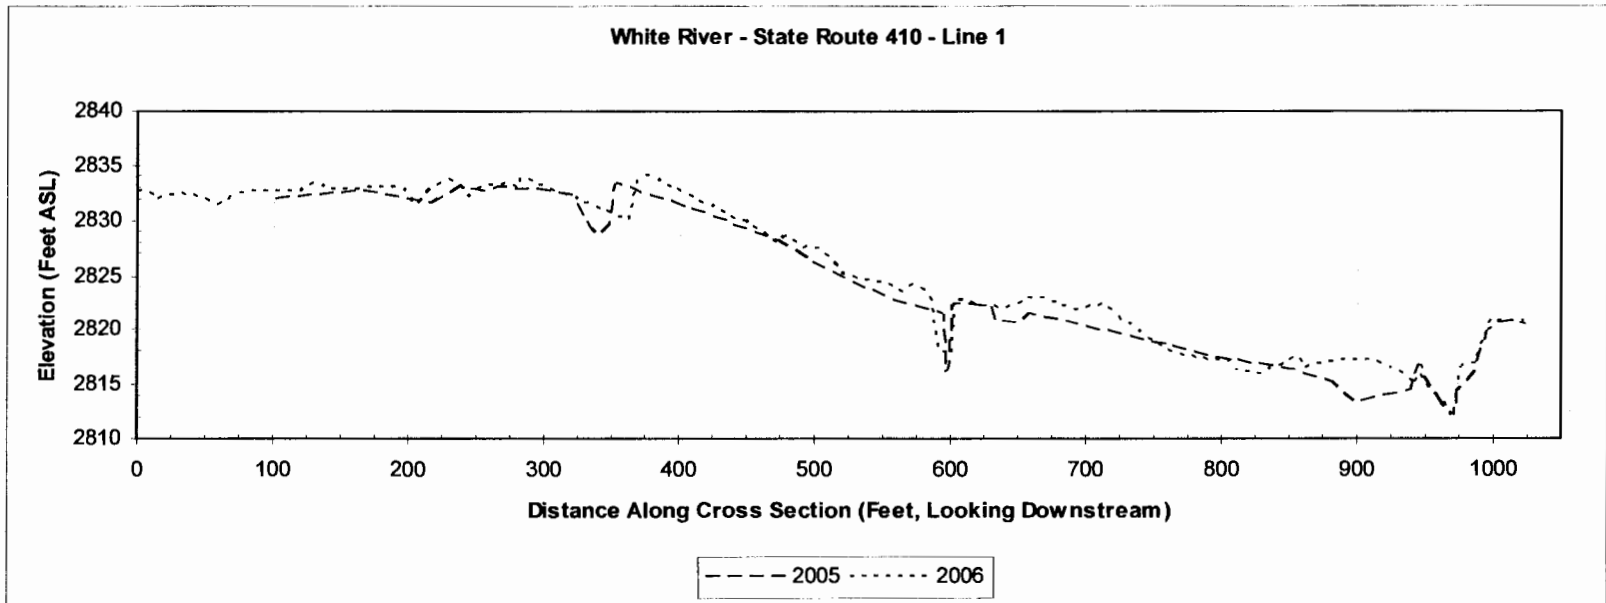
▲ FIGURE 4.20  
 Cross Section 1 at SR 410 (White River). Vertical Exaggeration  $\approx 8.1x$ .

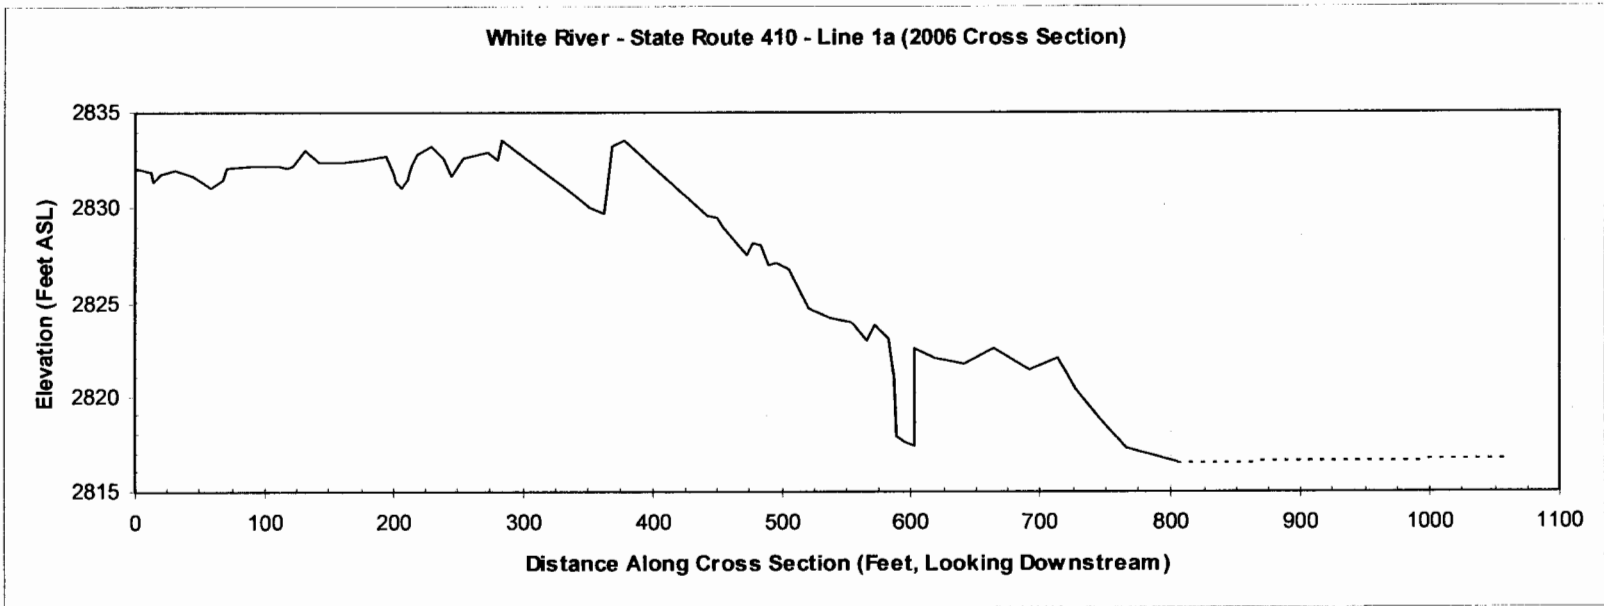
▲ FIGURE 4.21

Cross Section 1a at SR 410 (White River). Line 1a does not include a bend (see text for explanation). Cross section based on 2006 survey data. Except for the beginning and end, no positions were taken along the dashed section. Vertical Exaggeration  $\approx 14.9x$ .

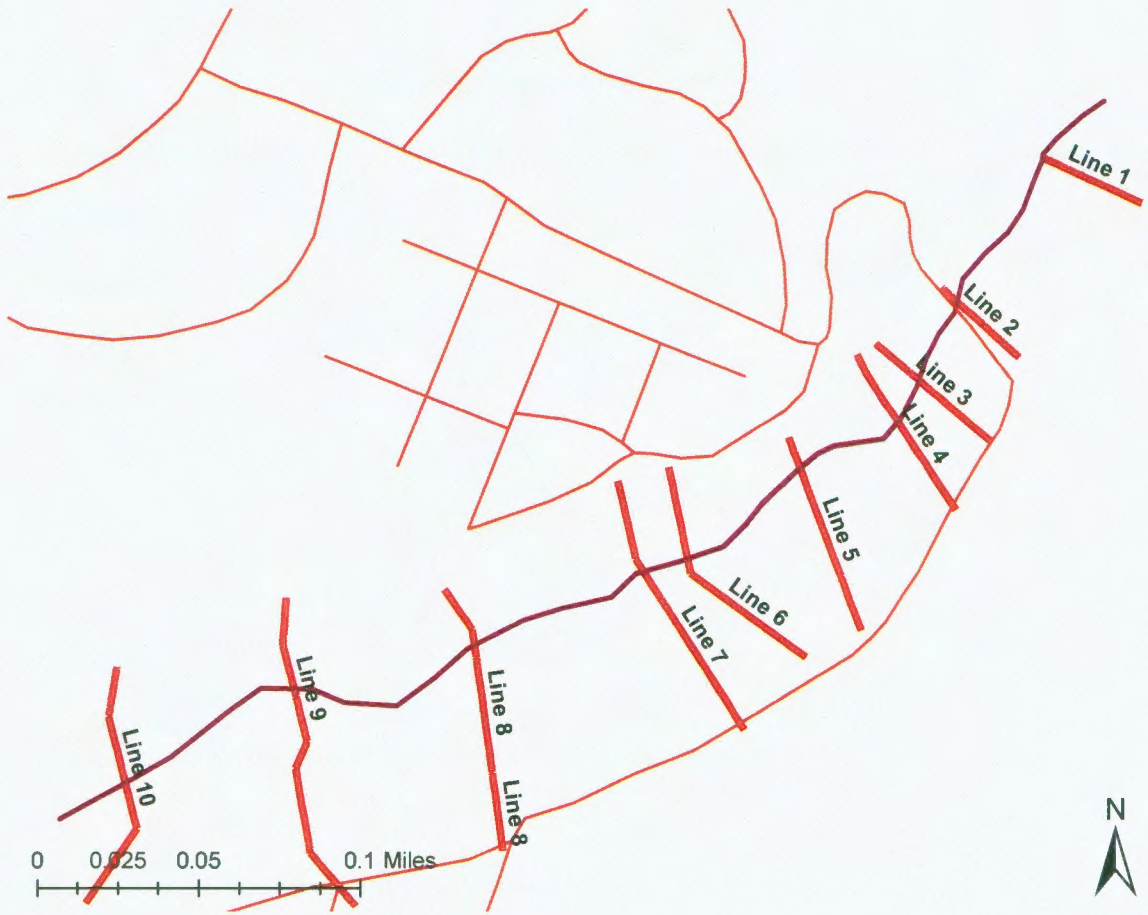
▲ FIGURE 4.25  
Map showing constructed long profile of Nisqually River at Longmire. Cross section lines included for reference.

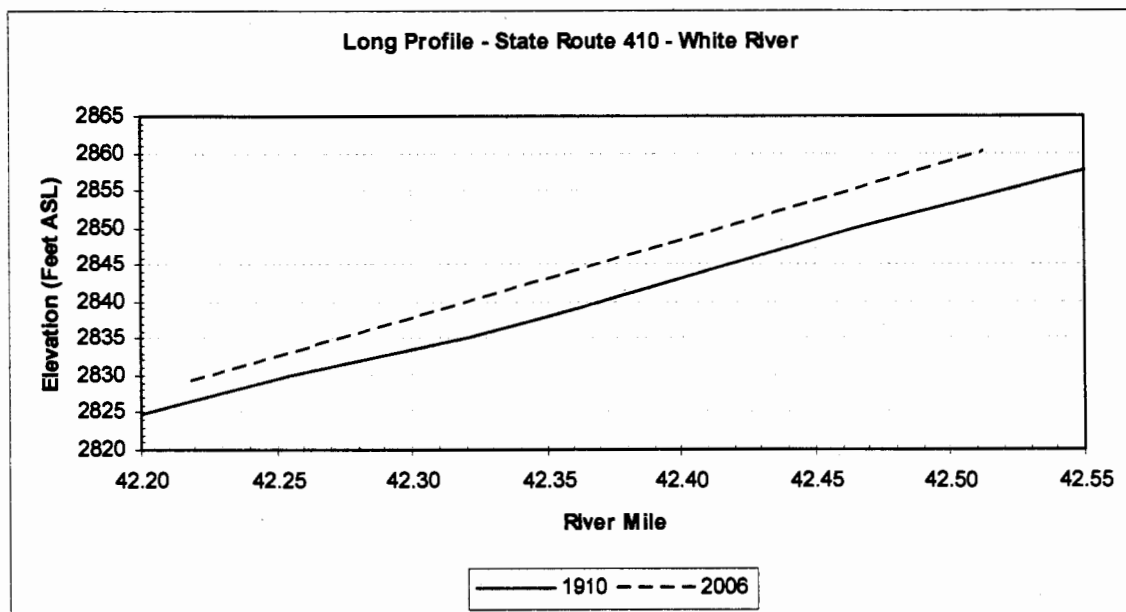
▲ FIGURE 4.28  
Long Profile of White River along State Route 410. Vertical Exaggeration  $\approx 14.0x$ .

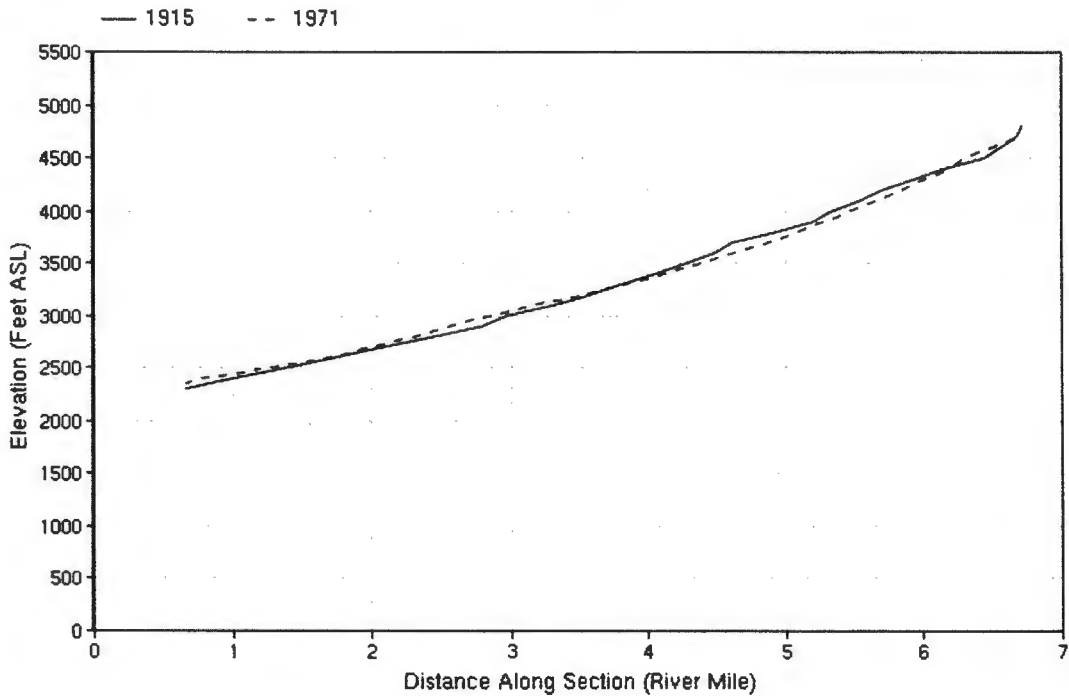
▲ FIGURE 4.30  
Long profile of Kautz Creek derived from topographic maps. Vertical Exaggeration  $\approx 1.9x$ .

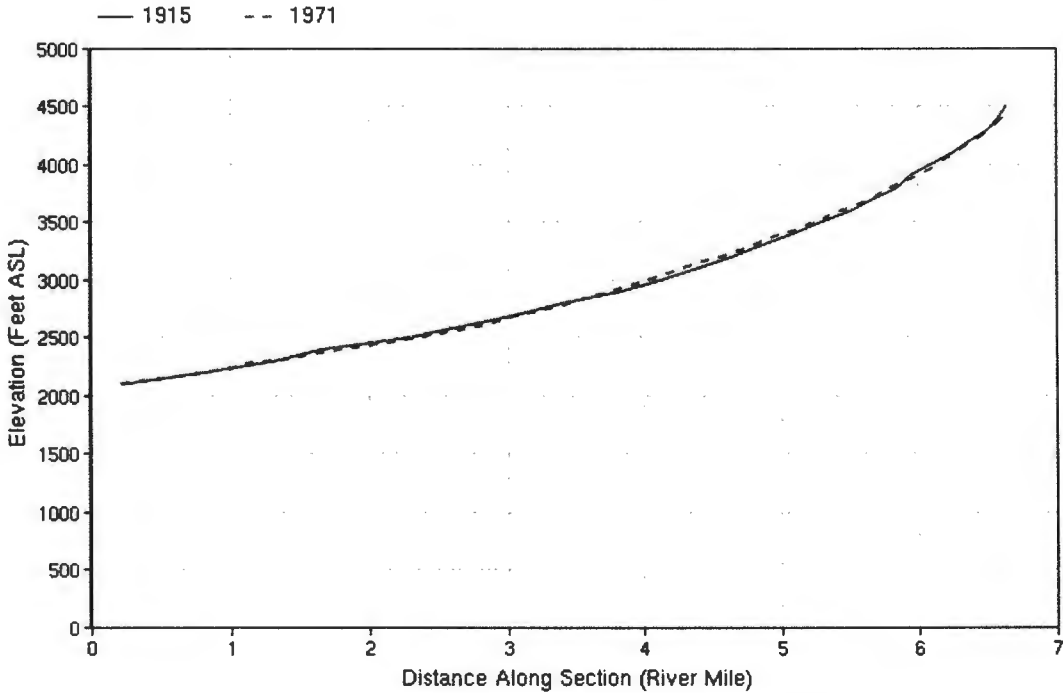
▲ FIGURE 4.32  
Long profile of Tahoma Creek derived from topographic maps. Vertical Exaggeration  $\approx 2.1x$ .

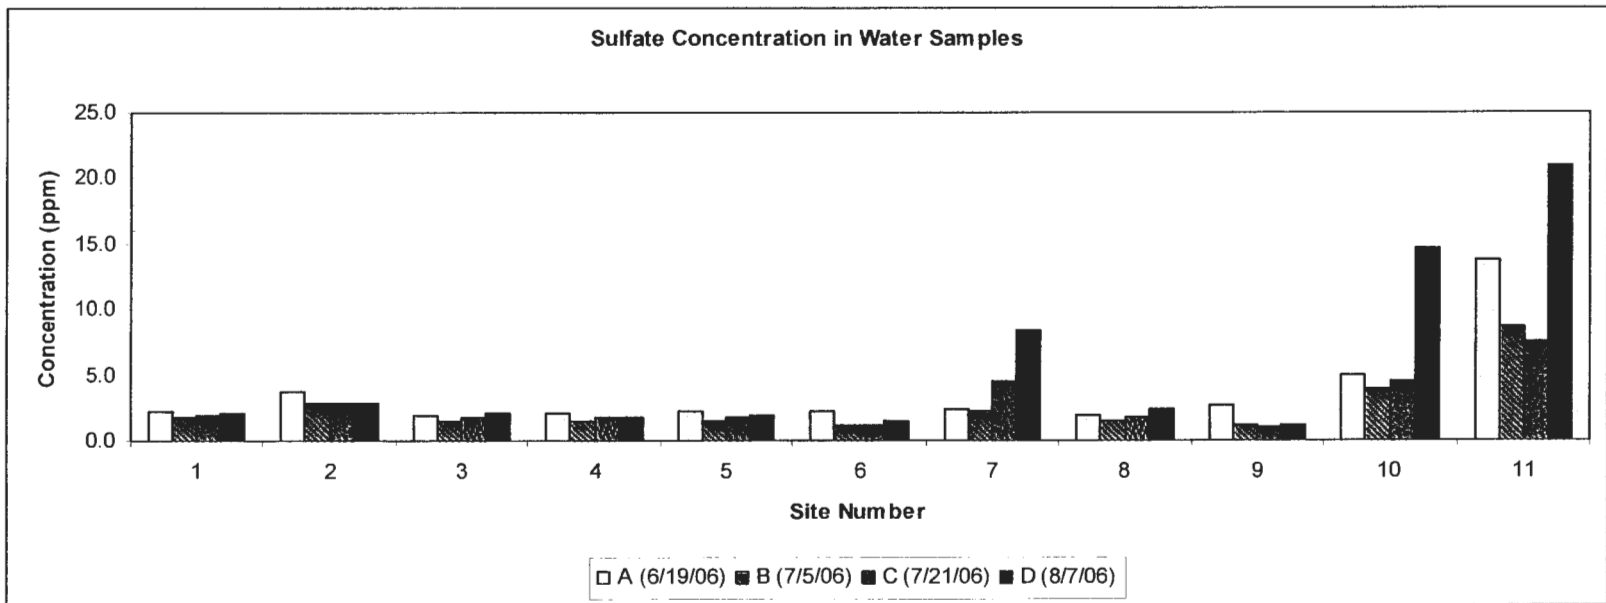
▲ FIGURE 4.35  
Sulfate ( $\text{SO}_4^-$ ) ion concentration in water samples from summer 2006.

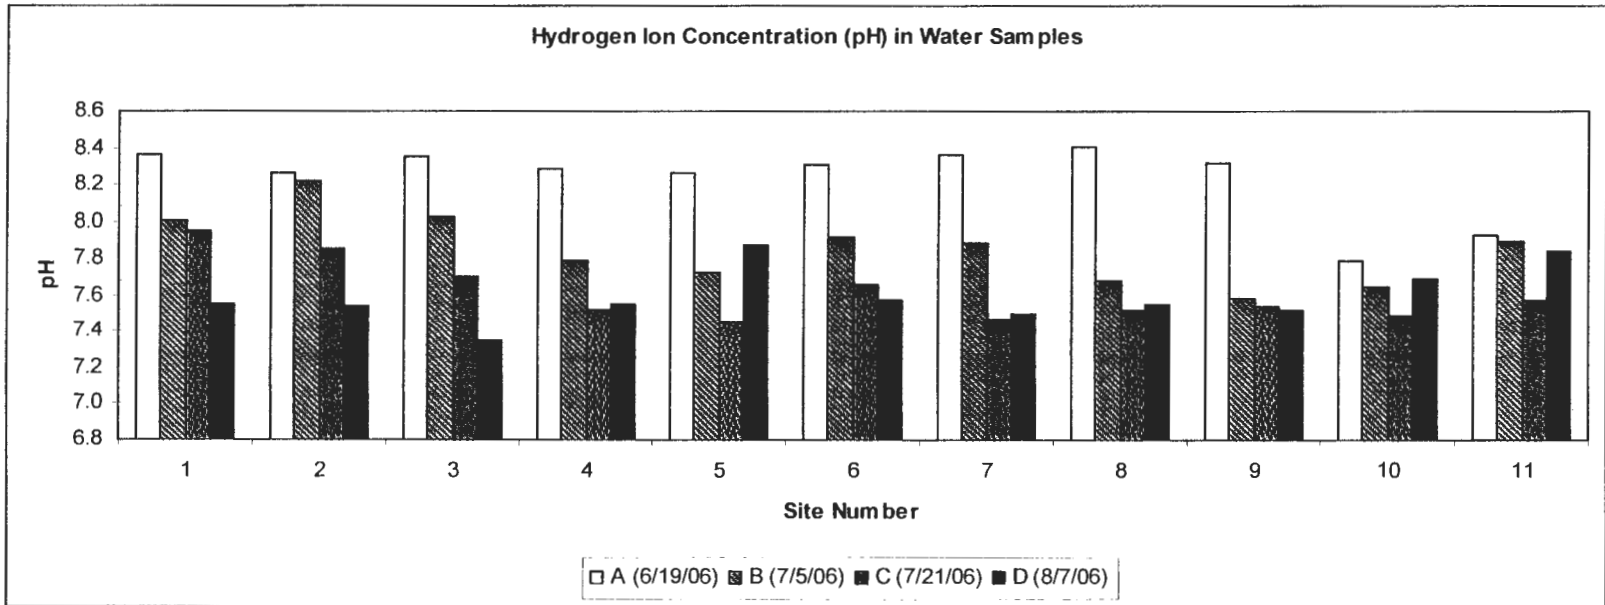
▲ FIGURE 4.36  
Hydrogen ion concentration (pH) in water samples from summer 2006.

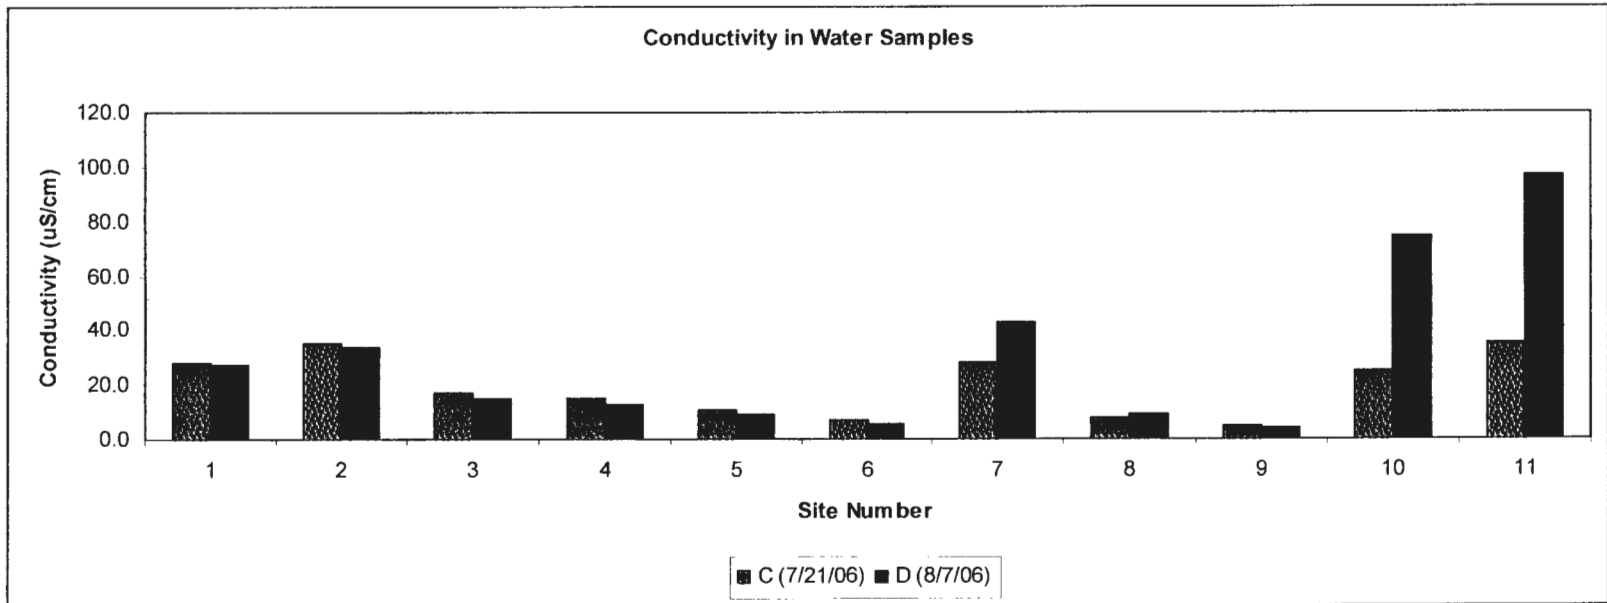
▲ FIGURE 4.38  
Conductivity in water samples from summer 2006.

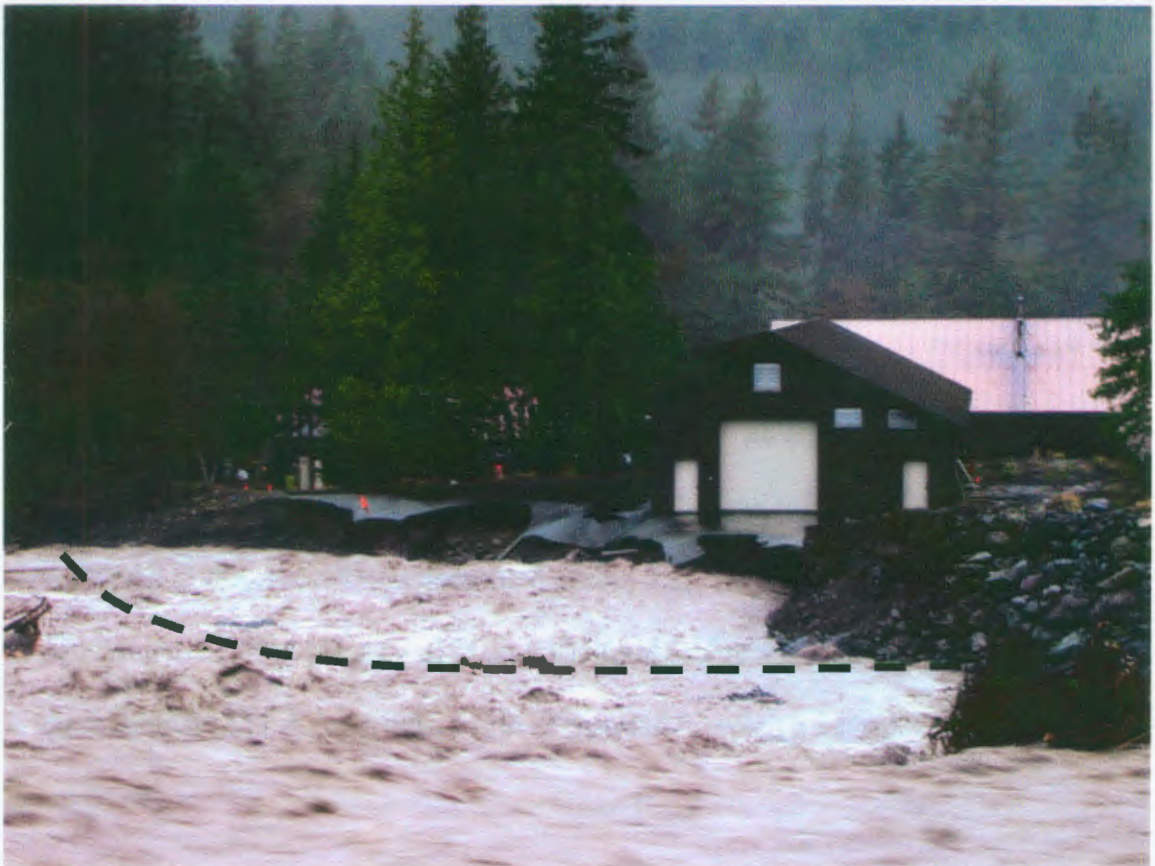
▲ FIGURE 5.1  
Damage to Emergency Operations Center, levee and parking lot from flooding in November 2006.  
Dashed line shows approximate former levee boundary. (Photo: National Park Service, 11/17/2006).

During the flood event, a portion of the levee protecting the Longmire compound failed and damaged portions of a road and one corner of the newly-constructed Emergency Operations Center (EOC; Figure 5.1). On the opposite bank, a small grove of trees growing on the river channel was completely destroyed, opening up a much wider active channel. Electric, sewer, and water lines for the Longmire compound were significantly damaged during the flooding (National Park Service, 2006).

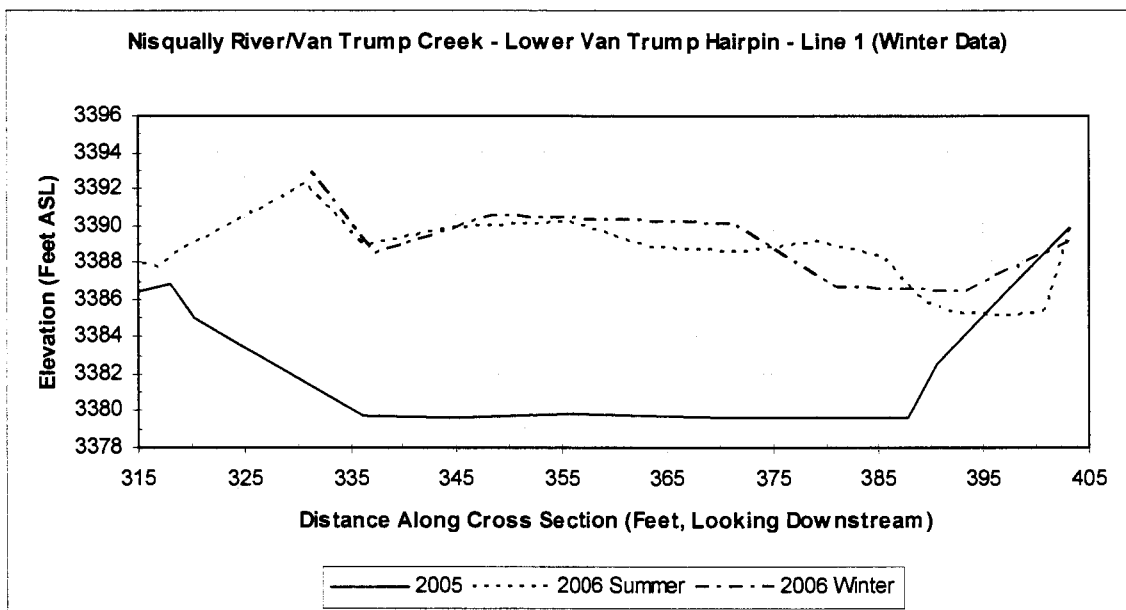
▲ **FIGURE 5.5**  
Cross Section 1 at Lower Van Trump Hairpin (Nisqually River/Van Trump Creek) showing change from November 2006 storm. Vertical Exaggeration  $\approx 1.7x$ .

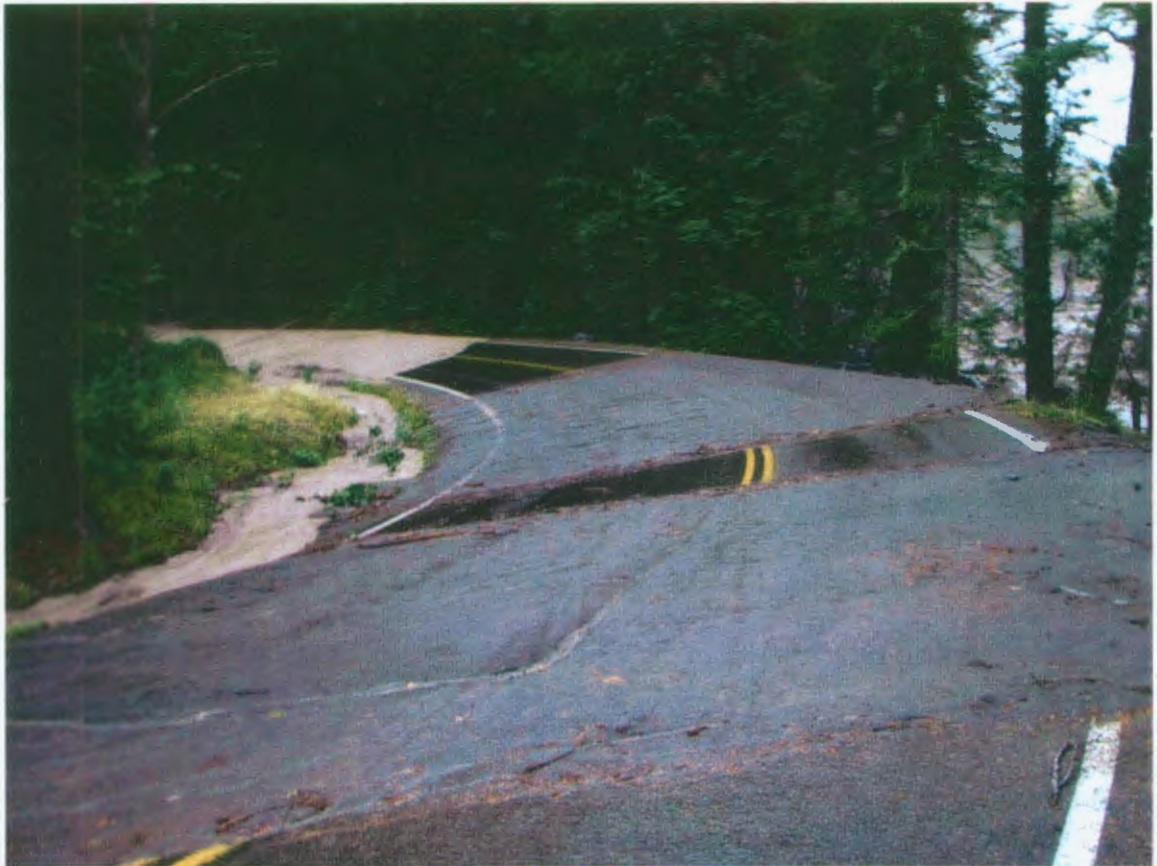
▲ FIGURE 6.3  
Van Trump Creek flowing across Lower Van Trump Hairpin during the fall 2005 debris flow. (Photo: National Park Service, 9/29/2005)

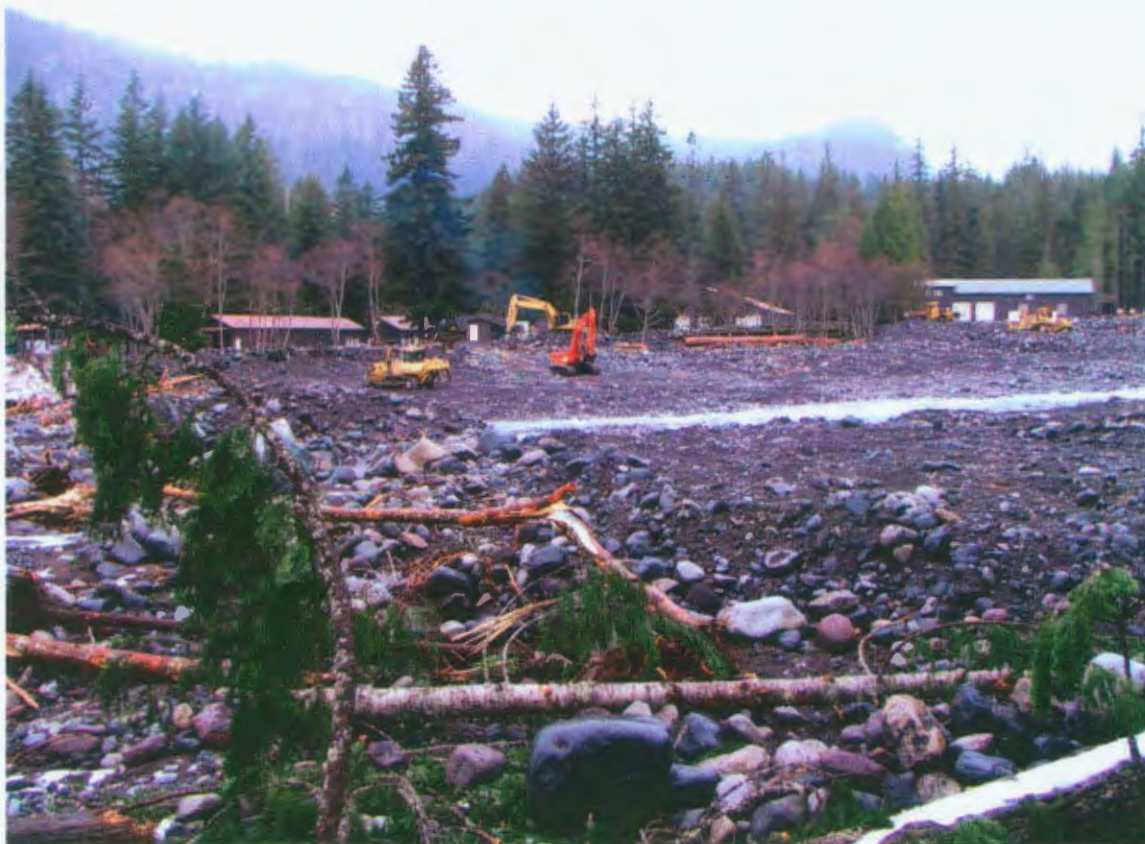
▲ FIGURE 6.9  
Bulldozers and heavy equipment channelizing and altering the natural active channel of the Nisqually River at Longmire following November 2006 flooding. (Photo: Scott Beason, 11/21/2006)
