Accelerated Testing to Compare the Corrosion Control Abilities of Common Barrier Coatings Used by Autobody Repair Technicians

Industrial Technology
Research Paper

by
Kelvin Karl Kramer

July, 1982

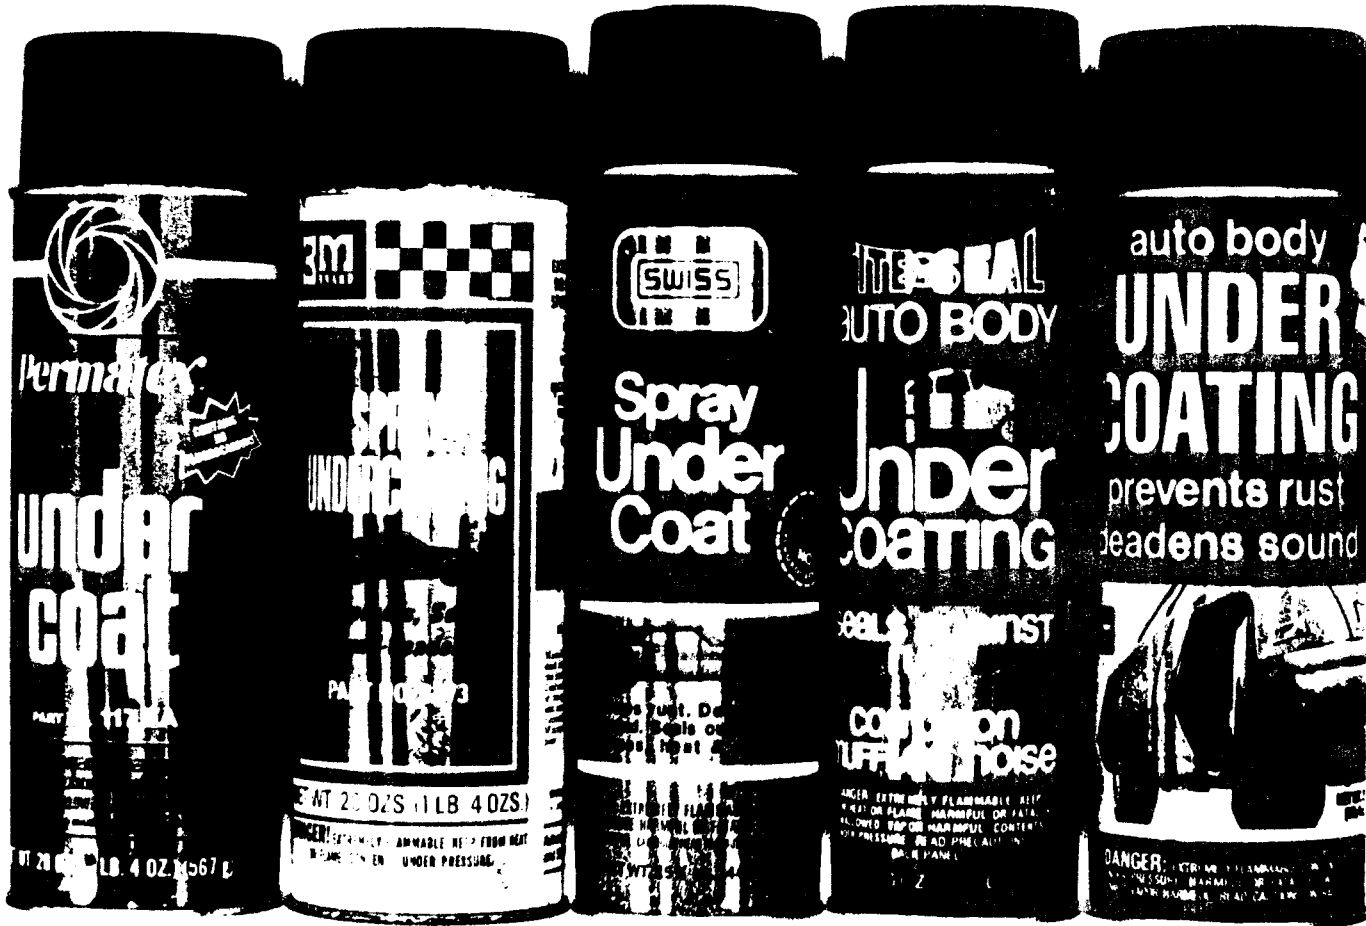
These products were evaluated in the immersion test

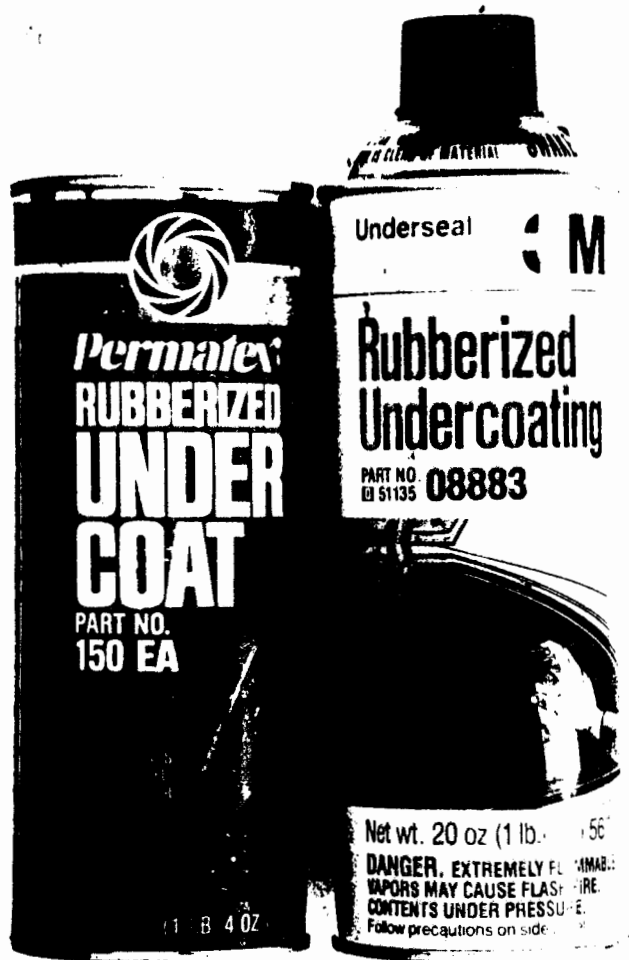
Shown here are the two brands of 'rubberized' undercoatings tested

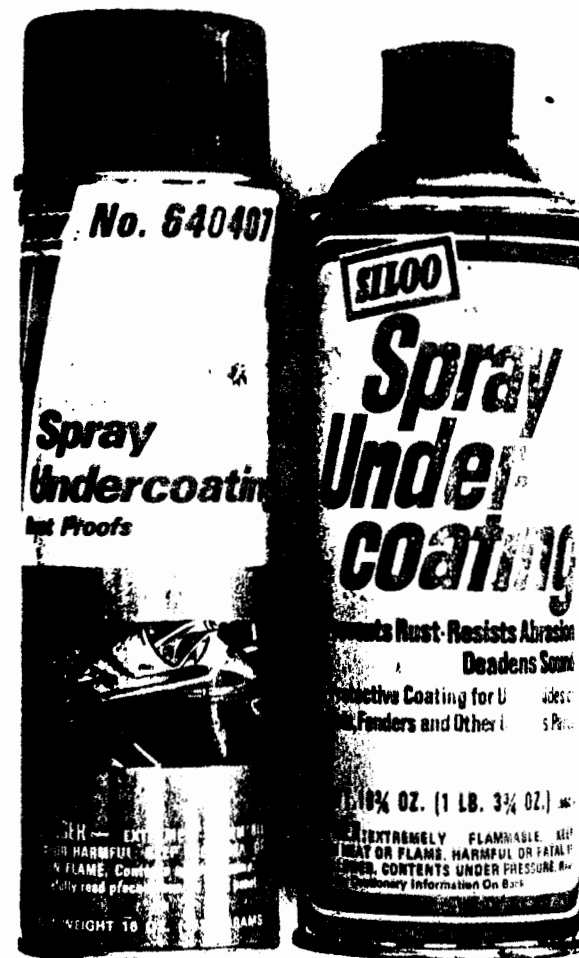
Shown here are the two brands which were tested in the salt-fog test only

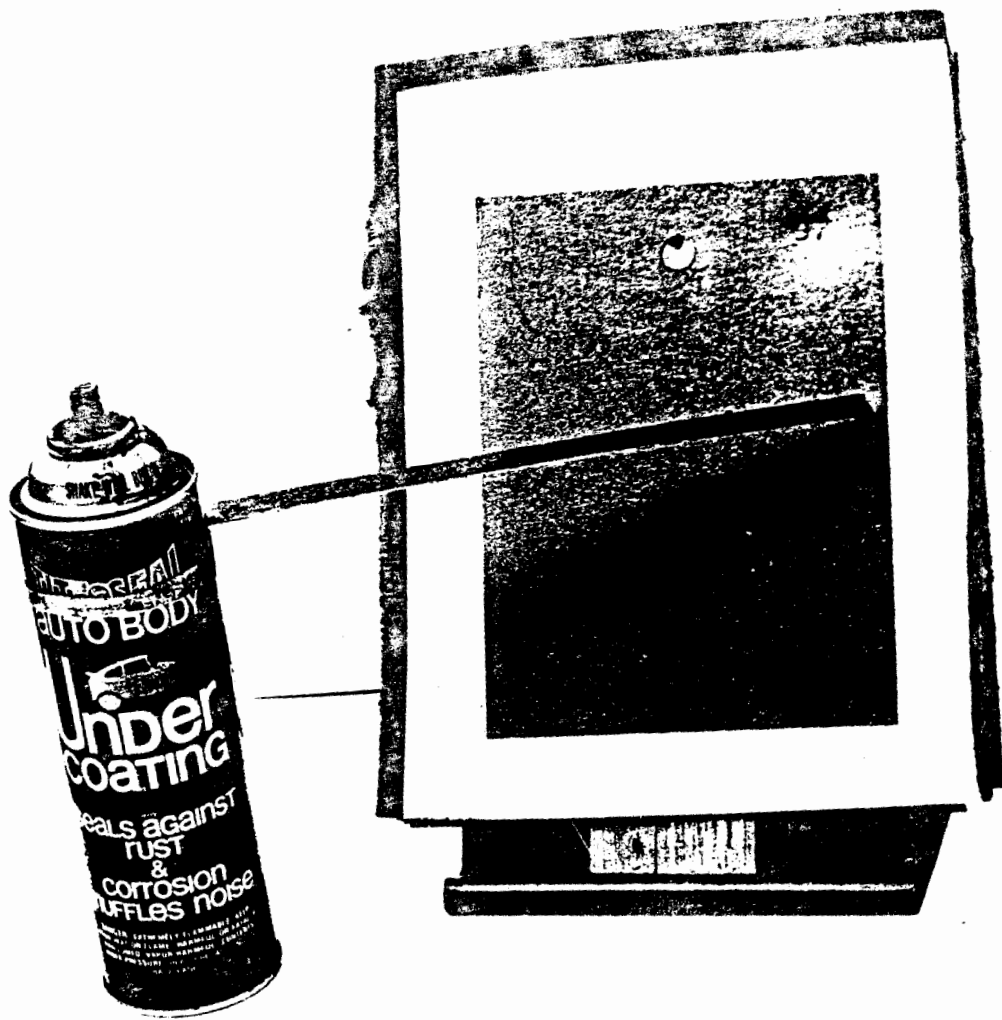
APPENDIX B
COATING APPLICATION AIDS

This illustration shows the spray guide and coupon support stand used to aid in coating application.

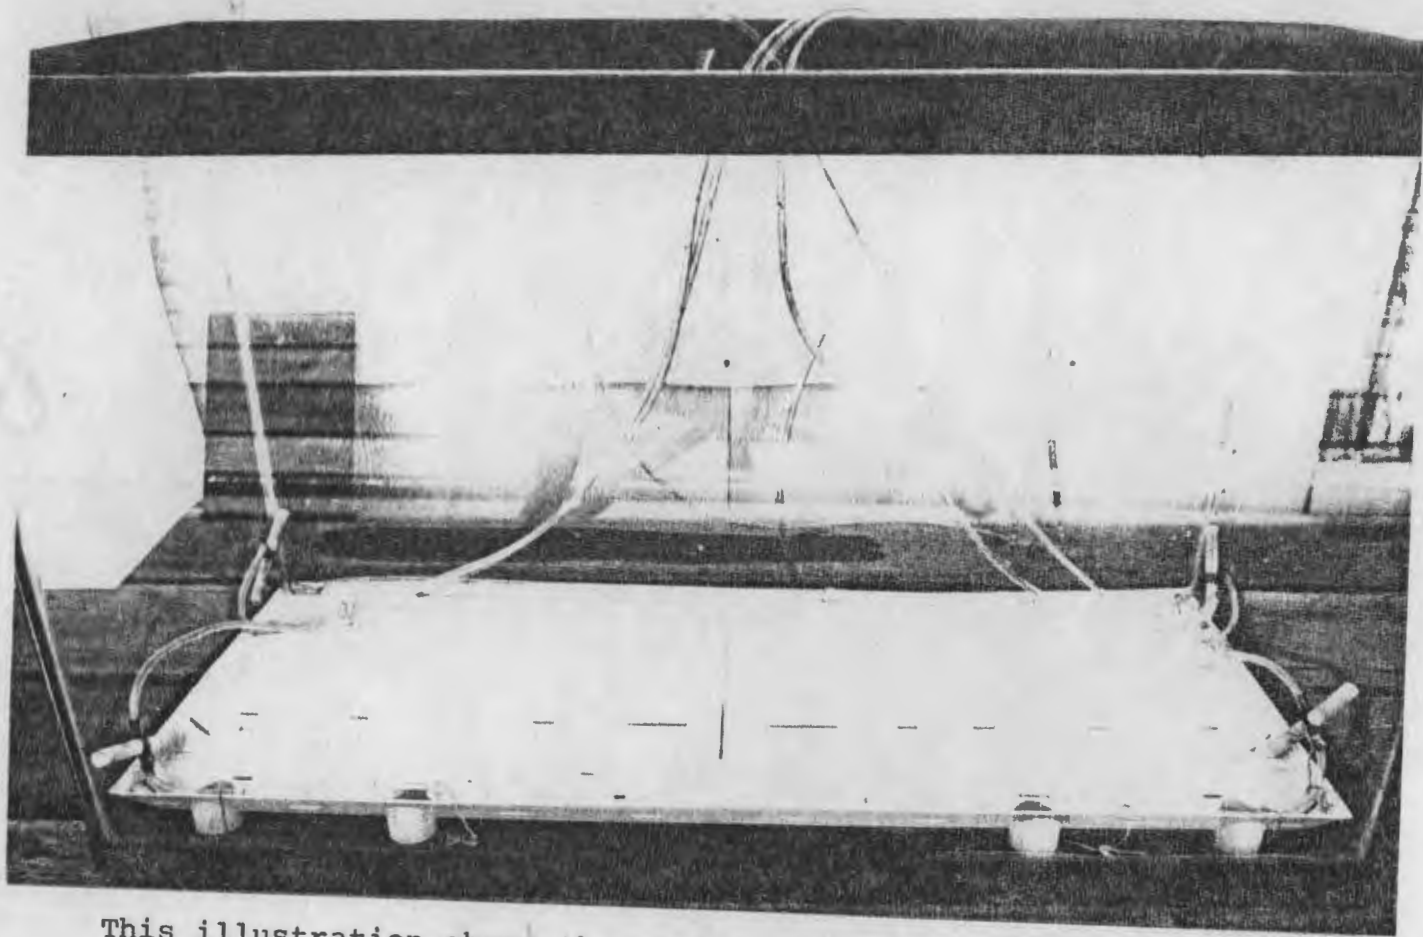
This illustration shows the positioning of the airstones at the corners of the aquarium

According to ASTM (Designation: G 31-72), aeration of the test liquid may or may not be specified. The researcher decided to aerate the solution to maintain constant temperature and to accelerate the corrosion rate. Because the heat source was from a central place in the middle of the back part of the tank, it would have been difficult to maintain a constant temperature throughout the entire tank area without using aeration. The resulting circulation stabilized the temperature throughout the tank with the only exception being the area adjacent to the heater. In addition, a piece of Plexiglas was placed between the adjacent coupons and the heater to avoid direct transfer of heat.

A singular source of air made it difficult to obtain even circulation throughout the tank. To verify that even circulation was obtained, careful observation of the corrosion growth on control coupons was observed during the first hours of specimen exposure. This visual observation did not indicate any observable differences in the rate of corrosion growth between the control coupons.

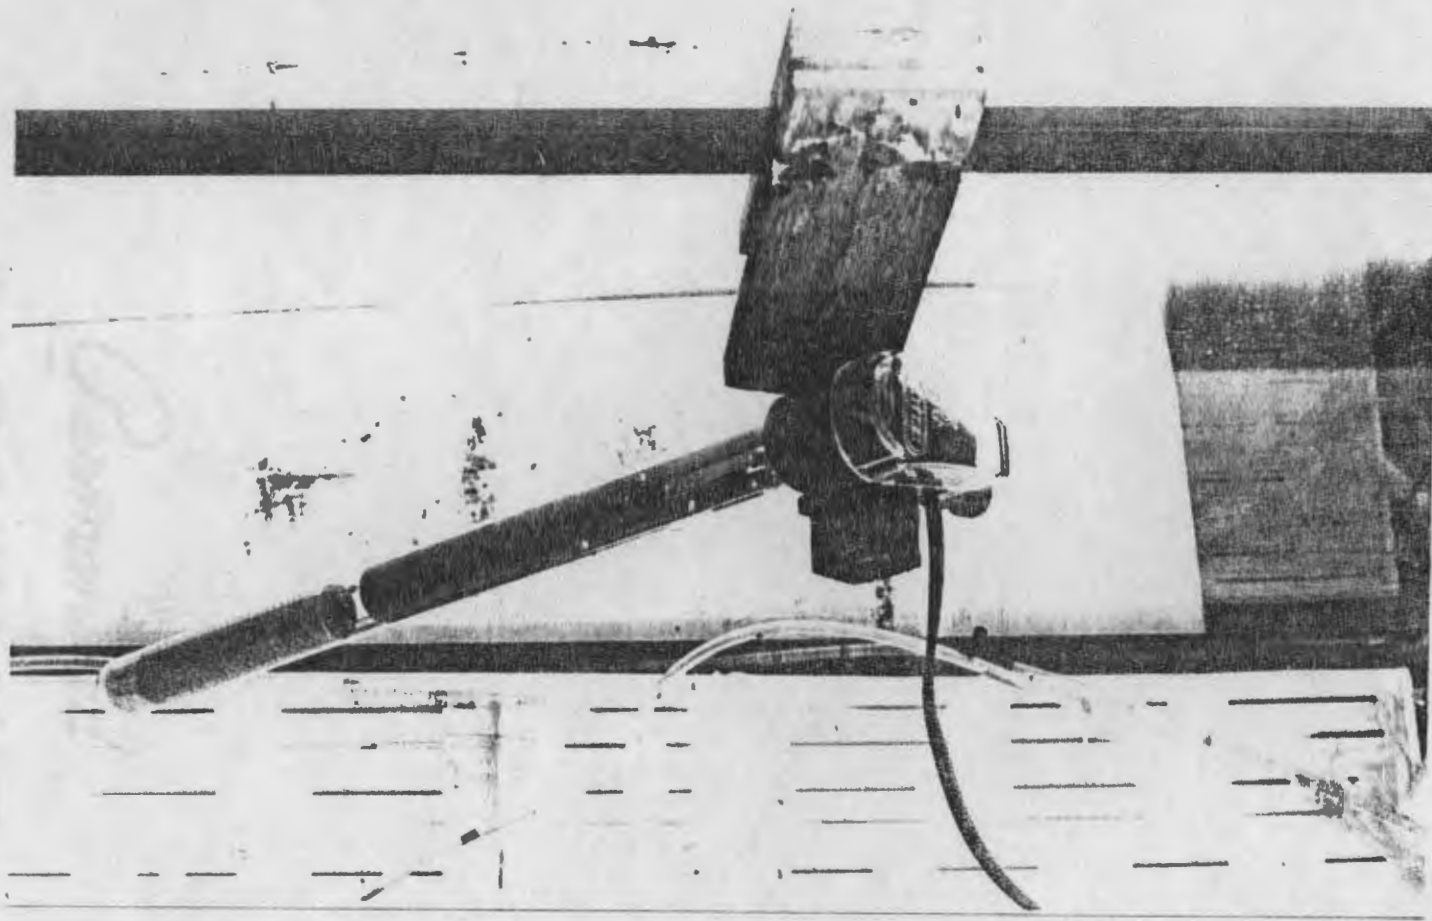
This top view shows the position of the thermostatically-controlled aquarium heater in the tank

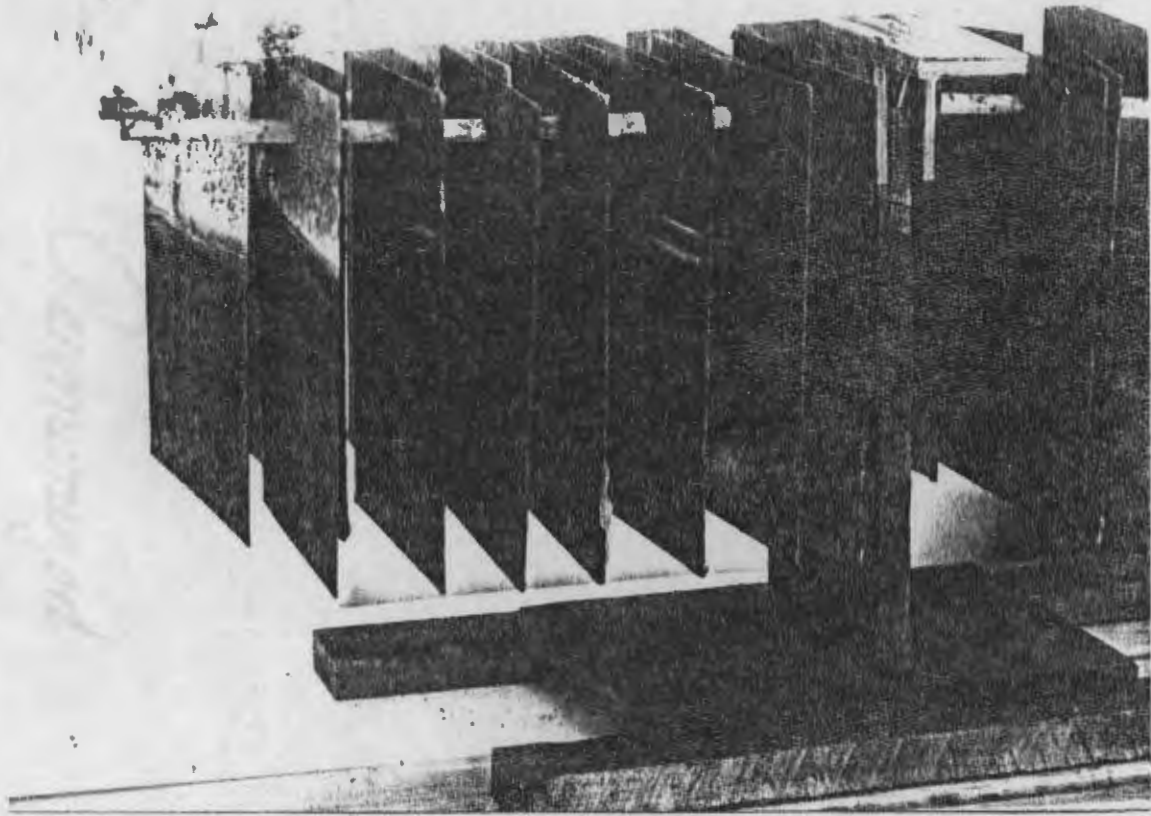
Coupon rack and coupons shown after exposure

Apparatus. The immersion tank used was a 29 gallon (109.78 liter) all-glass aquarium measuring 29 inches (73.66 cm) long by 12 inches (30.48 cm) wide and 18 inches (45.72 cm) high. The aquarium was fitted with a matching top that fit snugly to prevent rapid evaporation of the test liquid. The top was used to prevent heat loss and to maintain a constant temperature. Since the aquarium was not filled completely, the remaining volume, being sealed by the cover, allowed an environment of very high humidity to exist around the upper third of the coupons which were not immersed in the salt solution.

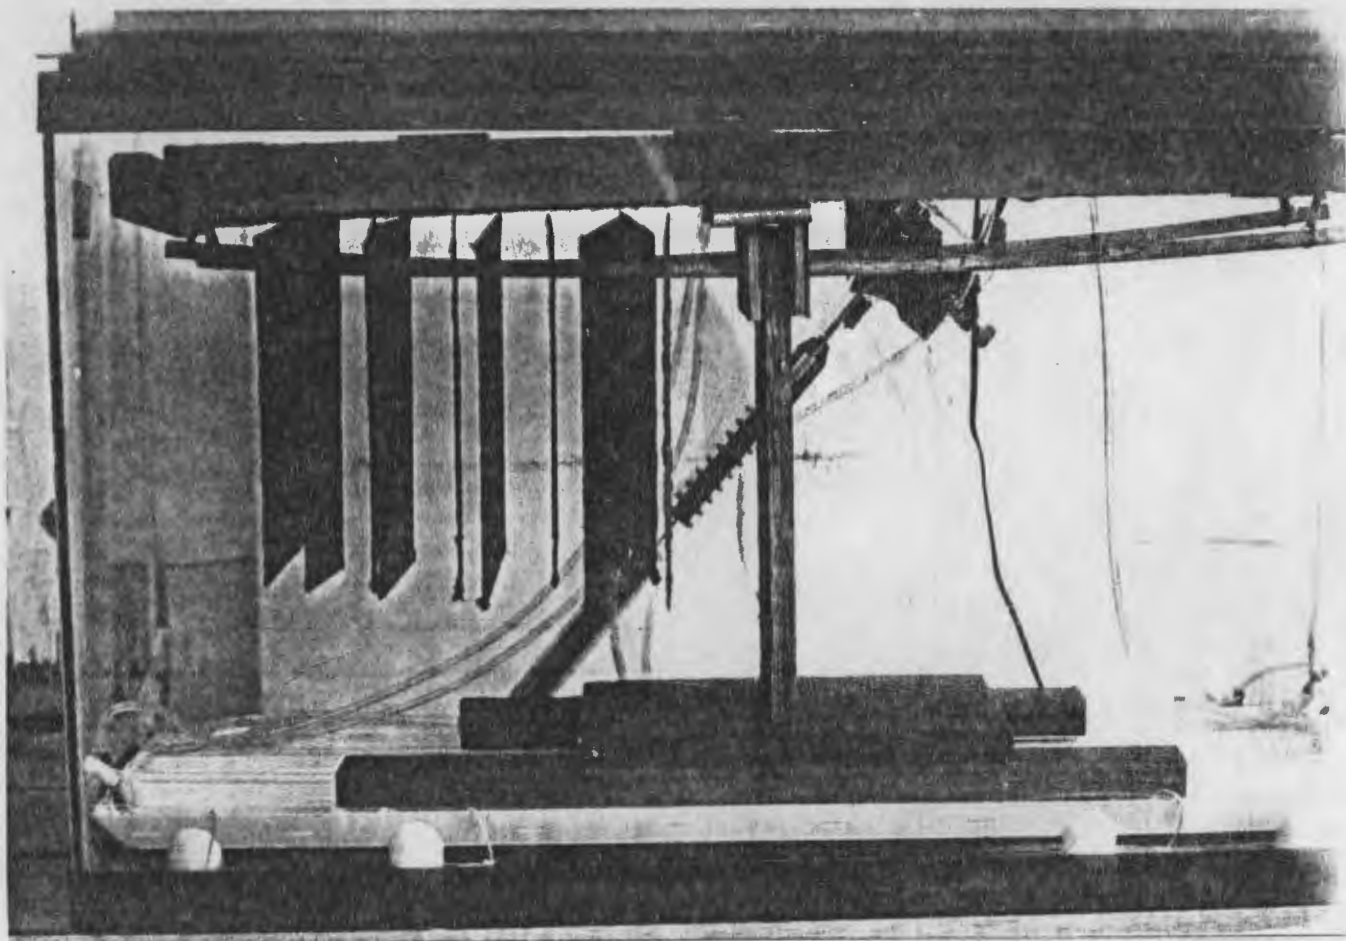
This picture was taken after tank was drained and cleaned. It shows the position of the coupon rack in the tank. Note coupons shown are not properly mounted.

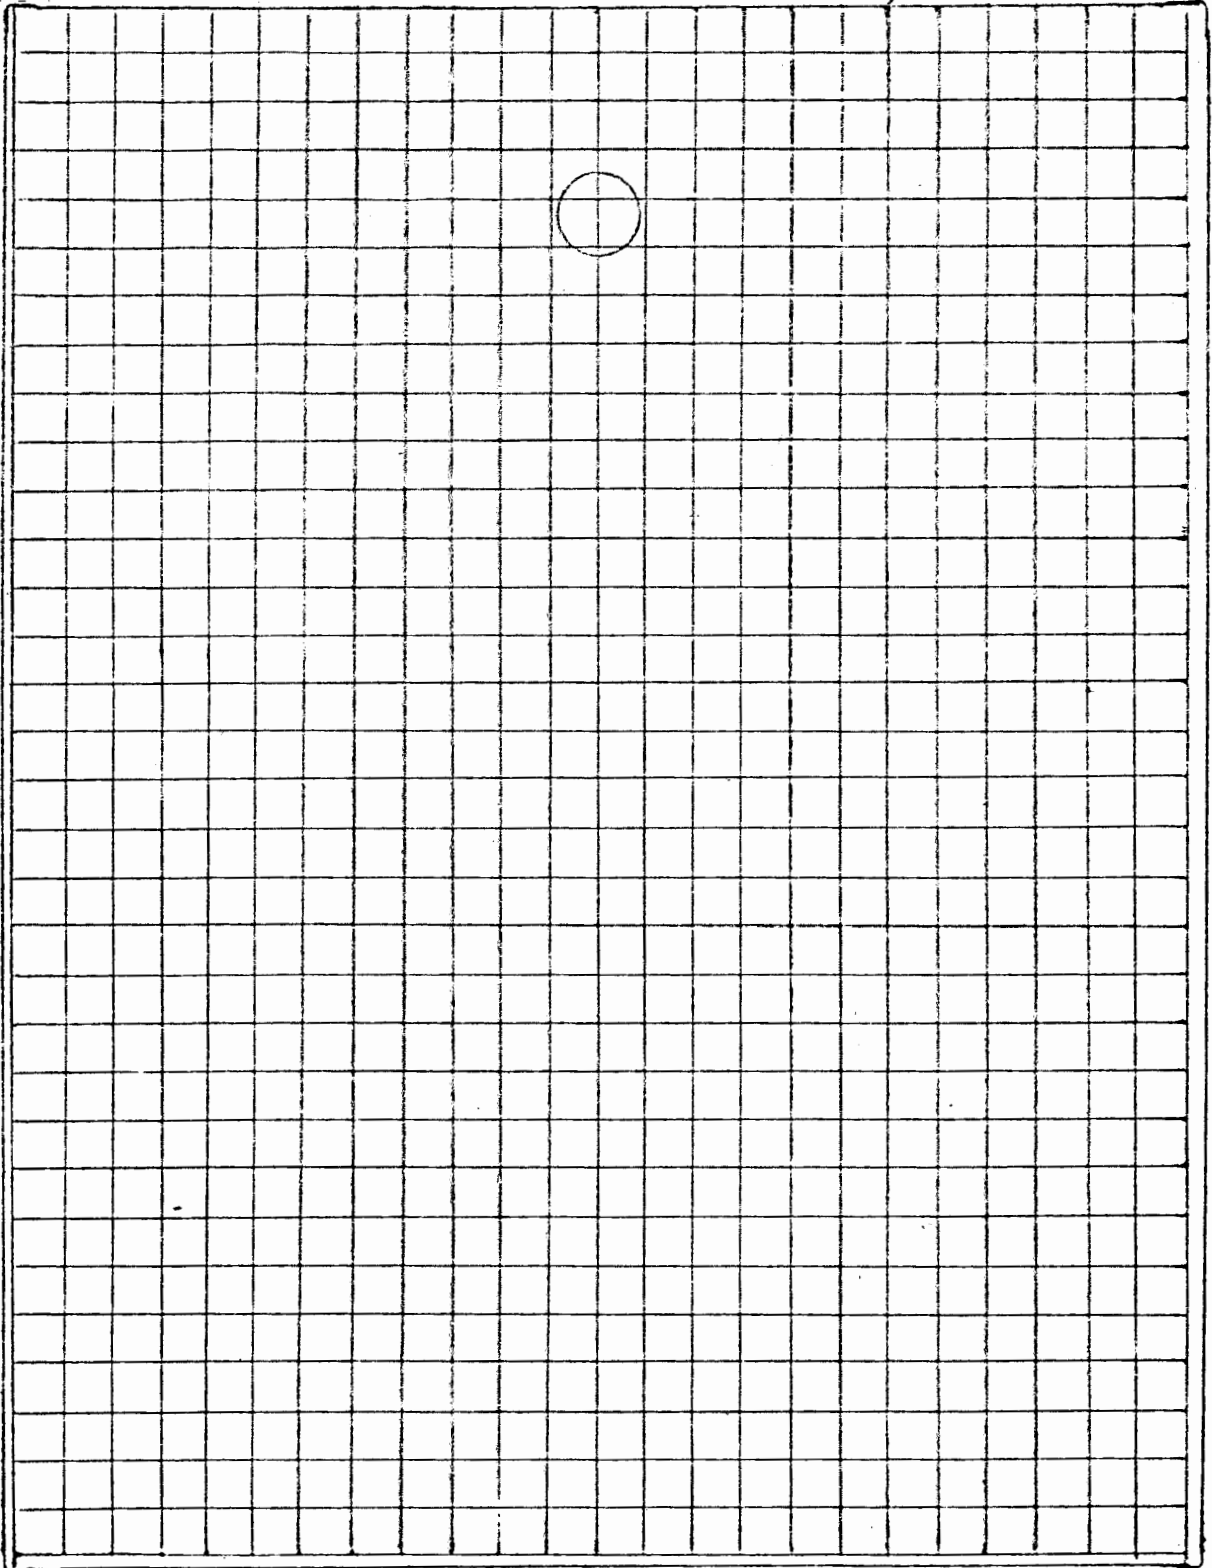
APPENDIX F
CORROSION EVALUATION GRID

To measure corrosion on the area of the coupon beyond the creep from the scribed line a special template was developed. By using a transparent sheet with a .25 inch (.64 cm) grid, the surface of the coupon was covered and the corrosion spots counted. By comparing the squares with one or more points of failure to the total number of squares, a percentage value was determined. These percentages were used for comparison purposes (See Appendix F).

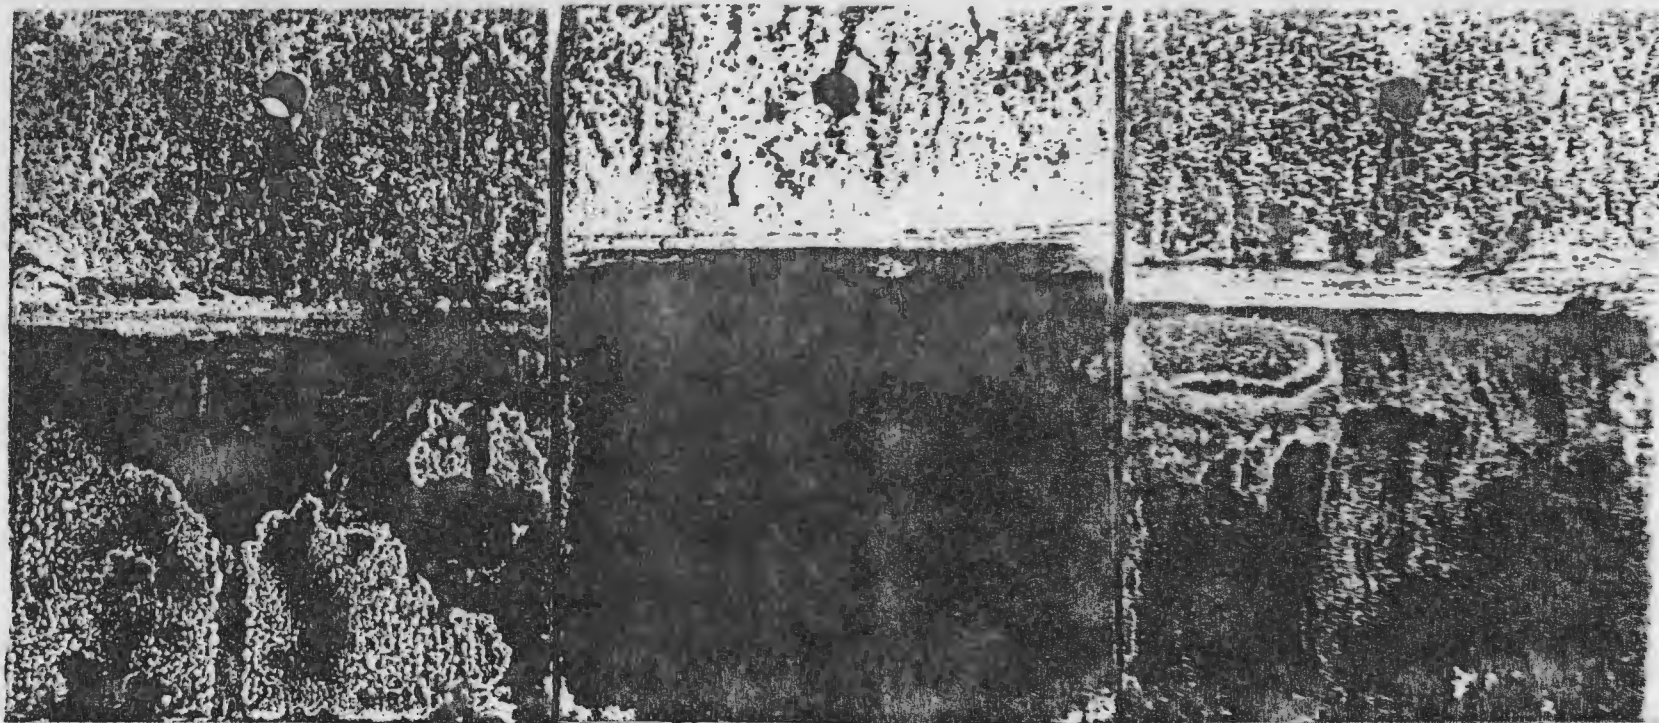
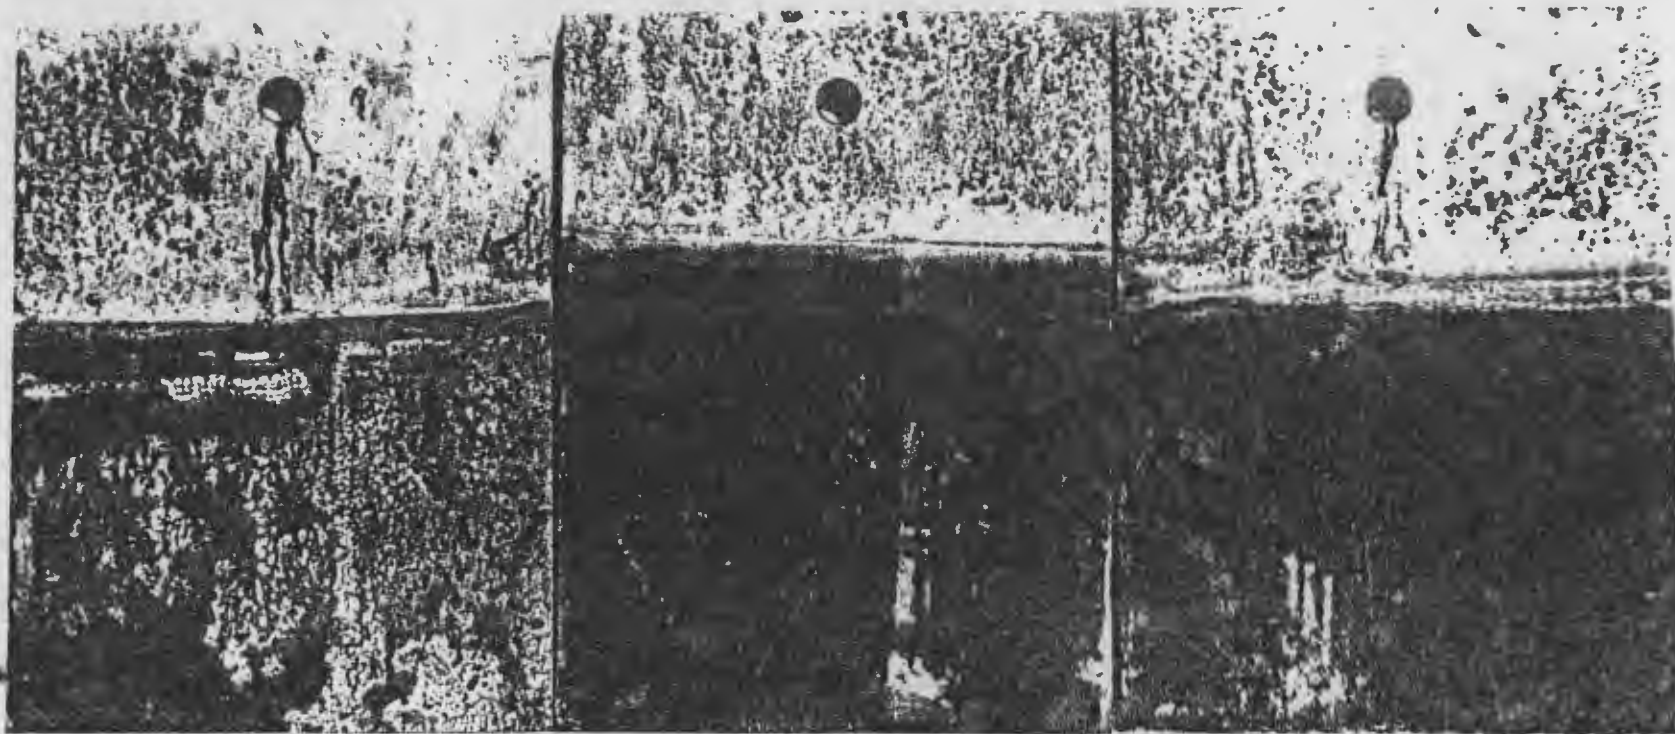
APPENDIX G
COATED COUPONS AFTER EXPOSURE IN IMMERSION TANK

Control - Front

Control - Back

Immersion test. After 336 hours of exposure in the immersion tank, all 26 test coupons showed signs of corrosion growth (See Appendix G). The bare metal coupons, when evaluated (using the template grid) all received a rating of 100% corrosion over the entire coupon surface. The percentage of coating failure over the entire coupon surface showed wide differences between the products tested (See Appendix I). The product with the lowest failure rating was Spray Galv with 1.5% and the highest was Permatex Rubberized with 100%. The measurement of corrosion creepback from the scribed line also showed wide differences between the coated samples. When comparing averages between coupons, the smallest was Spray Galv with .03 inch (.40 mm) and the largest was Permatex Rubberized with 2.88 inches (6.55 mm). Comparison

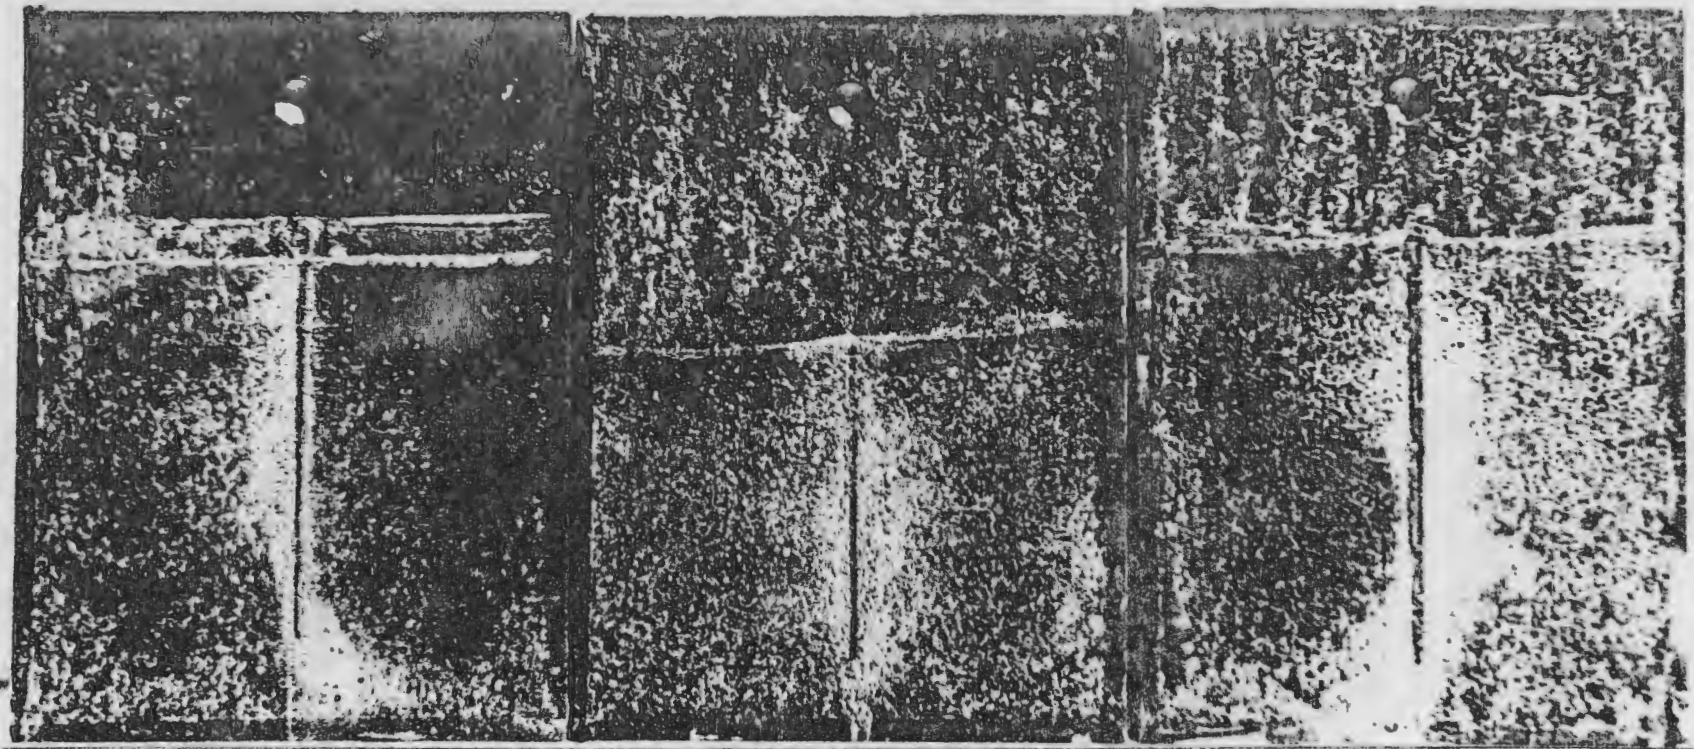
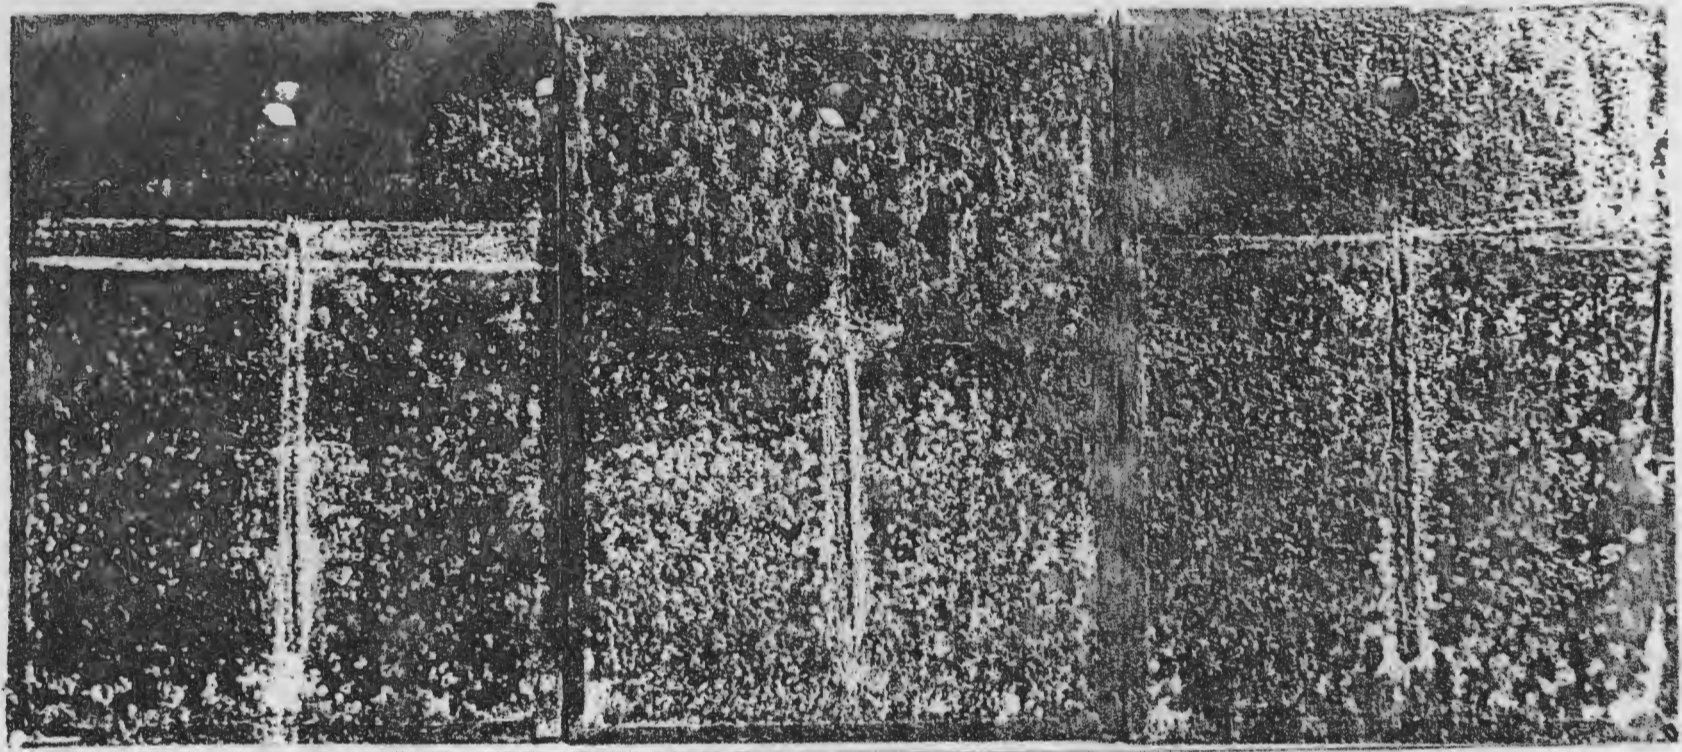
Permatex Rubberized - Front

Permatex Rubberized - Back

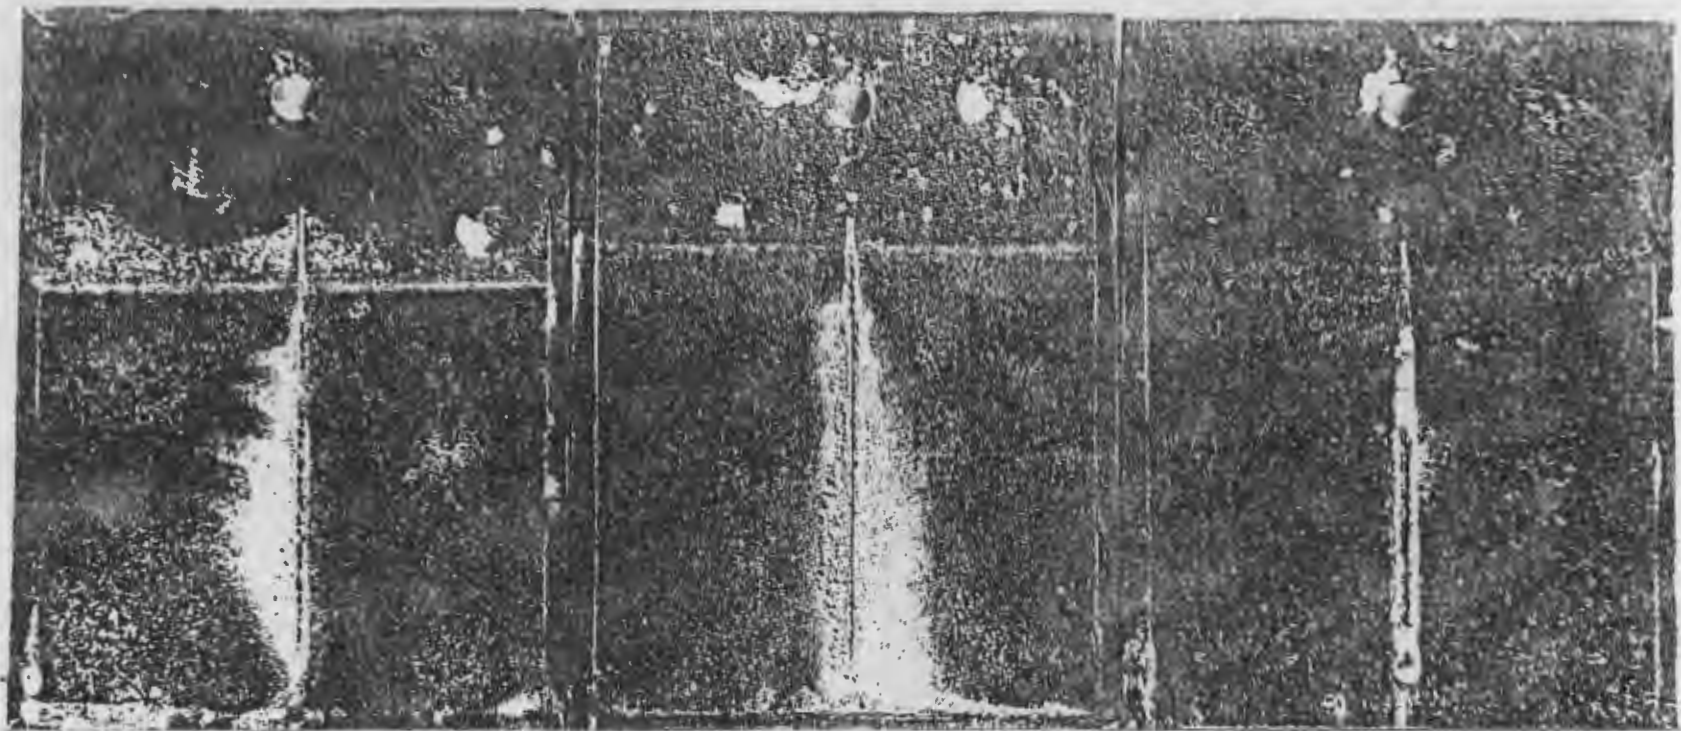
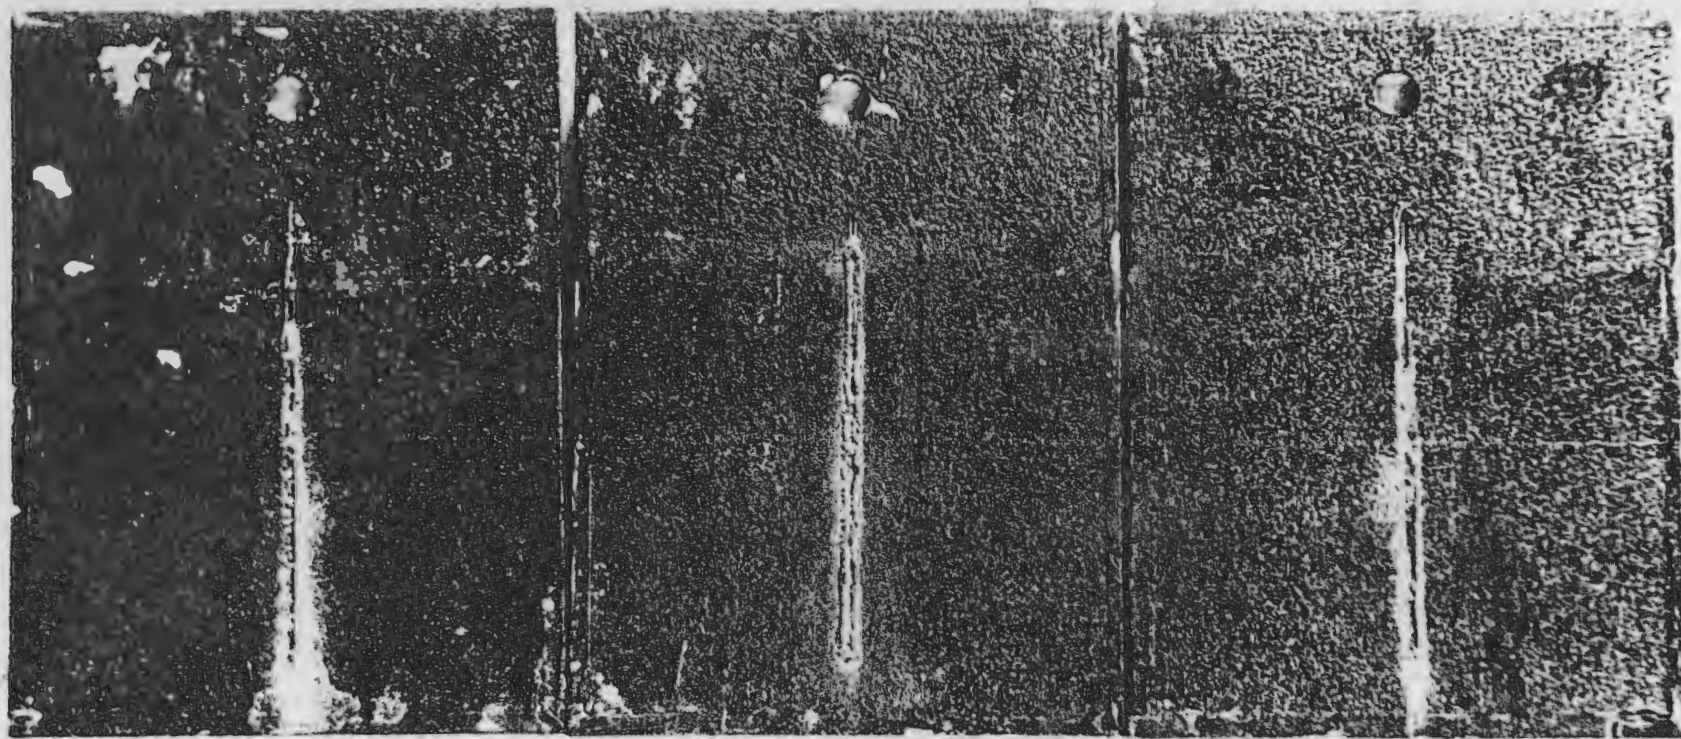
Swiss - Front

Swiss - Back

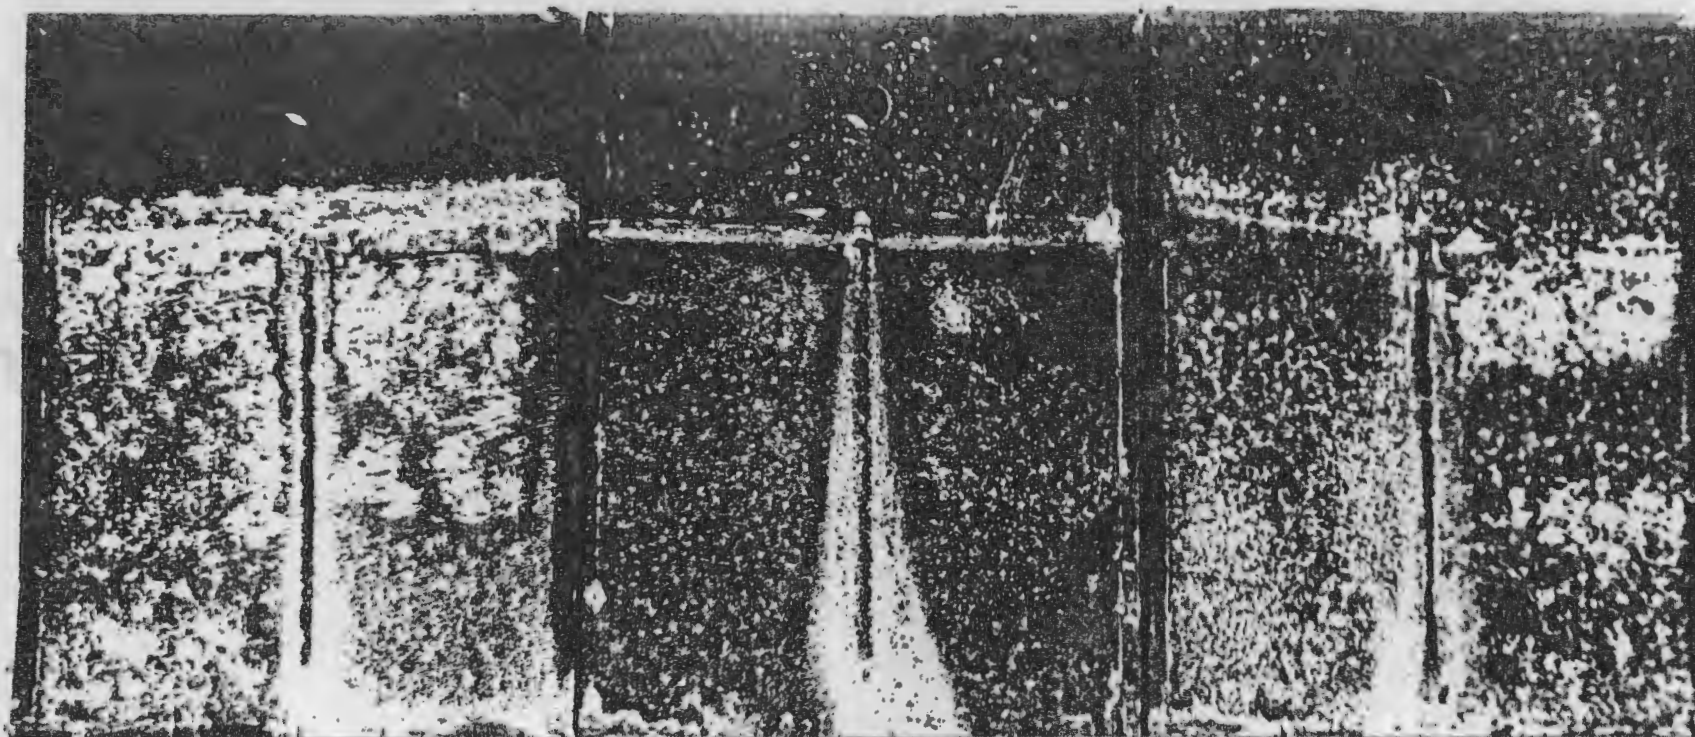
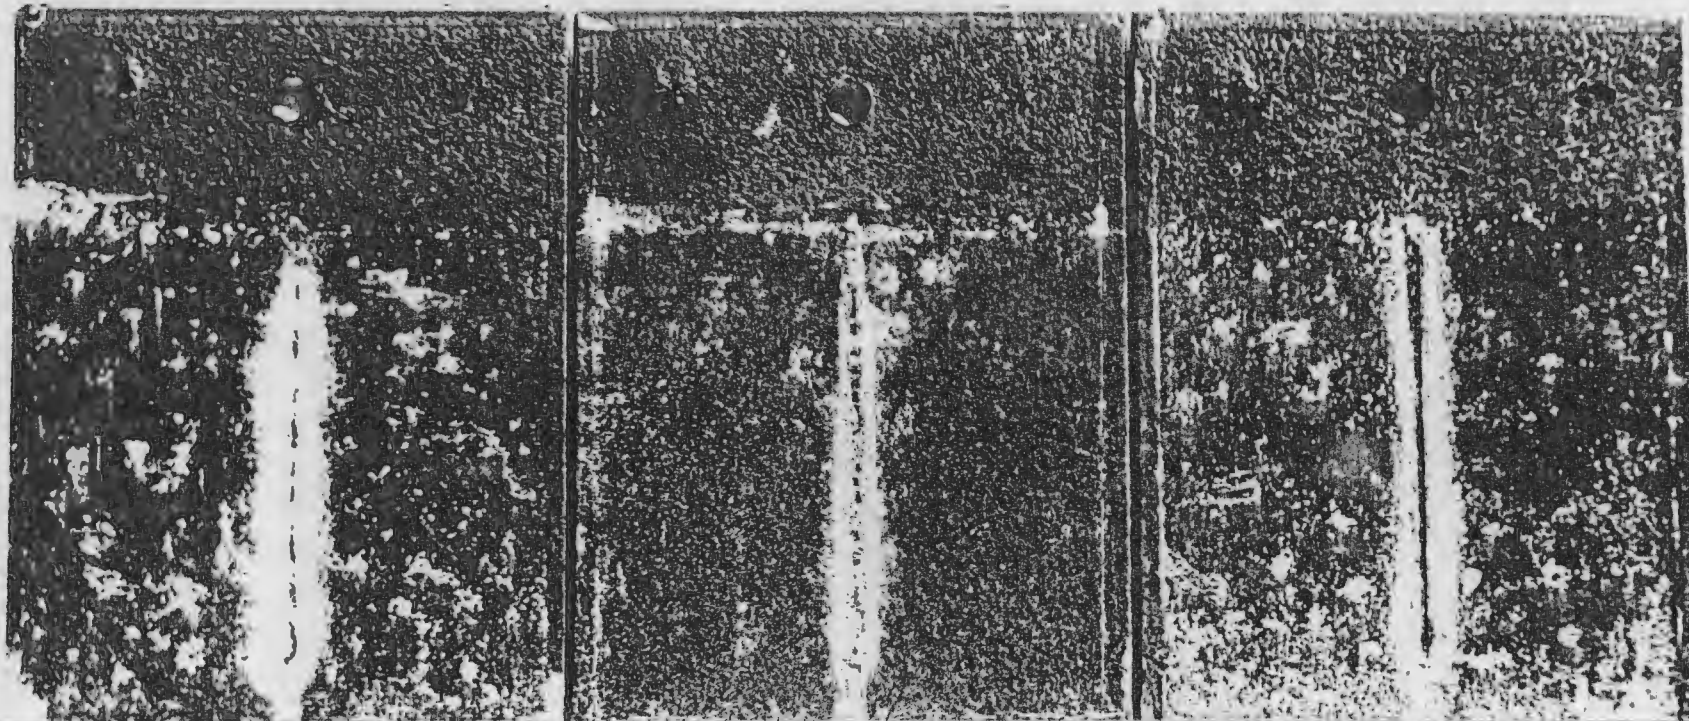
Tite-Seal - Front

Tite-Seal - Back
