Accelerated Testing to Compare the Corrosion Control Abilities of Common Barrier Coatings Used by Autobody Repair Technicians

Industrial Technology
Research Paper

by
Kelvin Karl Kramer

July, 1982

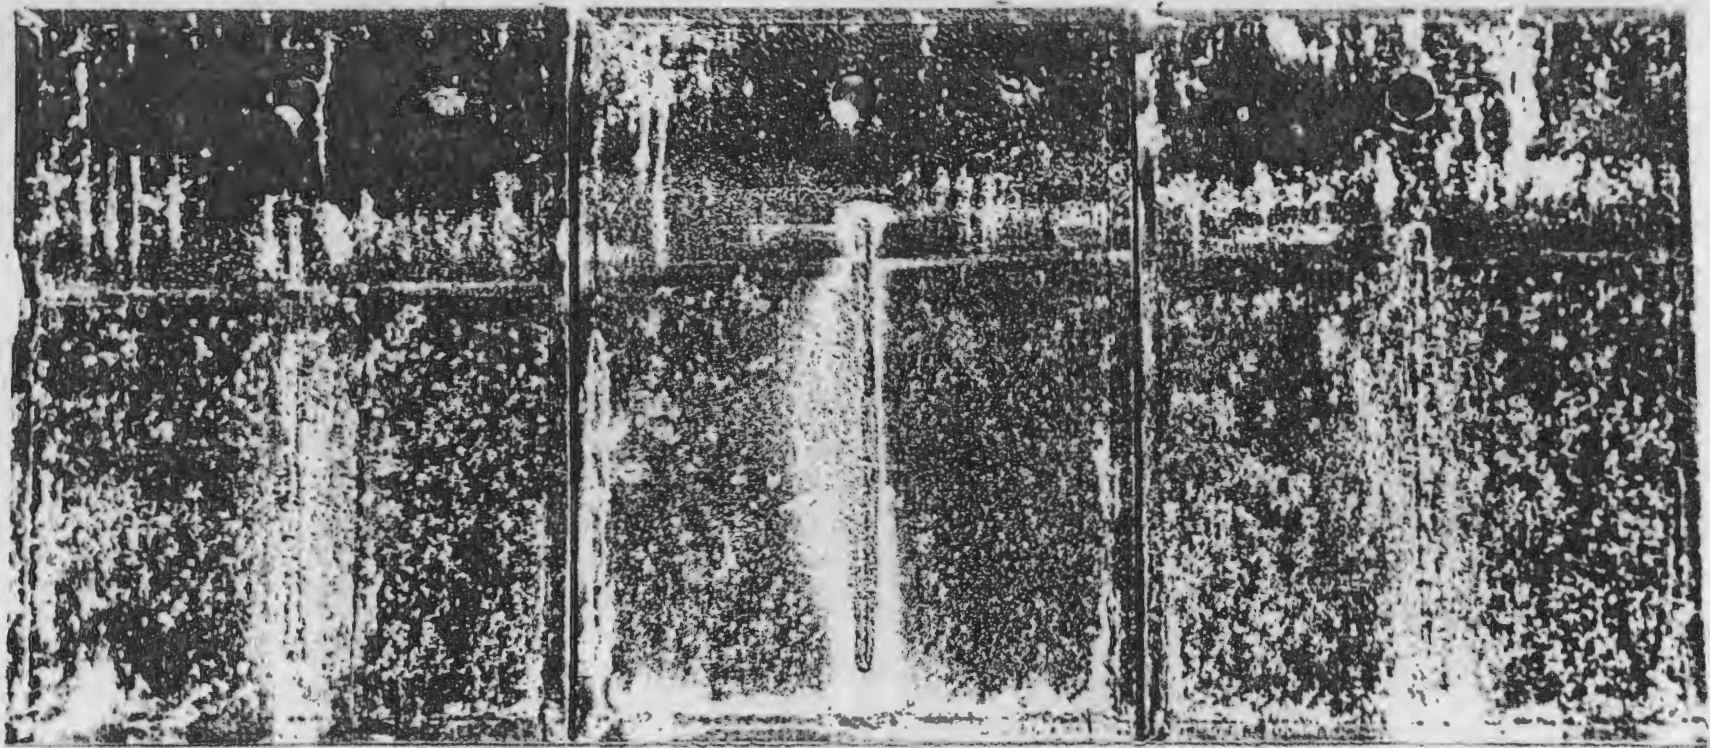
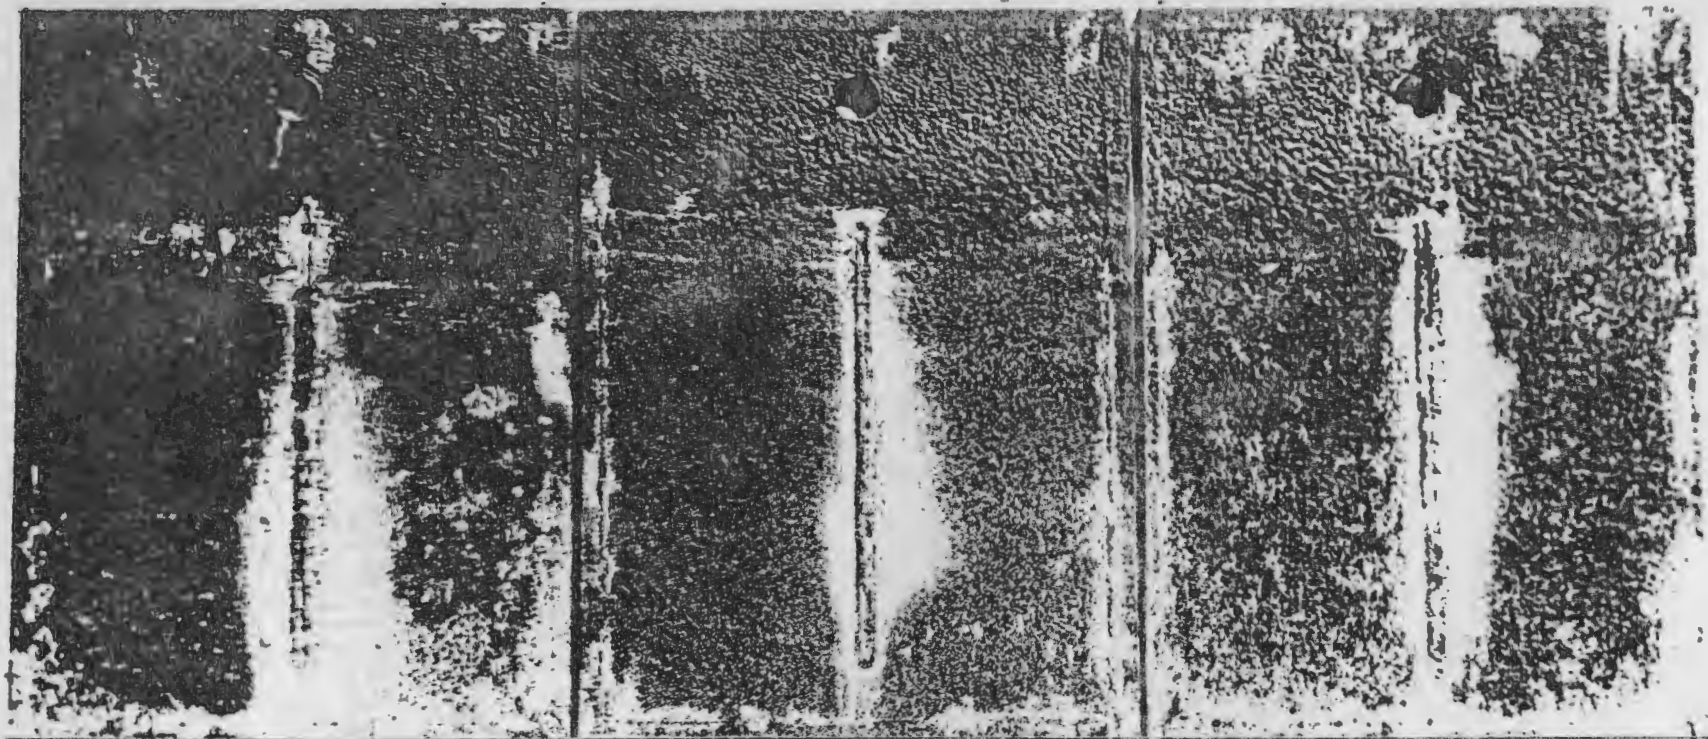
3M Rubberized - Front

3M Rubberized - Back
