1993

Applicability of an Autodeposited Organic Coating as a Primer for Agricultural Tractor Hitch Assemblies to Improve Corrosion Resistance

Joseph Wayne Wilson
University of Northern Iowa

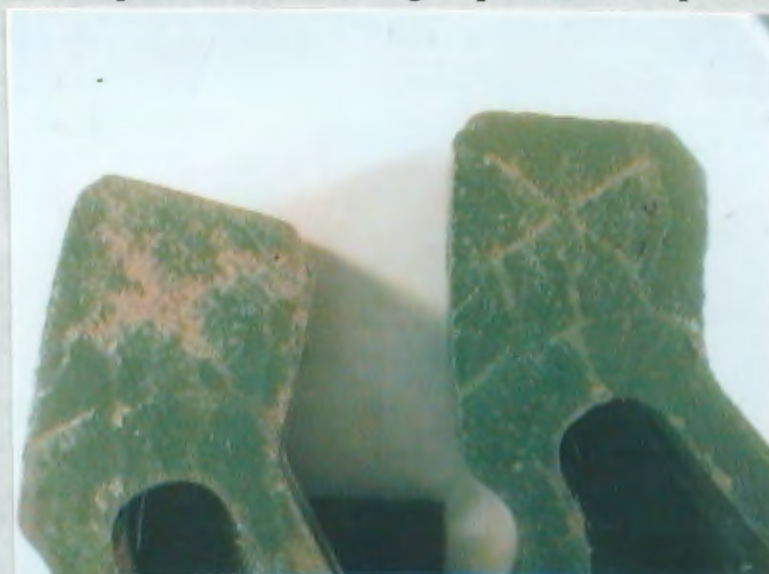
In Figure 5 the loss of adhesion on the baseline panel (number 17) was not as severe as in the case of the baseline panel (number 15) shown in Figure 4. This was, in part, believed to be due to the rough texture of panel 17 providing some mechanical bonding of the coating.

Figure 5: Salt Spray Test Creepback Examples
Left panel baseline, Right panel autodeposition
