Civilian Conservation Corps Rubble and Masonry Dams and Gully Morphology in Northeastern Iowa

CIVILIAN CONSERVATION CORPS RUBBLE AND MASONRY DAMS AND
GULLY MORPHOLOGY IN NORTHEASTERN IOWA

An Abstract of a Thesis
Submitted
in Partial Fulfillment
of the Requirements for the Degree
Master of Arts

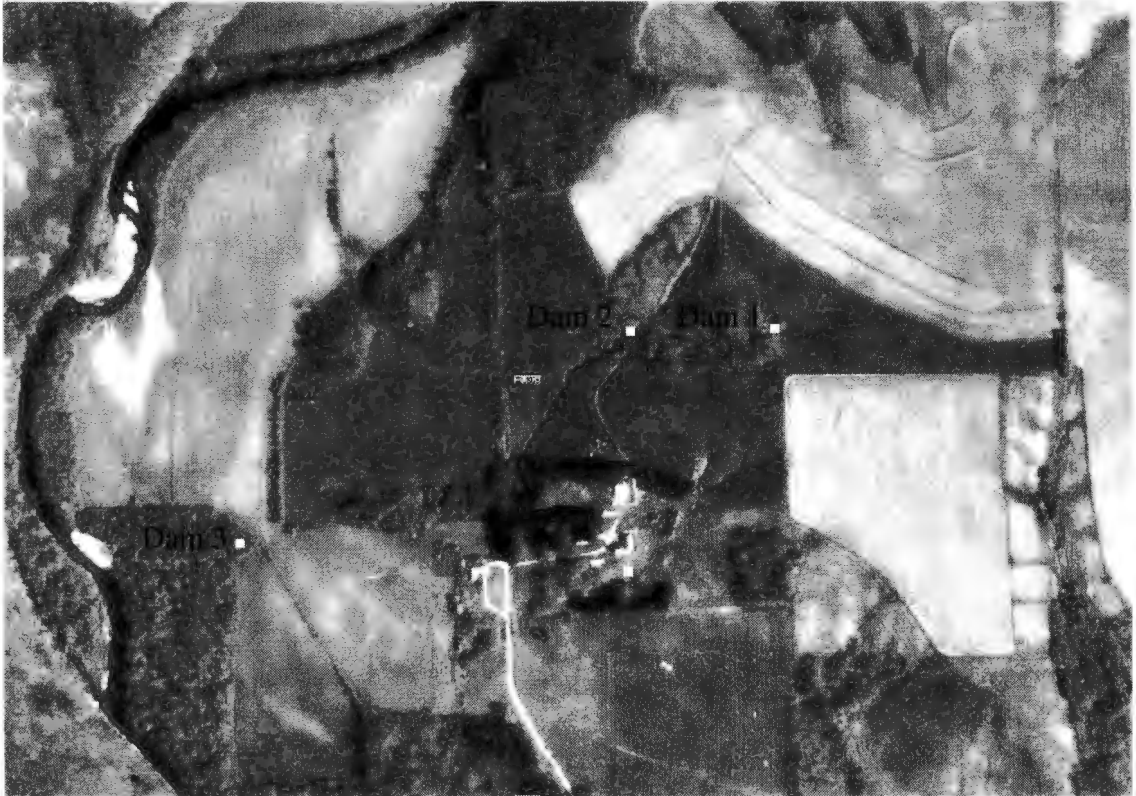
The first dam (Dam 1) along Johnson Gully was built very near the head of the gully about 400 meters from the local drainage divide. The location of this dam is also the edge of a wooded area that follows the steep sides of the gully down to the second dam along Johnson Gully (Figure 6). Dam 1 has failed sometime within the last 5 years, and is slowly being destroyed by continued erosion.

Figure 6. Location of all dams on Johnson Gully. Locations of dams are indicated by white squares. Top of image is north. Scale unknown. (Photo from: Microsoft Corporation, 1998).

\ Dam 2 is approximately 200 meters down-valley of Dam 1 (Figure 6).\ Dam 2 is in much better condition than Dam 1. The length of Dam 2 from north to south across the gully is 12.05 meters. The top of the main wall of the dam runs from the north for

Dam 3 is about 686 meters downstream of Dam 2 (Figure 6). It was built in an area of much lower local relief than Dams 1 and 2. The main wall of Dam 3 is not as high as those of Dams 1 and 2, but is much longer than those of the other dams.

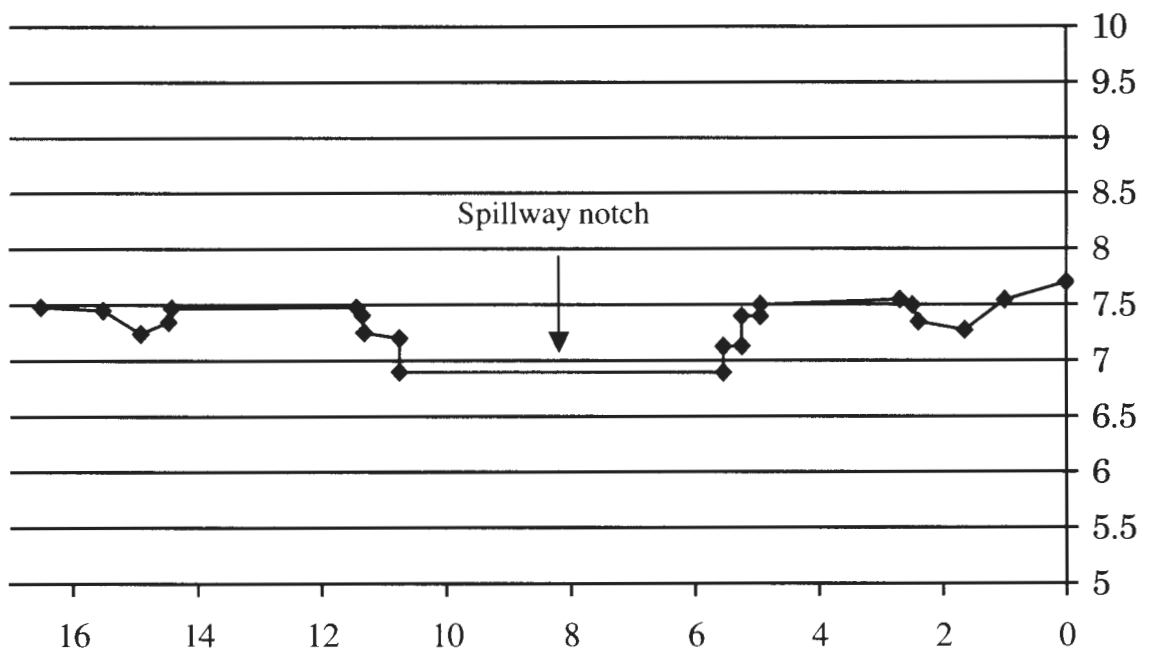
2.55 meters to the south before it starts to taper down into the notch. At the beginning of the notch, it steps down through the layers of limestone that were stacked on top of each other 0.65 meters horizontally and 0.58 meters vertically into the spillway notch. The spillway notch then runs southward for 5.2 meters until it steps back up to the top of the dam 0.4 meters horizontally and 0.61 meters vertically. The top of the main wall of the dam then extends on for another 3.0 meters south (Figure 16).

The thickness of the of the main wall of the dam at the very top is about 0.35 meters, while the thickness of the dam at the spillway notch is 0.64 meters. The spillway of Dam 2 drops 2.2 meters from the lip of the spillway down to the apron. The apron is not the original apron that was built with the dam (Figure 17). It was replaced by a concrete apron in the mid 1980s (Scott Johnson, personal communication, March, 1999).

Figure 16. Cross section across the top of Dam 2. Horizontal and vertical units are in Meters.

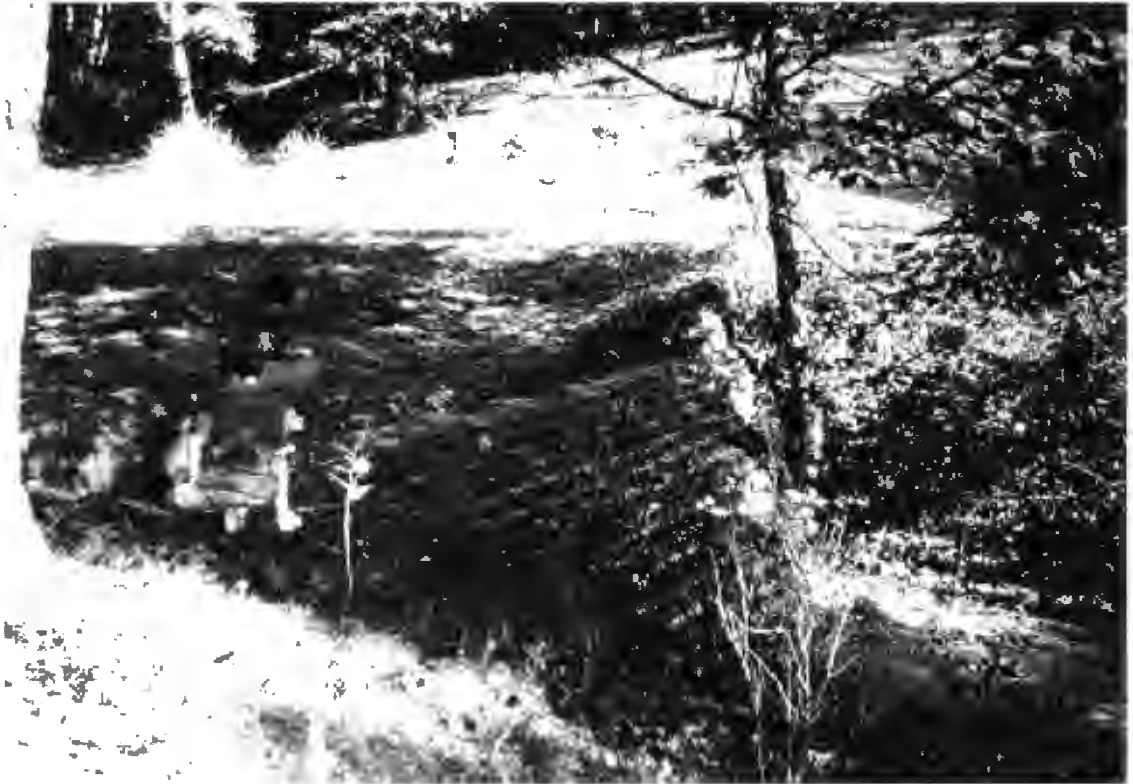
The reason this dam has been maintained is because a road runs across the historical alluvium fill in the gully just upstream of the dam, and the road is needed by the landowner to move heavy equipment from the farm to the fields (Figure 18). The concrete apron has helped keep the dam stable. Remnants of the old baffle wall that was a part of the end of the old apron are still visible in the gully not very far downstream of the new apron. The new apron does not have a baffle wall. Portions of the new apron are being undercut, as the water is not slowed as it runs across the concrete apron and flows over its end into the gully. The concrete apron extends downstream 4.65 meters from the

Figure 18. View from the north toward the southeast of Dam 2. This fill behind the dam is used to drive farm equipment over the gully to the field above.

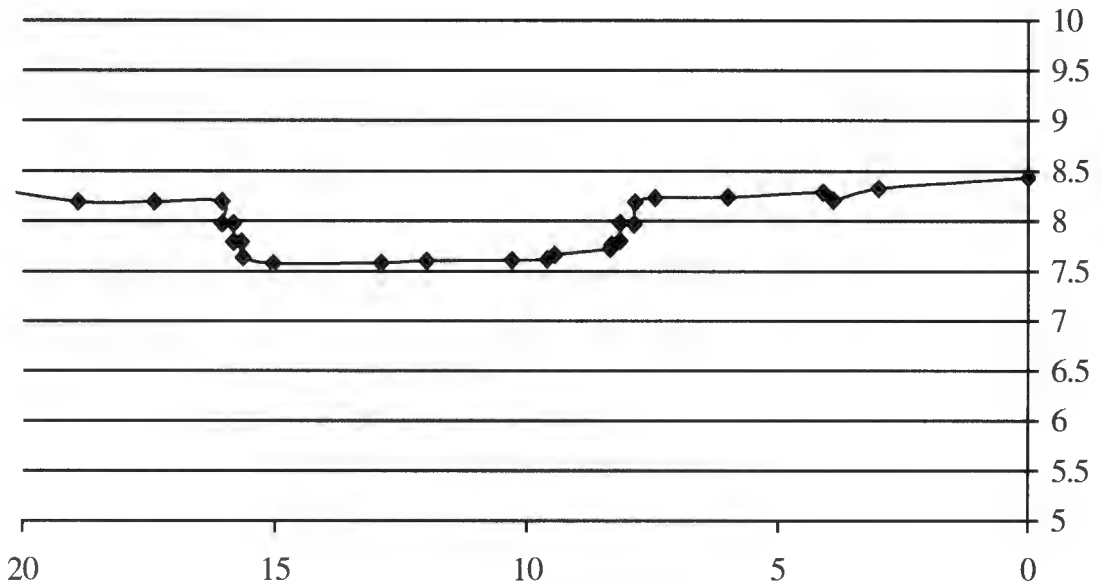
The length of the main wall of the dam is 15 meters. The spillway notch of the dam starts 3.85 meters from the north end, and steps down vertically 0.57 meters in a horizontal distance of 0.5 meters. The north side of the notch is filled with sandy alluvium to a depth of .13 meters. The bottom of the spillway notch extends for 7.15 meters before it steps back up vertically 0.62 meters in a horizontal distance of 0.41 meters. The dam then extends an additional 2.84 meters to its southern edge (Figure 22). The thickness of the dam wall at the notch is about 1 meter.

Figure 22. Cross section across the top of Dam 3. Horizontal and vertical units are in meters.

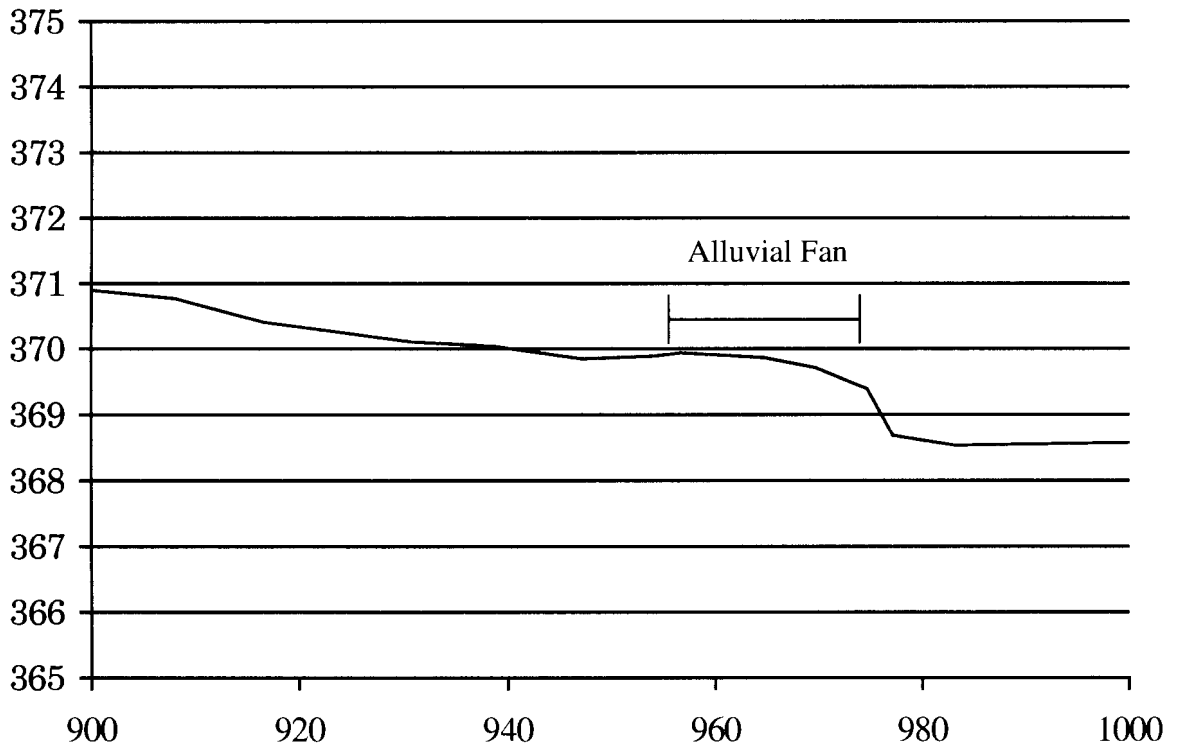
past. The fan has aggraded to such an extent that the cross-sectional measurement of the fan shows that the area to the north is actually lower in elevation than the channels on the fan (Figure 25). There is also a slight rise in the longitudinal profile due to the alluvial fan (Figure 26). During the surveying of Johnson Gully, it was observed that snow melt that reached the alluvial fan pooled in its shallow channels and slowly infiltrated into the ground. The characteristics of this sector of the gully are markedly different from the rest of the gully.

Figure 26. Longitudinal profile of the alluvial fan. In the depression (at approximately 945 meters) before the fan, water often sits and dissipates into the ground. Gully is sloping to the west (right). Horizontal and vertical units are meters.
