Property Studies of Alaskan Silts in the Matanuska Valley, Big Delta, and Fairbanks Areas

Iowa Engineering Experiment Station

BY R. W. STUMP, R. L. HANDY, D. T. DAVIDSON, AND C. J. ROY

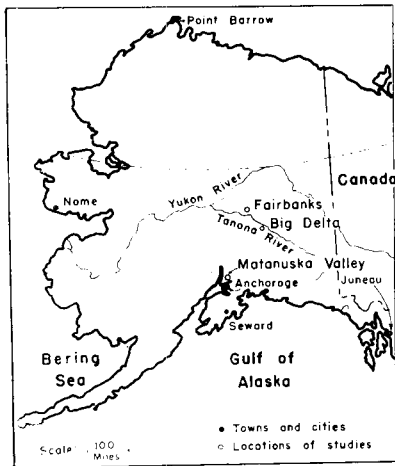
Figure 1. Locations of the three areas of study.

Big Delta, and Fairbanks regions, and the beach deposits and physiography of the Point Barrow region. The areas of study are shown on the map, Figure 1. The report considers only the first three regions, and summarizes the work done during the first contract year, 1 June, 1954 to 1 June, 1955.

The location of the Big Delta area is shown in figure 1. The area of study in 1954 was that east of the Delta River valley as far north as the Tanana River, and the Big Delta airport marked the southern boundary. The Delta River is a braided stream, similar to the Matanuska River, and deposits from valley glaciers are prominent on its floodplain.

The location of the Fairbanks area is shown in figure 1. The field party of 1954 spent several days in reconnaissance of the area.

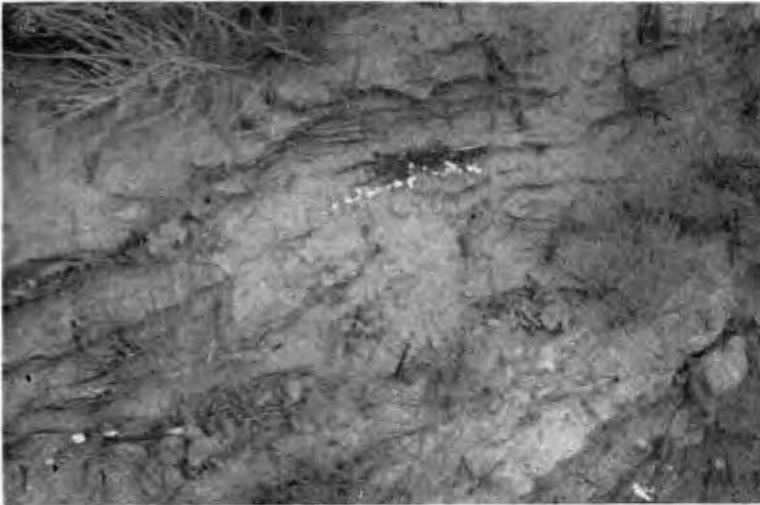
Figure 12. Carbonate fossils forming calcareous silt.

The Matanuska Valley silt is not ordinarily calcareous. In this respect, it is unlike the loess of the Midwest United States, in which carbonates are generally abundant. Some calcareous concentrations were found in thin lenses in the Matanuska Valley silt; these were found only in sections in which were found carbonate—shell fossils (see Figure 12).

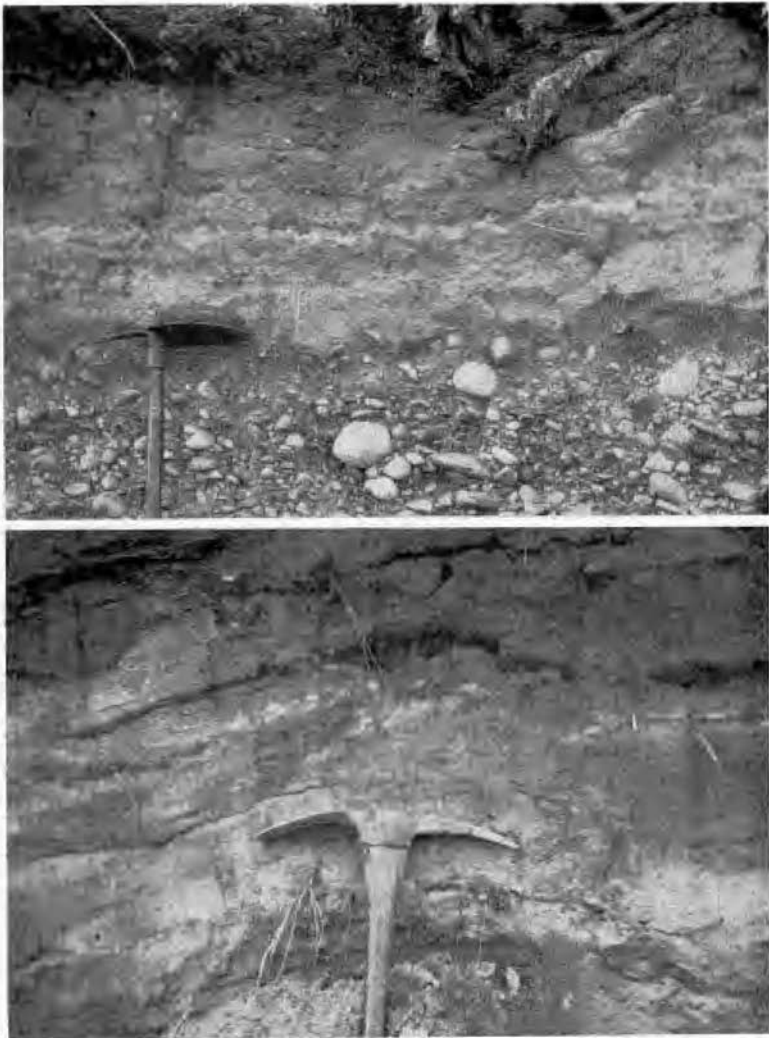
Figure 13. Ash layers in the silt. A, above, ash layer at M55; B, below, contorted ash

contorted, and generally thinner in the thinner silt to the west and south. Here all the bands are usually not discernable. Many of them are broken and discontinuous. Figure 13a shows an ash layer and 13b shows how they may be deformed.

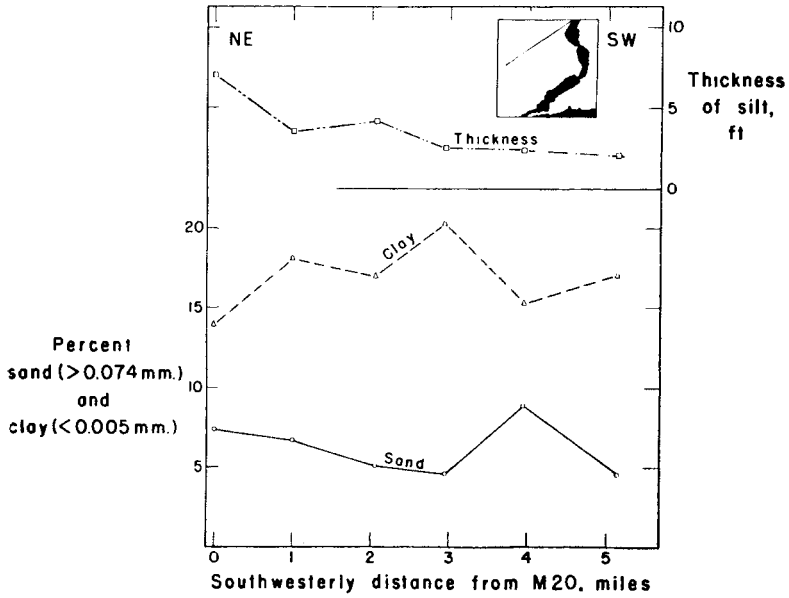
Figure 16d. Thickness and sand and clay percent variation along the northeast-southwest traverse.

The sand percentage and the clay percentage of the mid-depth samples, and the thickness of the silt along the five traverses are shown in Figure 16. The sand percentage is related to thickness on the river traverse and to a lesser degree on the north-south and northeast-southwest traverses. The particle-size and thickness correlations on the east-west and especially on the southeast-northwest traverses are poor. This last traverse runs almost parallel to the sand percentage lines crossing Palmer Terrace.

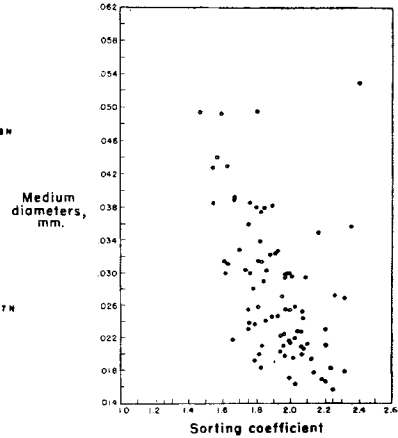
Figure 23. Graph of sorting coefficient and median diameter.

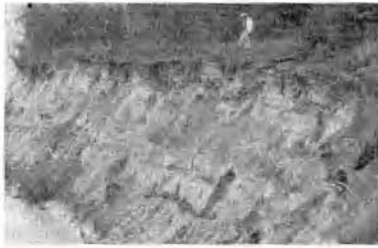
Figure 27. Silt exposure along Delta River.

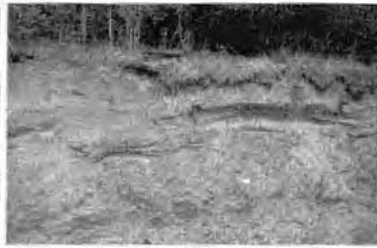
Figure 28. Silt exposure 1/2 mile east of the Delta River.

The silt is very thin in the southern extremity of the area, measuring less than two feet thick. There is a very rapid increase in thickness north of Delta Junction. Here the silt is thick (approximately 20 feet) along the riverbank. The silt exposure is shown in figure 27. The thickness along the river gradually decreases north of D3, and there is a rapid thickness decrease eastward from the river. Figure 28 shows a thin layer of silt covering a hill one-half mile east of the river.

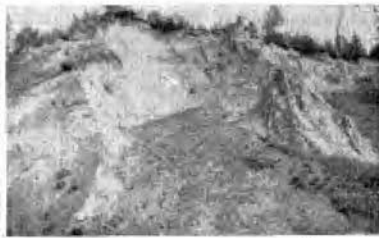
Figure 34. Ester Island sample site.

The Ester Island section (F8) is an old placer gold mining pit. Oxidation is occurring at the present surface of the silt and down recently formed cleavage planes. The latter show diffusion banding. Figure 34 shows the sample site of the Ester Island section.
