Proceedings of the Iowa Academy of Science

A NOTE ON A SINK HOLE

E. J. CABLE

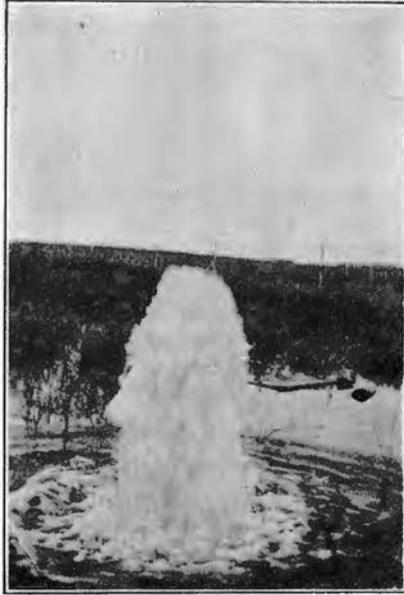
Fig. 32. Sink hole south of Rolfe, Pocahontás county.

hole not only filled up with water, but became a spouting spring. A column of water several feet high and several inches in diameter was continuously forced up. The phenomenon was so unusual that its fame spread and people came from considerable distances to witness the novelty. Although the spouting was continuous for three or four weeks the amount of water forced up varied and it was observed that there was a gradual decrease in the flow, until after the heavy spring rains the flow ceased and finally even the lakelet disappeared. Compare figures 32, 33 and 34.

That the water was not the immediate run-off was shown by the fact that the water forced up through the sink hole was clear and free from sediment. The phenomenon may have been due either to tile ditches connected with this particular sink hole, or a natural drainage to this particular joint or fissure. Sufficient underground drainage was directed to the joint to develop the hydrostatic pressure.

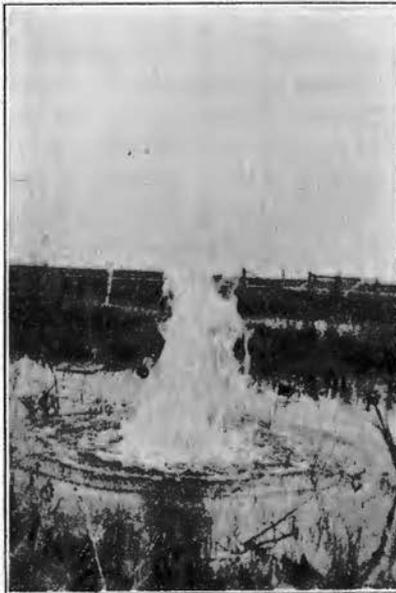
Fig. 33. The same sink in a later stage.

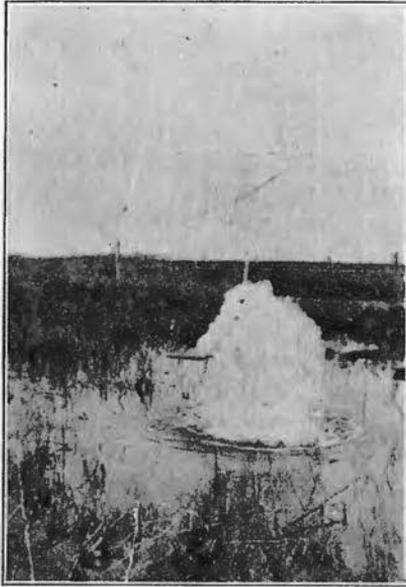
Fig. 34. The same sink in a still later stage.
